Pioneer MXT-X366BT Metal Case Replacement

This guide details how to remove and replace the metal sleeve surrounding the radio.

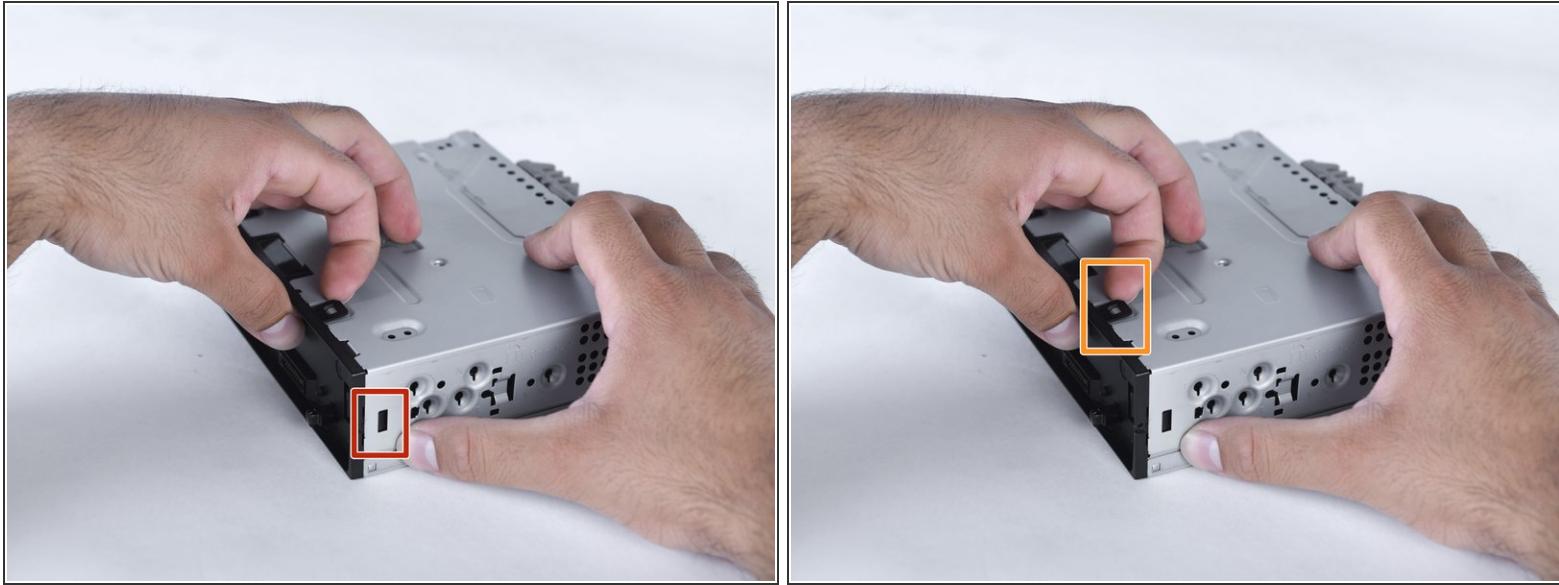
Step 1 — Metal Casing

- Apply small amount of pressure inward with a plastic opening tool to release bottom clip.
- Pry the top clip with the plastic opening tool to release it.

ⓘ The head unit is symmetrical and has the same amount of clips on the other side.

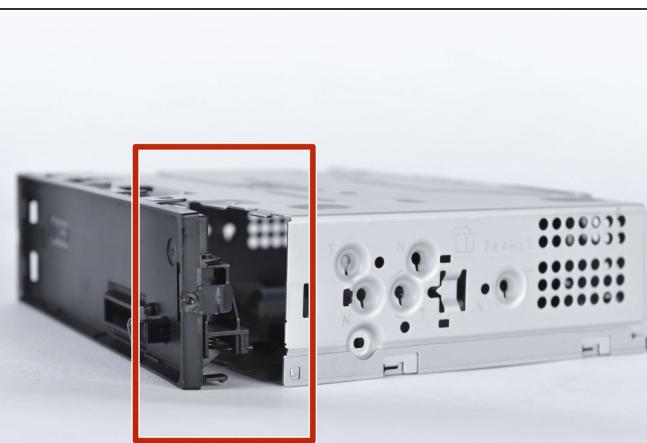
Step 2

- Remove the face plate holder.

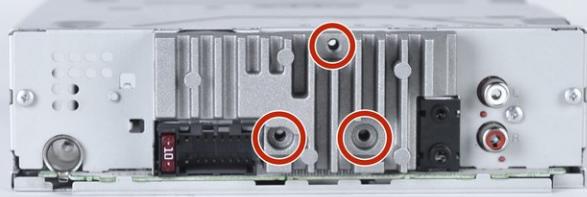
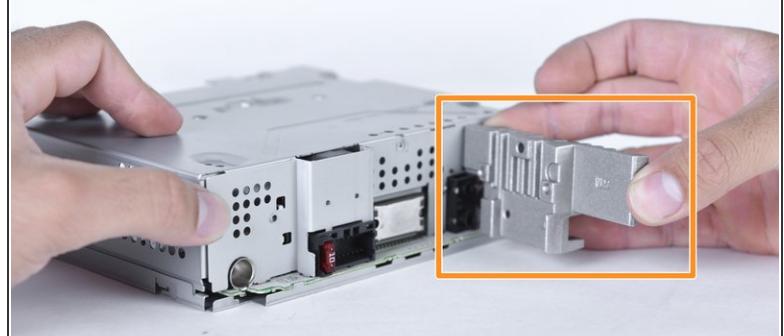
Step 4

- Remove the inner three 5mm Phillips head screws, with a Phillips #2 screwdriver, attached to the metal backing.
- Remove the metal backing that is now free.

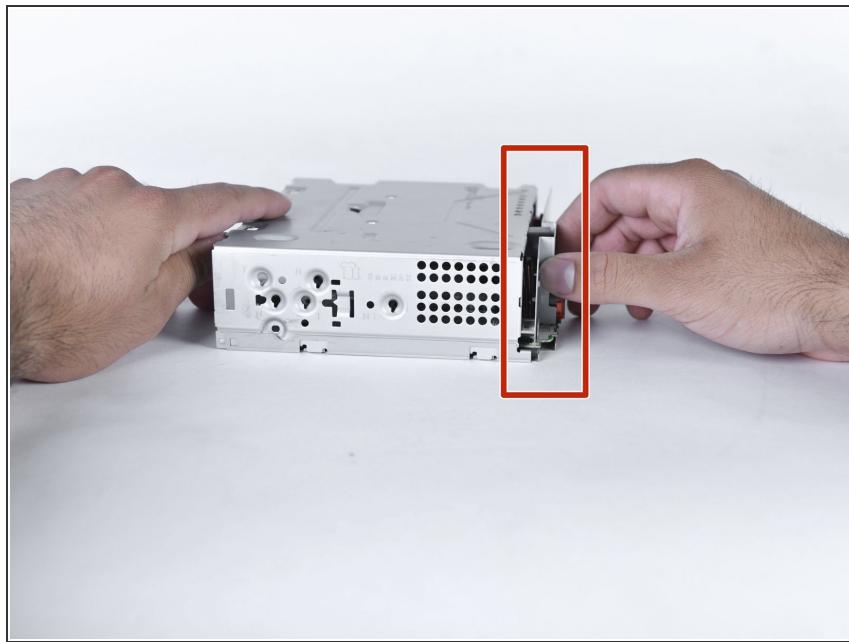
Step 5

- Carefully slide the metal casing forward.
- *i* Metal piece standing is the rear of the head unit.
- ⚠ Edges are sharp.

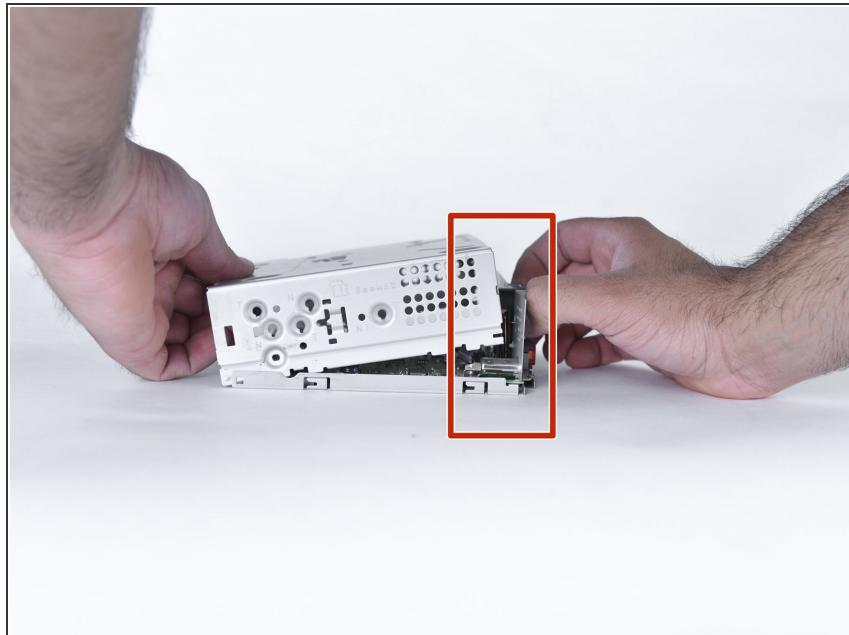
Step 6

- Lift the metal casing from the rear and pull it away.
- ⚠ Edges are sharp.

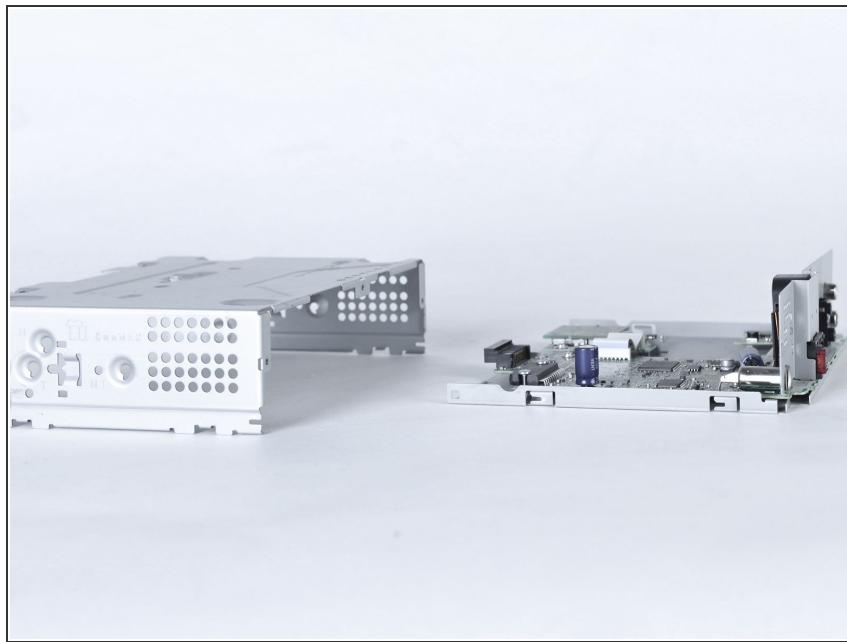
Step 7

- The metal casing is now fully removed.
