# Puffco Peak Teardown

Repair your Peak charging jack instead of chucking it.

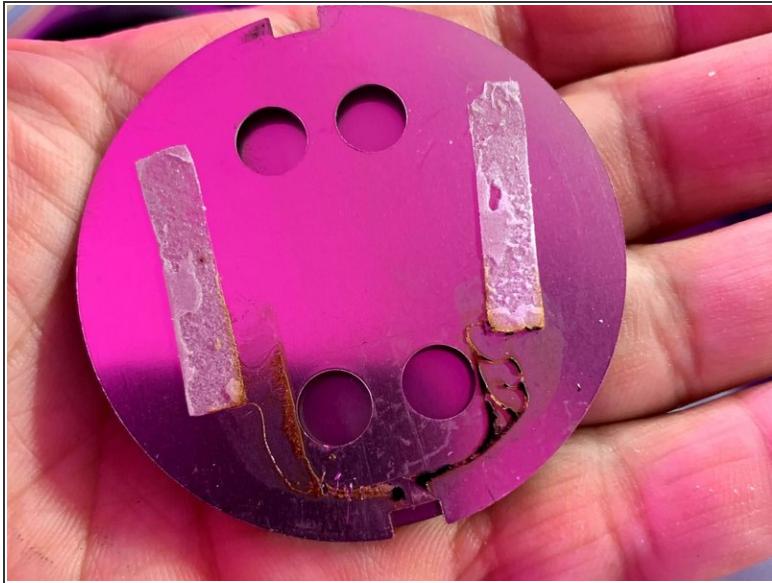
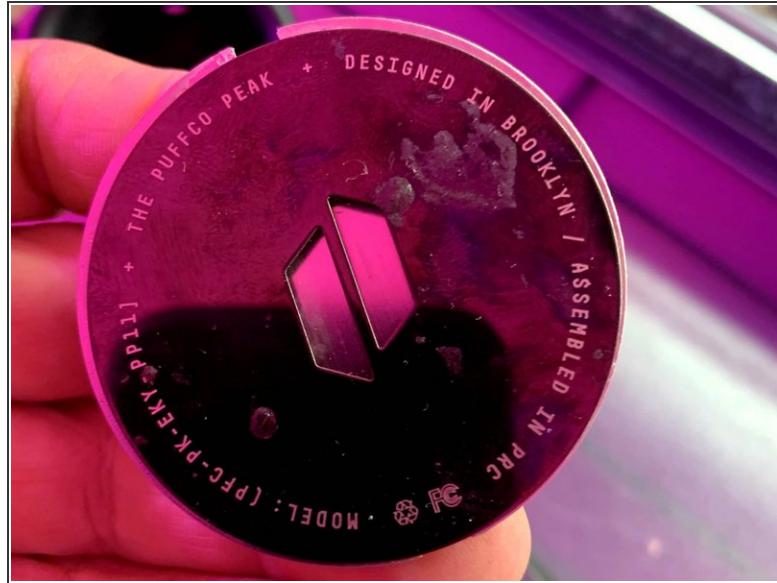
## Step 1 — Remove base plate

- This is held on with adhesive tape. You can warm this up with something to soften the glue

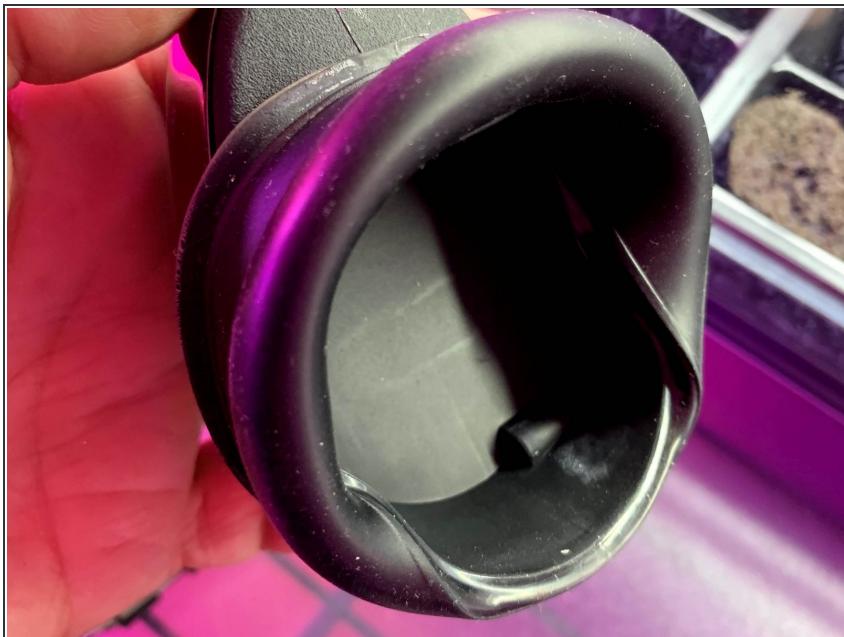
## Step 2 — Remove the rubber boot

- After removing the glass, roll the rubber boot from the bottom up, and slide off in one piece.

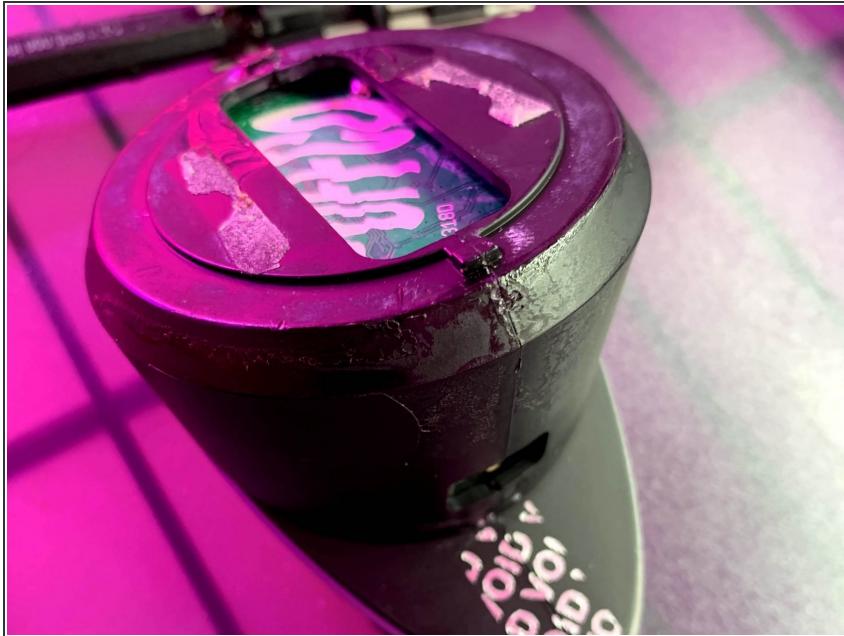
## Step 4 — Separating case halves

- Once screws are removed, remove the warranty tape (notice the void after removal). The halves are held together with glue. I warmed mine up on a heating mantle.
