# RYDIS H68 Pro Side Brush Motor Replacement

The motor that controls the side brush may be defective causing the side brush to stop spinning in your RYDIS H68 Pro. Replacement guide here.

Written By: jude auguste

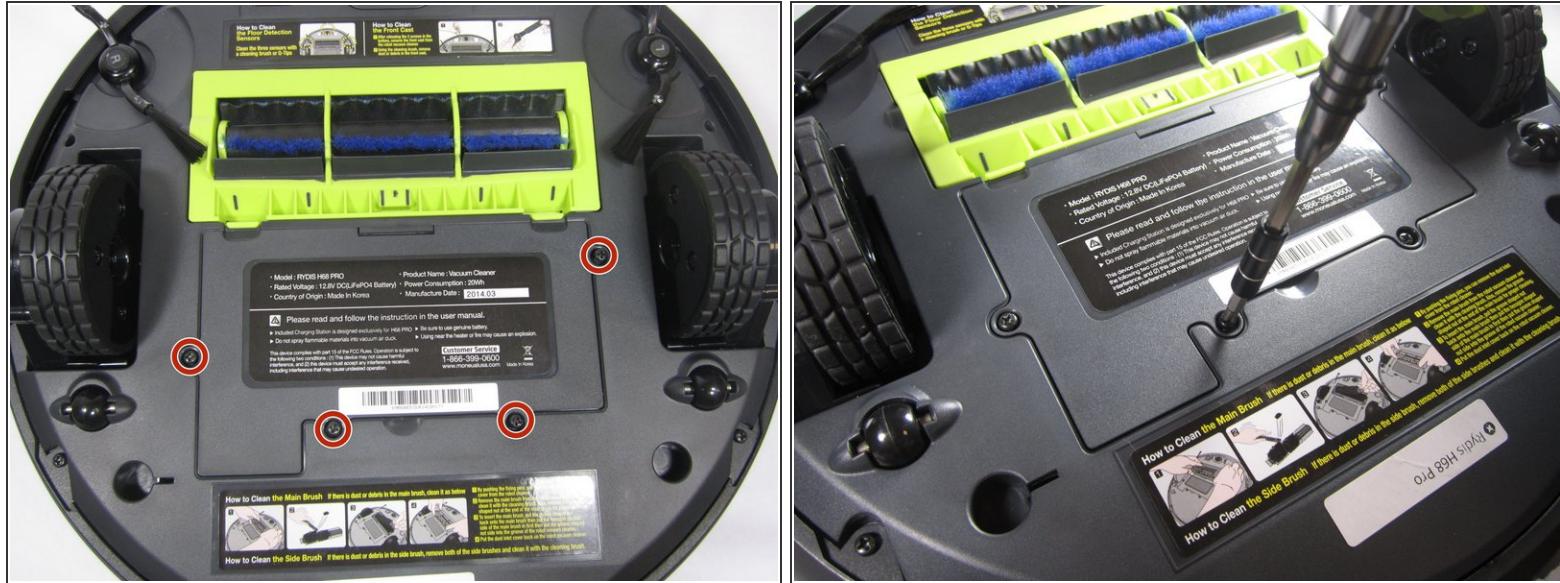
## Step 1 — Battery

- Flip the vacuum over so that the wheels are facing you.
- Use a Phillips #1 screwdriver to remove the four 10mm screws that surround the battery cover.

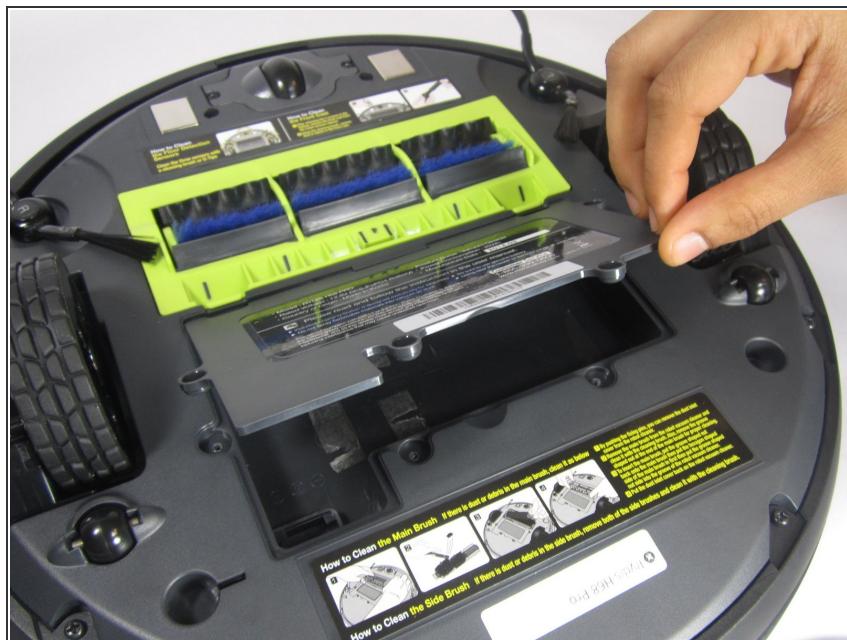
## Step 2

- Lift up the battery cover to reveal the battery.
- Remove the battery.

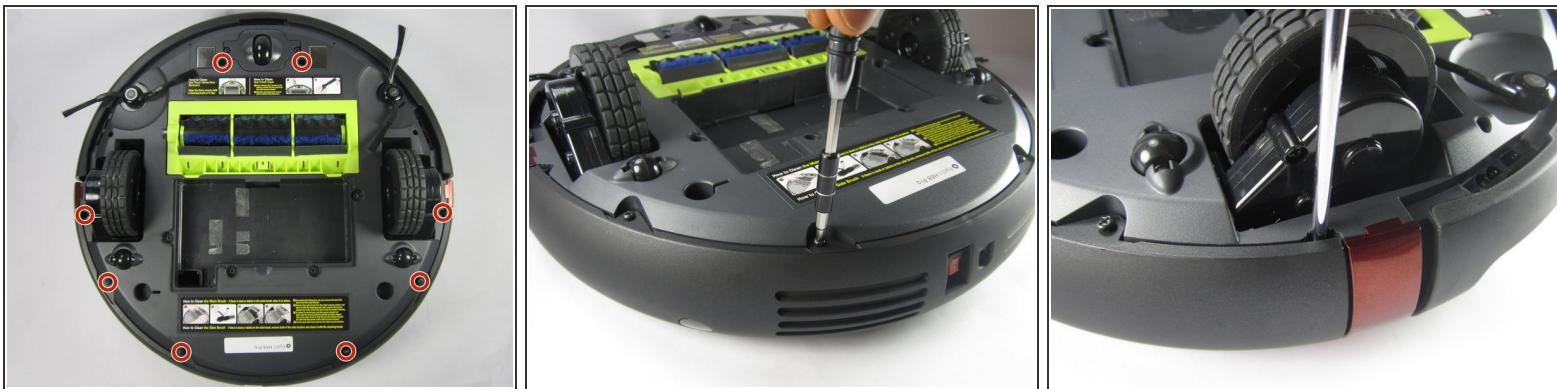
## Step 3 — Bumper

- Remove the eight 10 mm Phillips #1 screws.

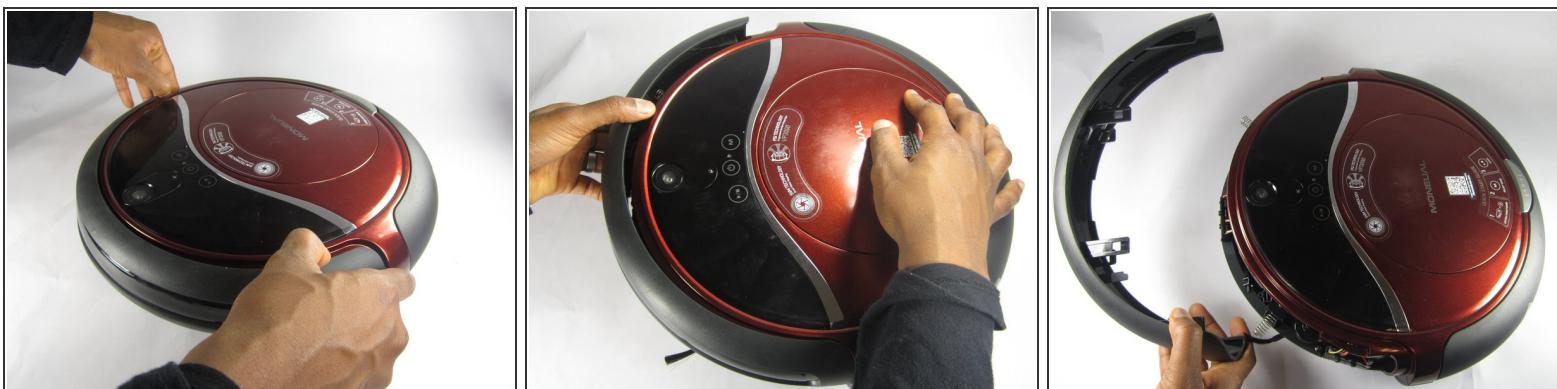
## Step 4

- Hold the front bumper and pull it off.

*(i)* It requires a lot of force to pull the bumper off.

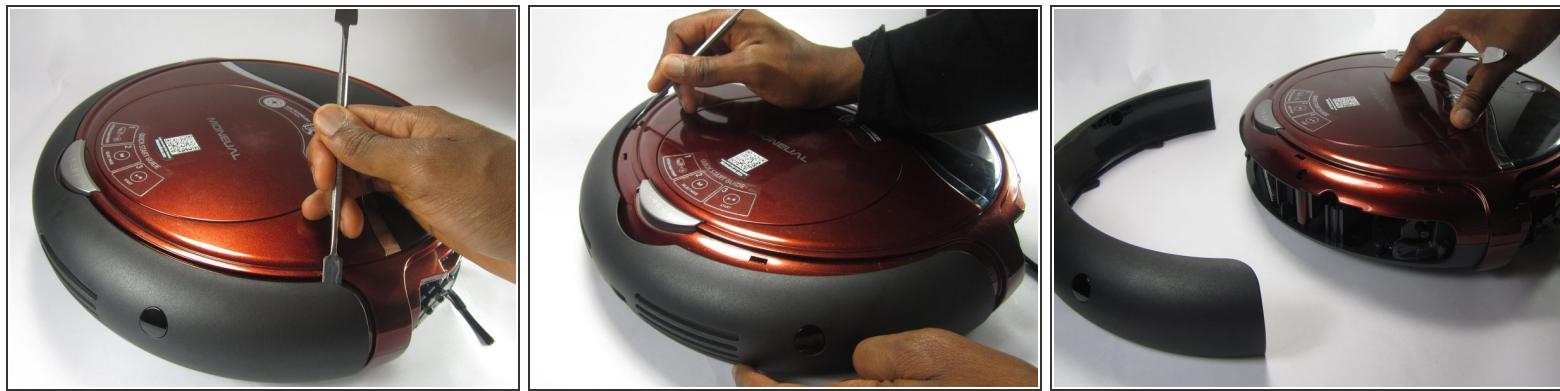
## Step 5

- Pry off the back bumper by going around the entire top of the bumper with the metal spudger.

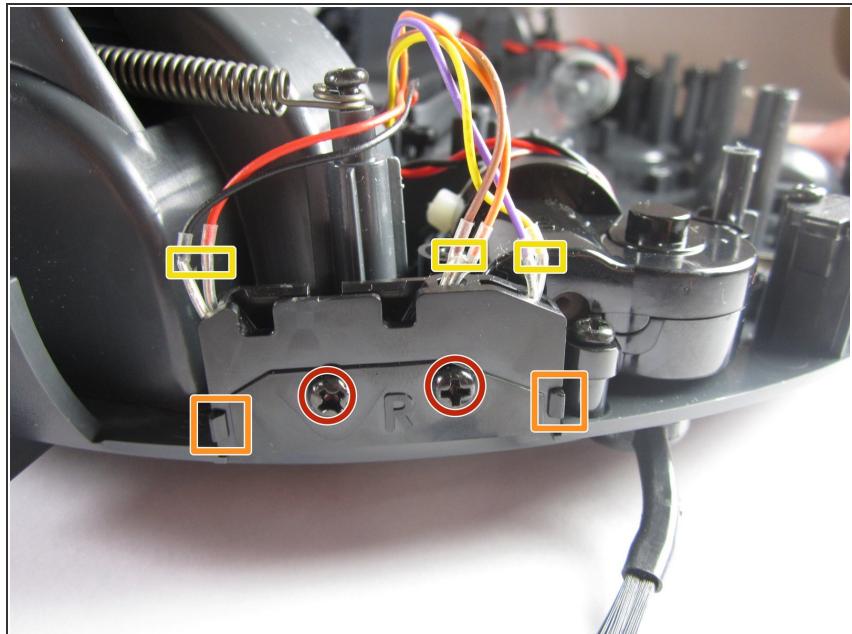
## Step 6 — Side Brush Motor

- Begin by unscrewing the 2 10mm screws using a Phillips #1 screwdriver.
- Unlatch the latches indicated. It can be easily done with your finger.
- Once unsecured, the covering for the sensors can easily be removed allowing access to the sensors.

*(i)* The reason for these first few steps is to avoid damaging the signal wires for the sensor.

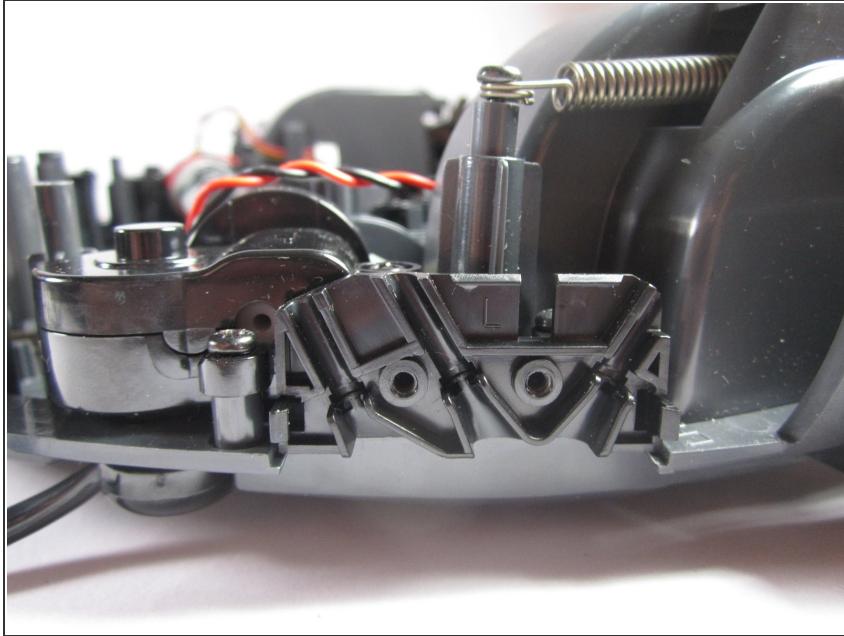
## Step 7

- This step just shows you how everything looks after the previous steps were completed.
- *i* There are sensors on both the left and right side. This can be done for either side.

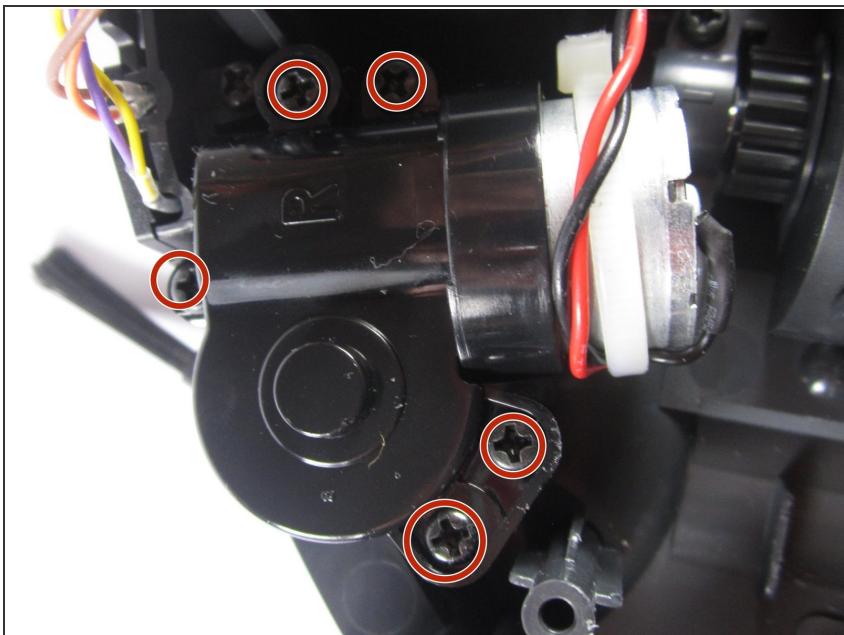
## Step 8

- Unscrew the five 10mm screws using a Phillips #1 screwdriver.

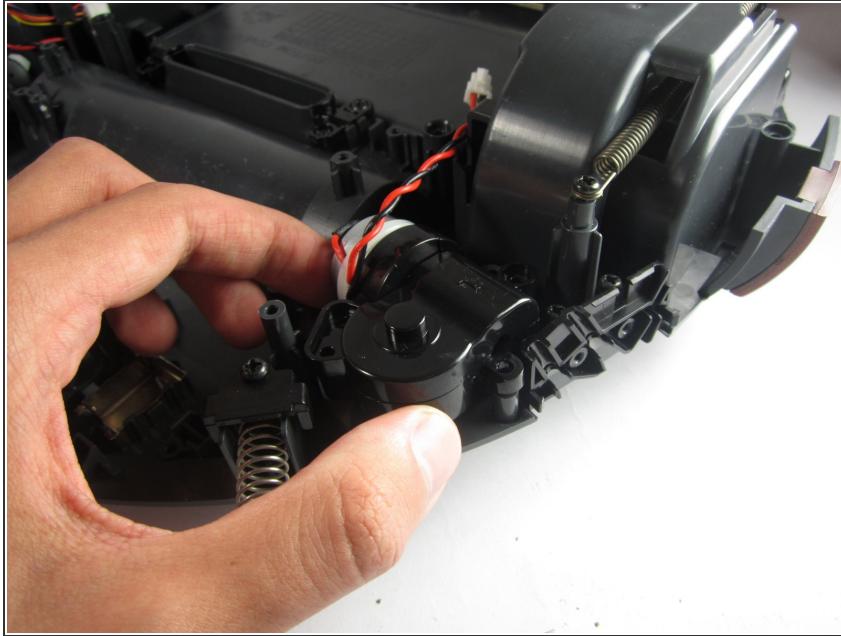
## Step 9

- The side brush motor can now be removed by lifting it up.

To reassemble your device, follow these instructions in reverse order.
