Rapoo E6700 Bluetooth Touch Keyboard Teardown

This 'guide' shows that it is NOT possible to repair a damaged USB connector on this device.

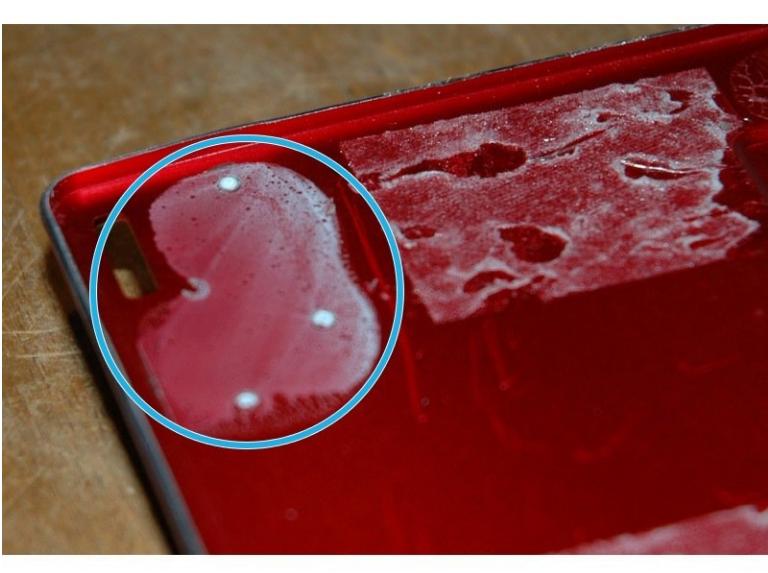
Step 3

- Well for those who try to get the keyboard off, someone has developed superglue.
- Yes you heard it, not just sticky double sided tape, also superglue applied in the marked areas.

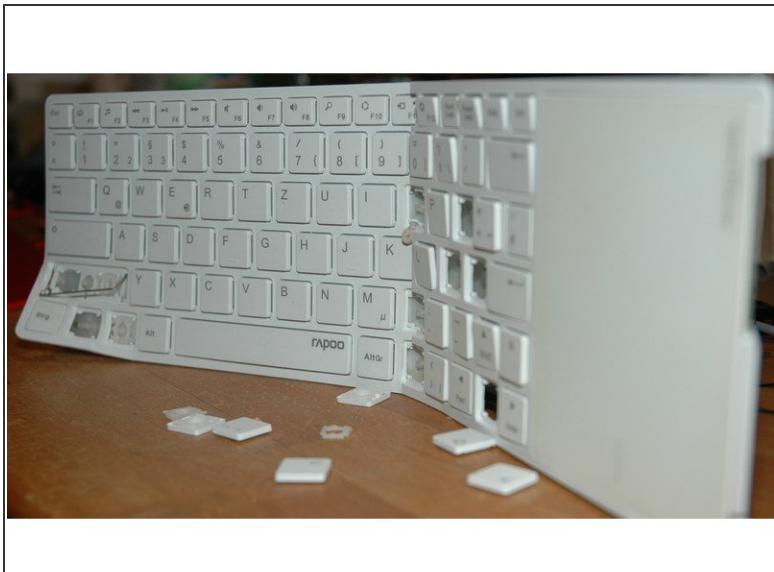
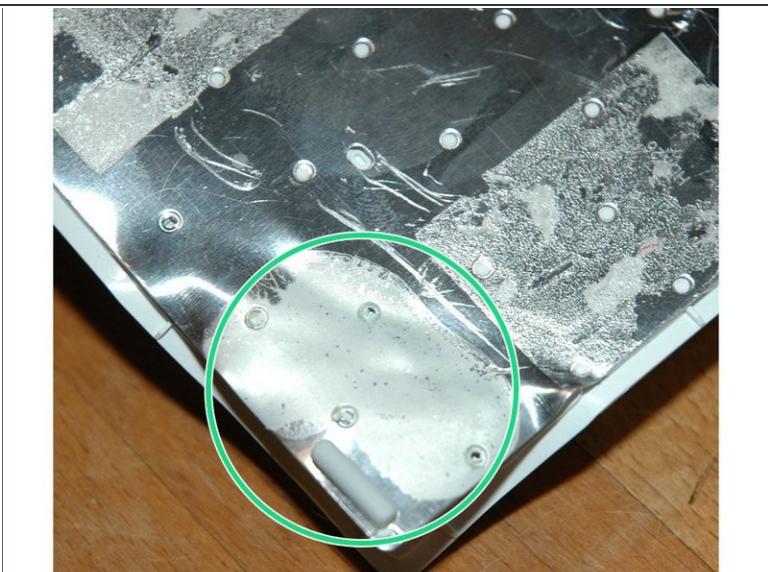
Step 4

- Here's the keyboard after 1 hour trying to separate the parts.
- And another view of the superglue residuals on the keyboard side.

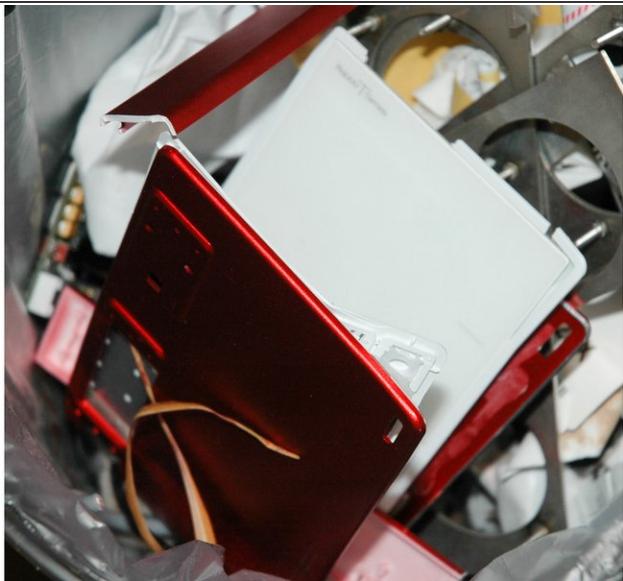
Step 5

- This is the '**repaired**' keyboard
- and the only reason to repair: the broken off (badly soldered) USB connector.
- What a waste of materials

To reassemble your device, buy a new one
