# Repairing Black and Decker - TS221 Ranger CD2000 Battery

Just like my other "high mileage" cordless screw driver, this Black & Decker model also stopped holding a charge. Here I will show how to build and replace the battery due to the unavailability of an original battery.

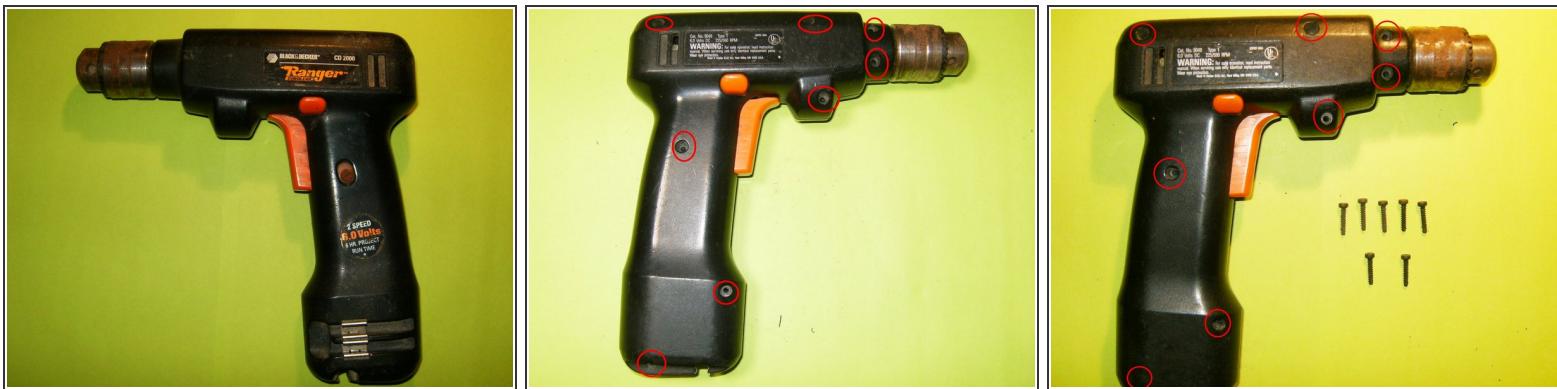
## Step 1 — Repairing Black and Decker - TS221 Ranger CD2000 Battery

- Here is my 2 speed TS221 Ranger CD2000 that does no longer hold a charge.
- Removed the 8 Phillips screws from the case.
- All screws are 3/4inch long and therefore the location of the screws does not have to be marked.

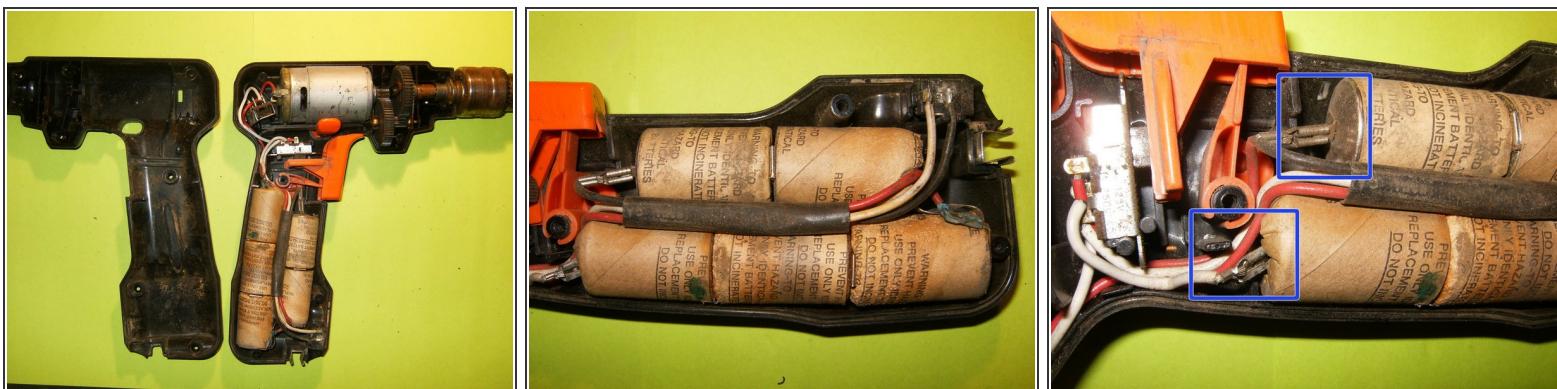
## Step 2

- Separate the case.
- Here is the old battery pack
- Disconnect the battery cables

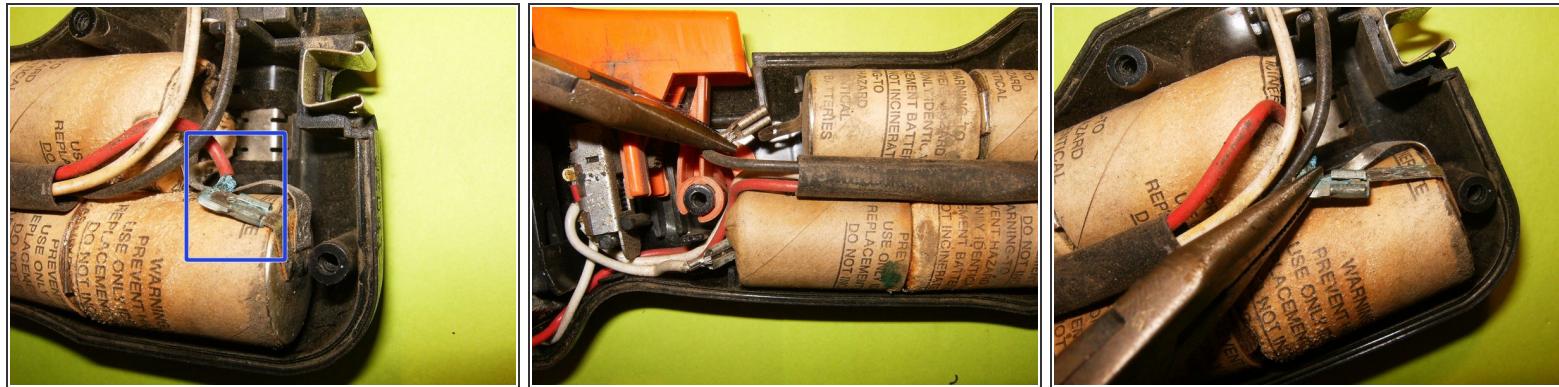
## Step 3

- Disconnect the battery cable on the bottom of the pack.
- It is easier to remove the top,
- and bottom cable with a pair of needle nose pliers.

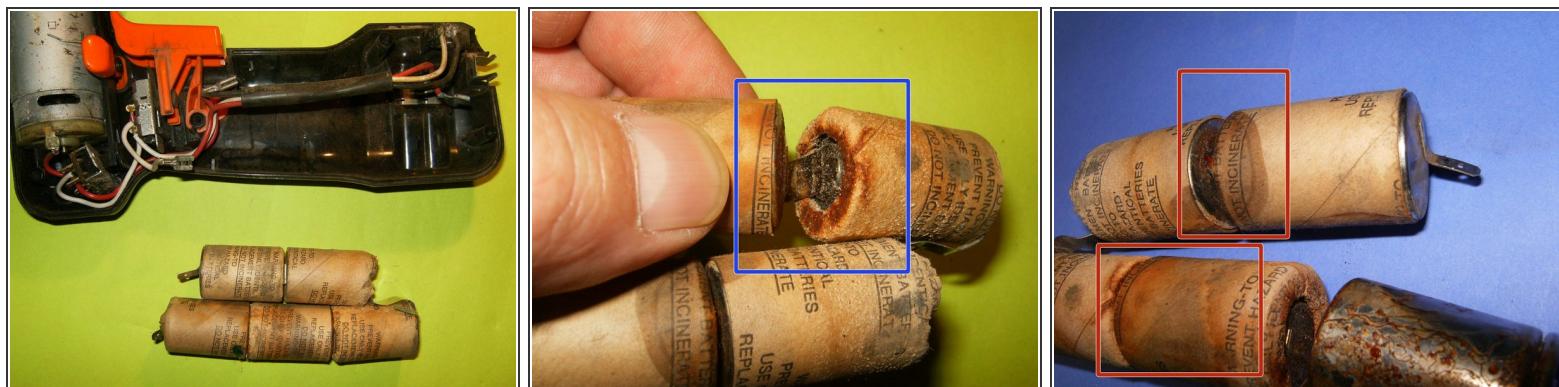
## Step 4

- Remove the battery pack
- Heavy corrosion can be found on all battery tabs,
- as well as some sort of liquid damage.

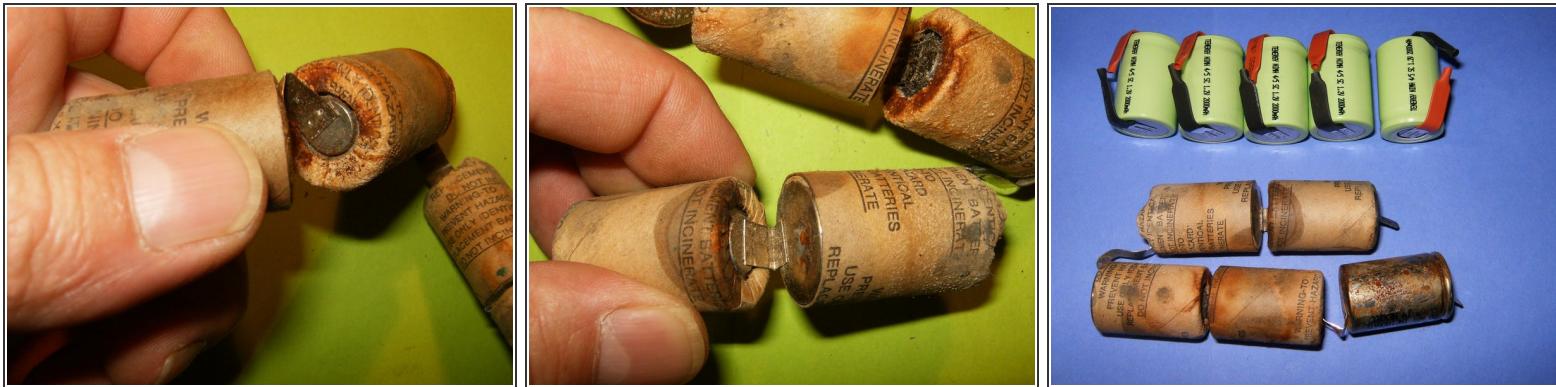
## Step 5

- The battery tabs or spot welded to the batteries.
- They are in series, meaning they connect from the positive post of one battery to the negative of the next.
- Here are the 5 replacement batteries. They are 4/5sub C batteries. This means they are 80% the size of a C battery. 1.3" (33.4mm) in length by 0.9" (23mm) in diameter. 5x1.2V in series gives 6V x 2000mah

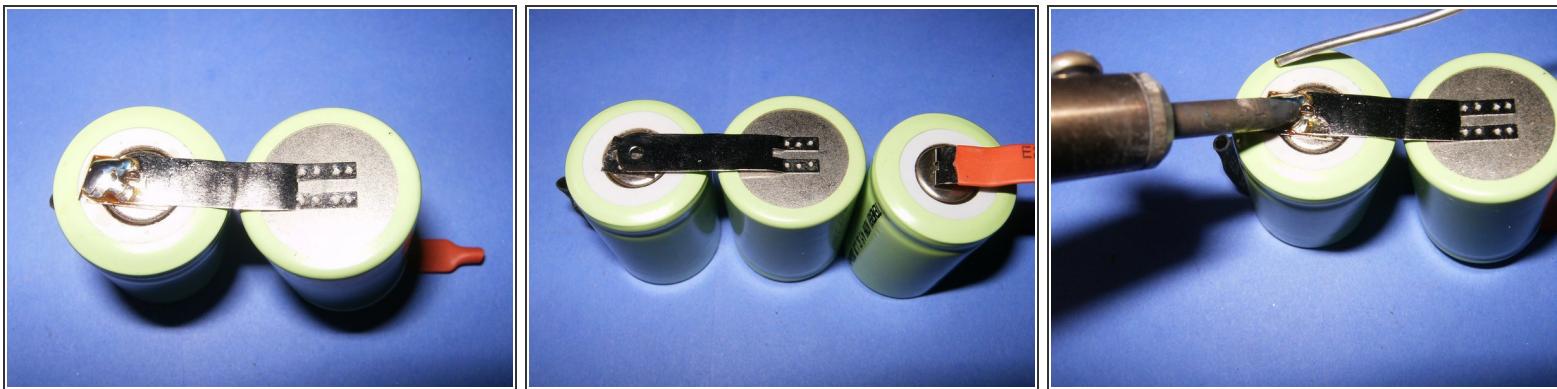
## Step 7

- Here is the first set soldered. Negative connects to positive.
- Continue with the next battery. Remember to now connect the negative from the second battery to the positive of the third.
- Again, use flux and solder the tab to the battery.

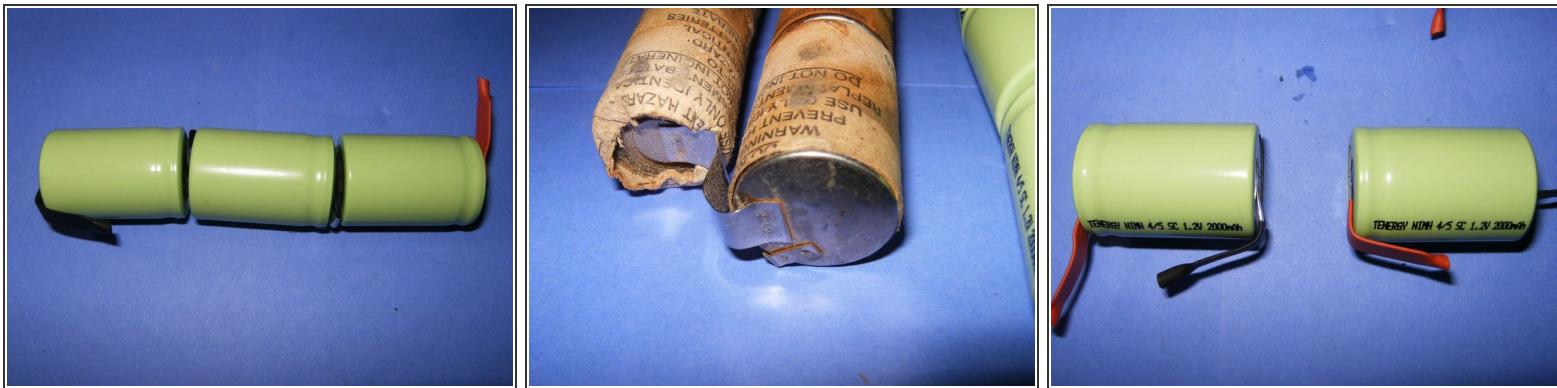
## Step 8

- Here is the completed first row of three batteries.
- To connect the next row, it is important to remember that the negative from the bottom row continues to connect to the positive of the top row
- Position the last two battery so that the polarity matches the way the connect to the back of three.
