Repairing Dolce Gusto Melody Water Seal

Showing how to repair the leaking water from the bottom of the machine caused by a dirty water seal near the bottom of the water tank.

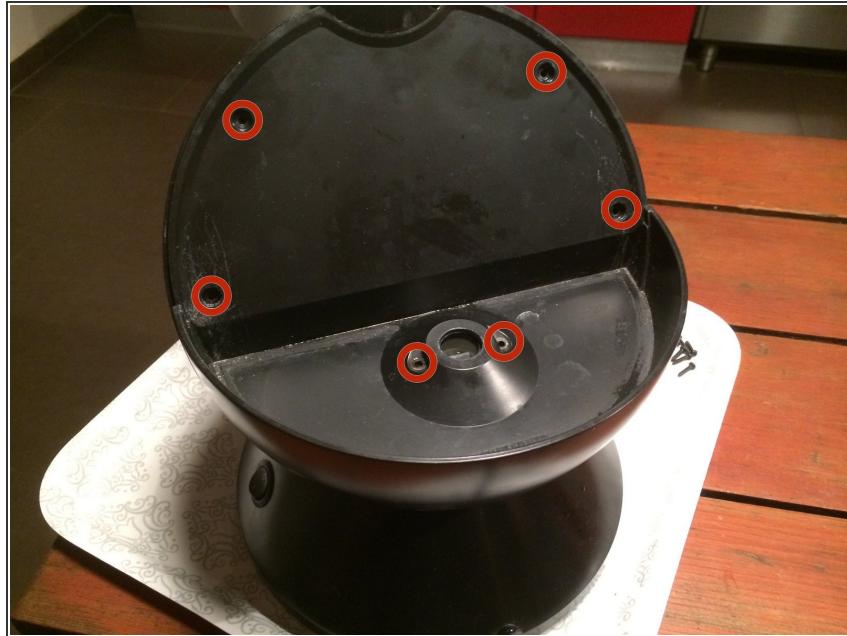
Step 1 — Repairing Dolce Gusto Melody Water Seal

- Remove the 6 screws from the back.

i Be sure to unplug the device before you begin the procedure.

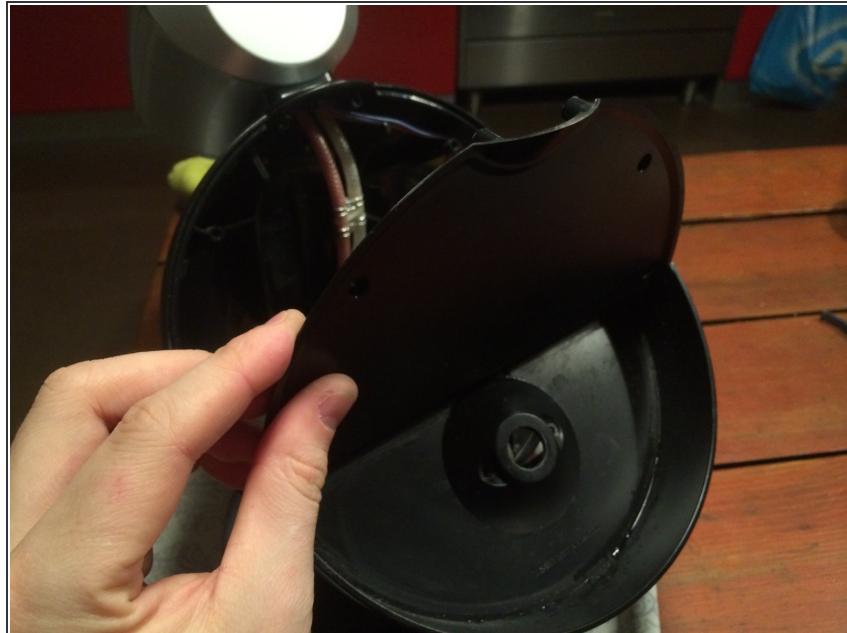
Step 2

- Gently pull at the top of the rear cover.

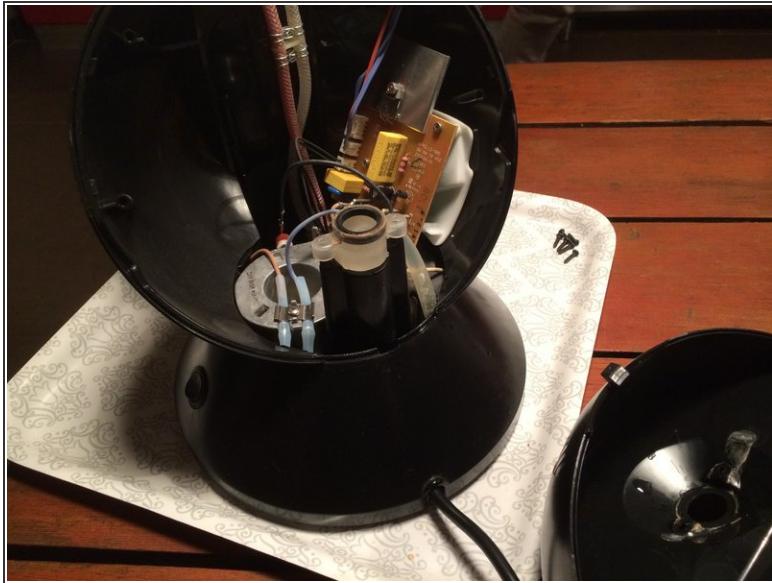
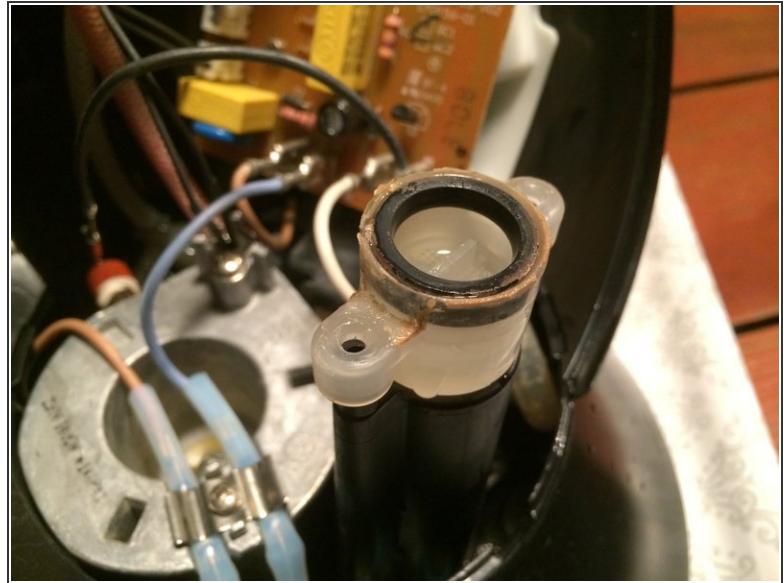
Step 3

- Locate the dirty seal inside

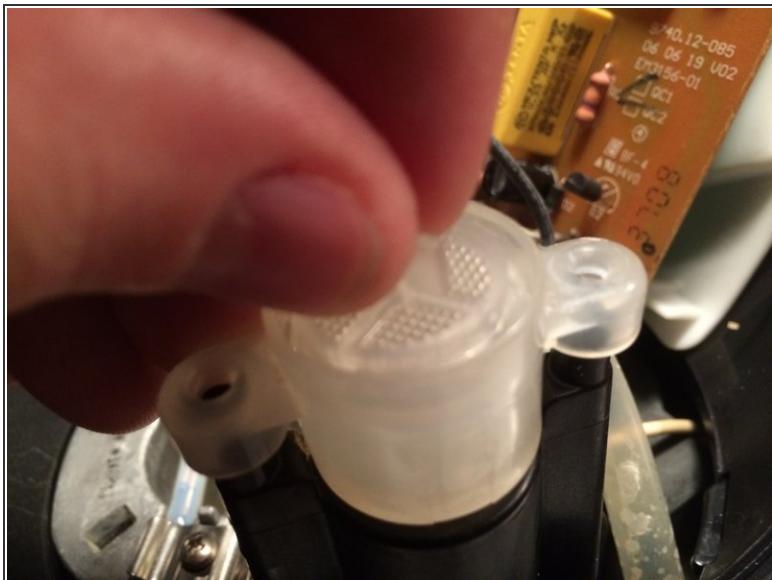
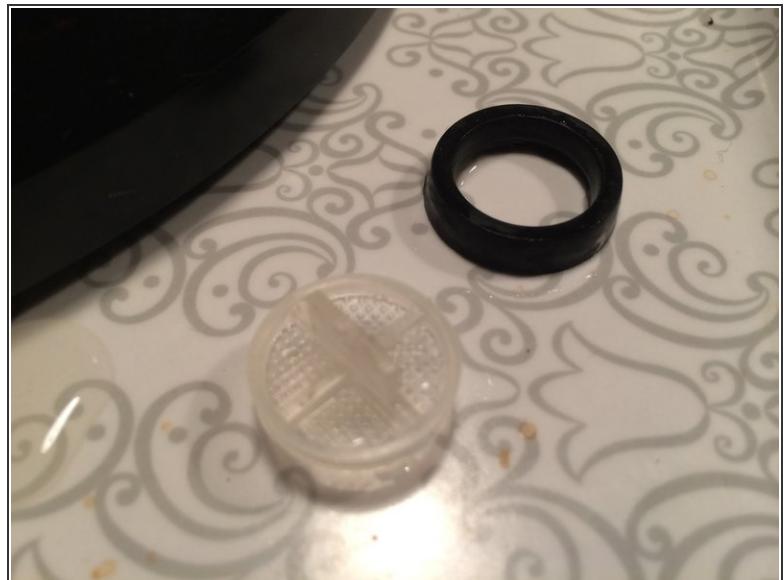
Step 4

- Pull out the rubber seal and the filter.

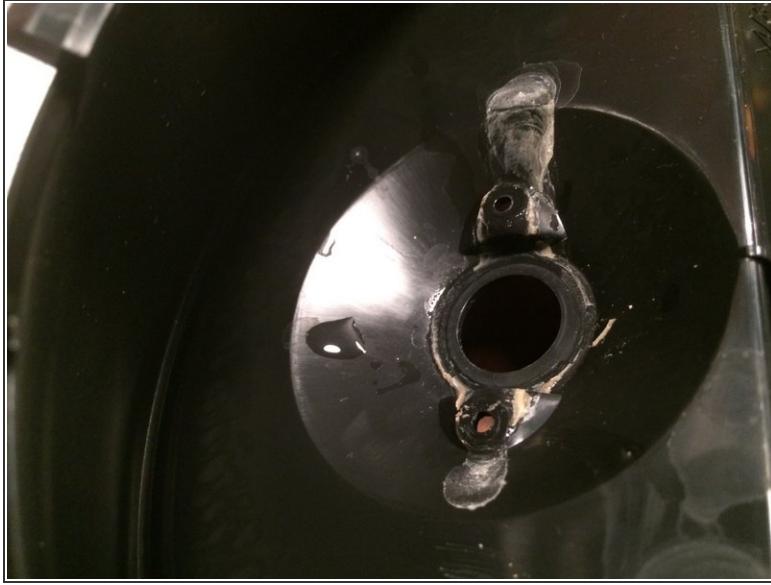
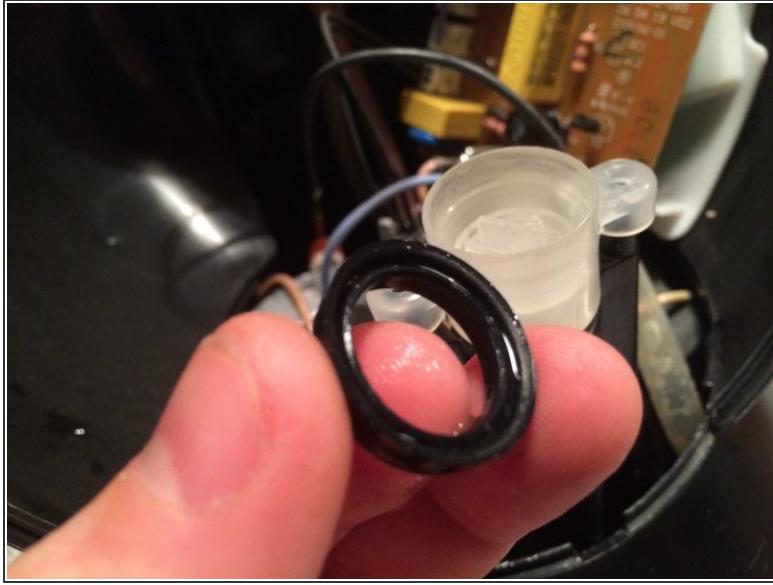
Step 5

- Clean the inside of the cover, the rubber ring, the filter and the holder of the rubber and filter.

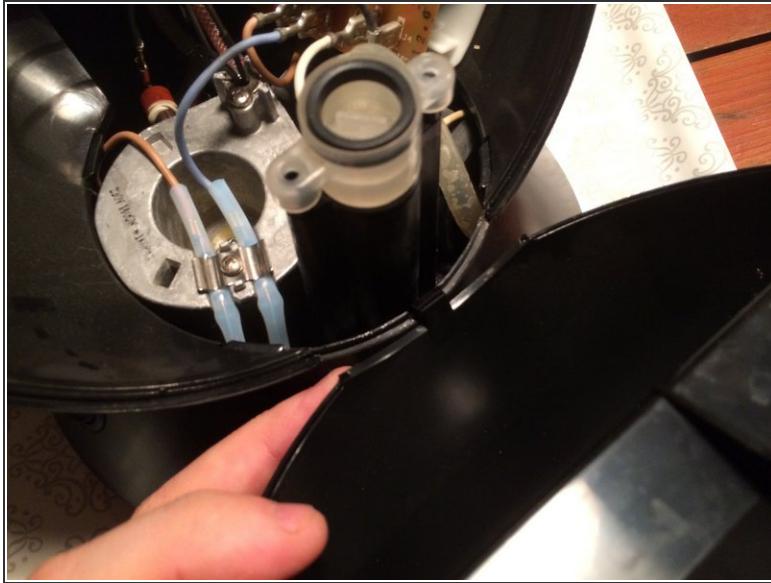
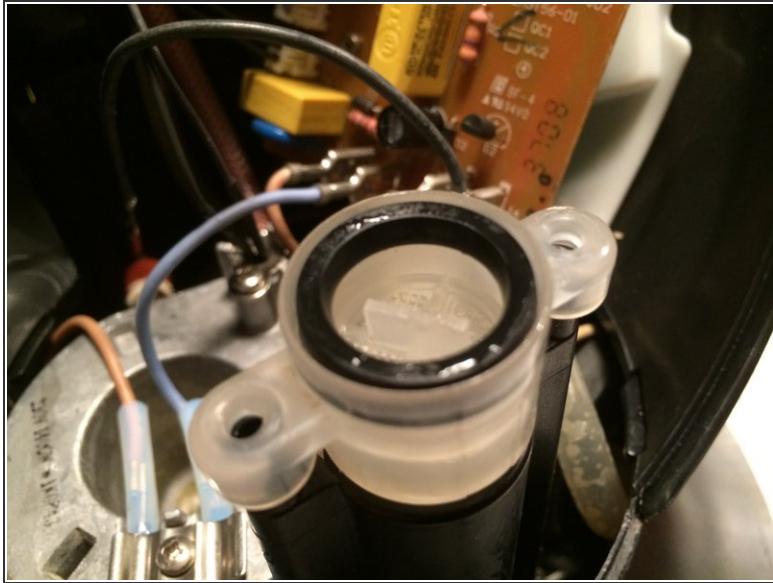
Step 6

- Put it all back together... First the filter, then the rubber ring... You need the smooth side of the ring facing up.

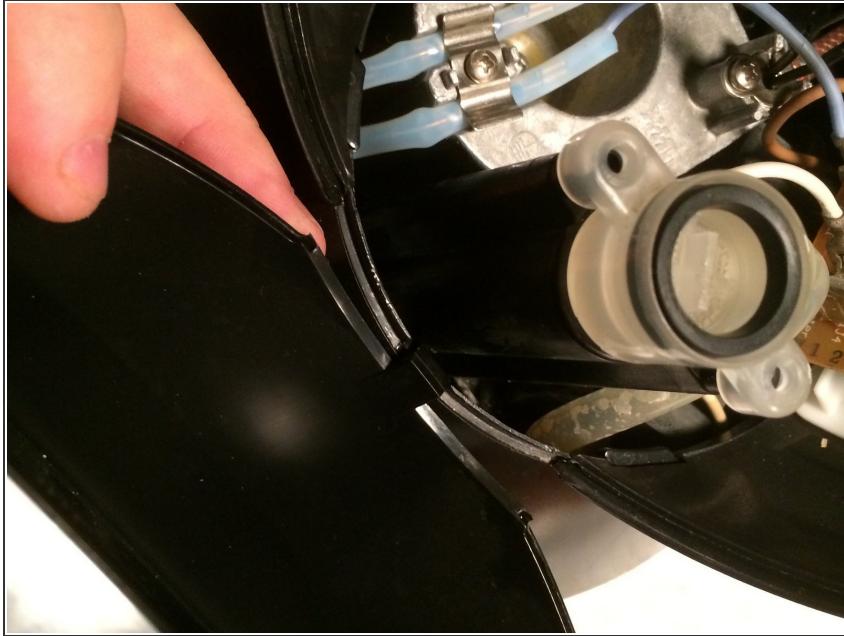
Step 7

- Hook back in the back cover, be careful not to break the clip at the bottom

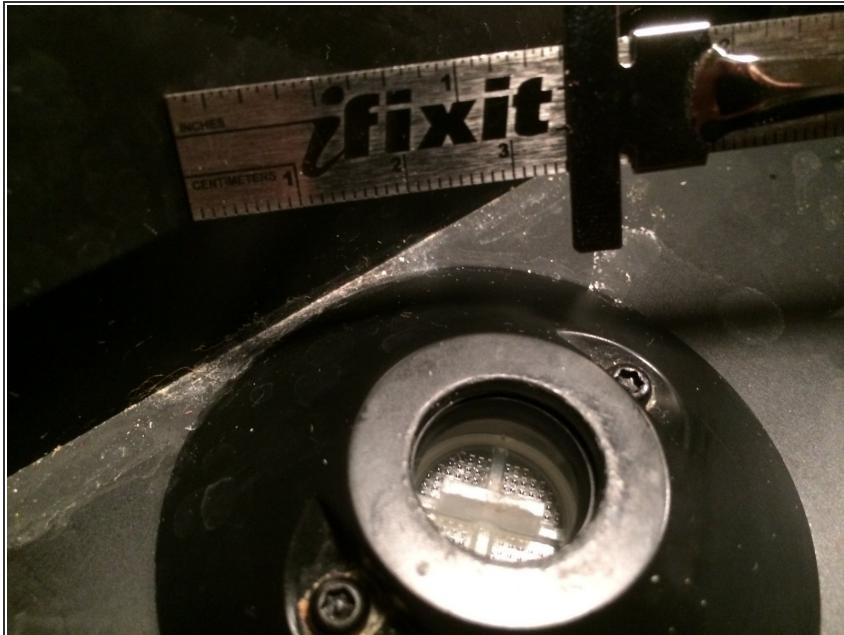
Step 8

- Back together... And you are ready to make some coffee...

In case you notice the water seal rubber is broken or has tiny cuts in it. You can re-order part: MS-0907124 - Krups Seal
