Repairing Mitsubishi WS-65511 Blinking green light fuse replacement

Repair of the green blinking light by replacing the capacitors on the DM board. This repair can also be performed on the following models: V21 MODELS WS-48511 WS-55511 WS-65511 WS-B55 V21+ MODELS WS-65611 V21++ MODELS WS-55711 WS-65711 WS-6571

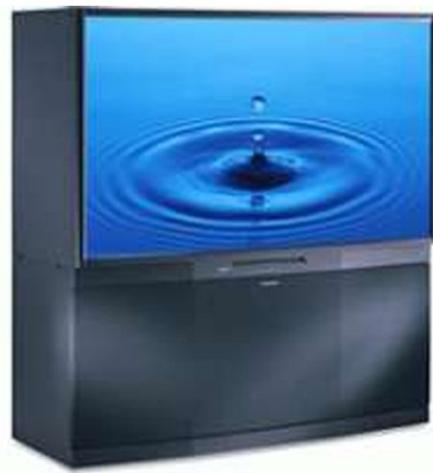
Step 1 — Repairing Mitsubishi WS-65511 Blinking green light fuse replacement

- Unplug the set. disconnect the coax cable and any other device plugged into the TV.
- Remove the back panel
- The antenna coax cable as well as other device connect directly to the DM module which is enclosed in a metal case.

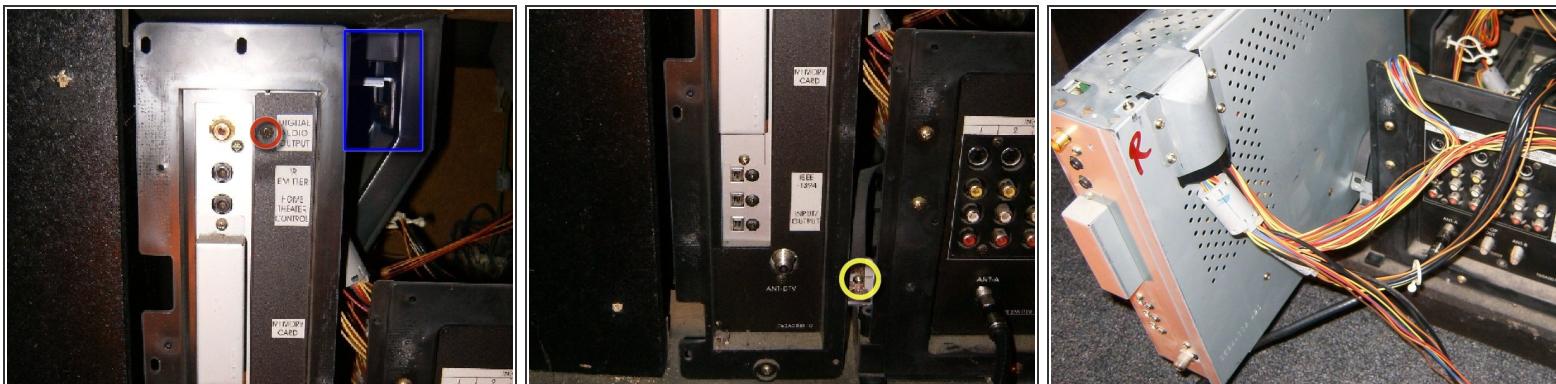
Step 3

- To the bottom right is a screw that connects a ground strap and holds the board to the chassis, undo that.
- With all the connector disconnected, the ground strap removed, pull the DM board carefully from the chassis. Some models have a small tab stop that you must push down to release the board.

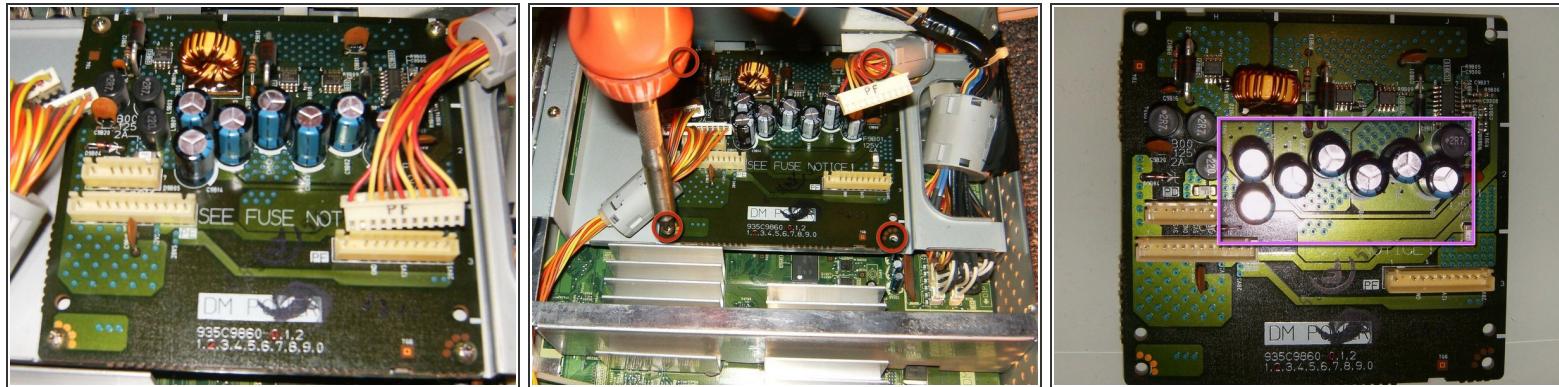
Step 4

- Remove the wiring attached to it (PD,PE,PF). These are simple connector and can just pulled of. These markings are **not** of importance to this repair. But they all are clearly marked on the connectors as well as the logic board they connect to. This will help to identify their proper position for the re-assembly.
- Remove the four screws holding the board on.
- This board has 7 1000uf 16Volt capacitors. These are the ones that have a tendency of failing. Inspect those for bulging tops as well as leakage. In this case, one capacitors was slighlty bulged.

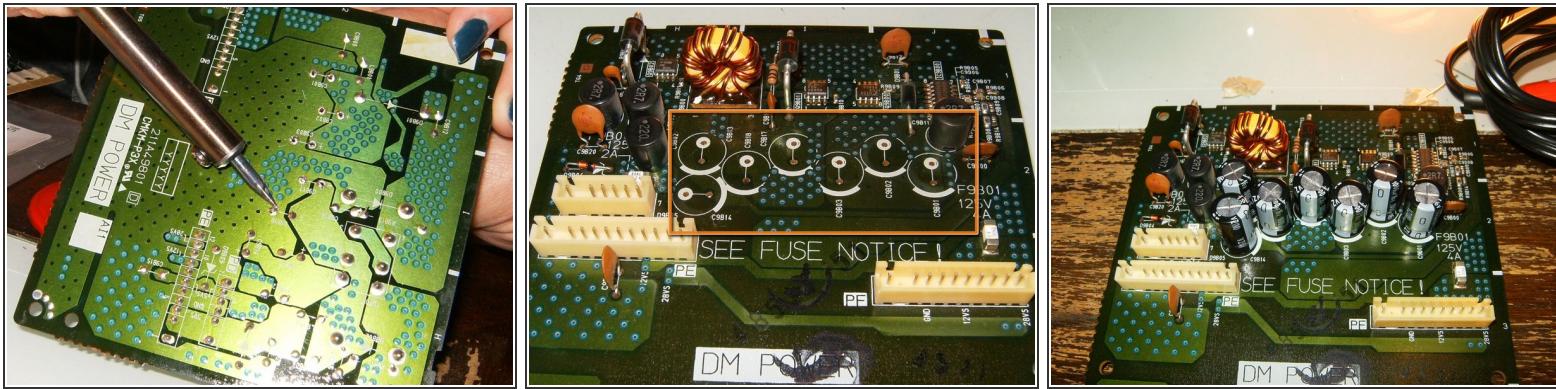
Step 5

- Unsolder all the capacitors and remove them. In this repair a 30watt soldering iron and solder sucker was used. The solder sucker can be substituted with soldering wick.
- Solder all the capacitors in their respective places. On the logic board, where the capacitors are located, is an outline of a circle with one part of the circle being heavier. It corresponds with the negative lead of the condenser.
- Once all the capacitors are replaced, double check the board to make sure everything is properly mounted.

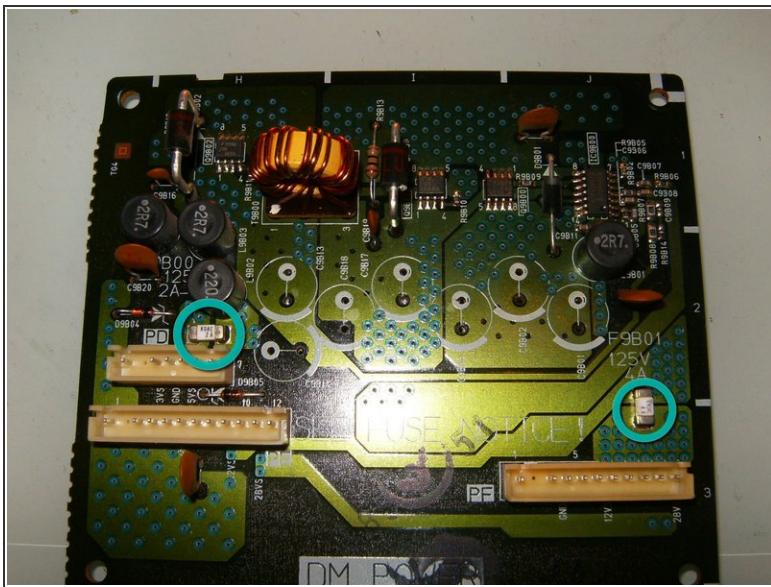
Step 6

- While the board and the DM power module are accessible check the SMD fuses for continuity. There are two on the daughter board. In this case, the fuses had continuity and were functioning.
- The main PCB has two fuses on the **underside**. In order to get to it, one will have to disassemble the module further. This was skipped in this repair.

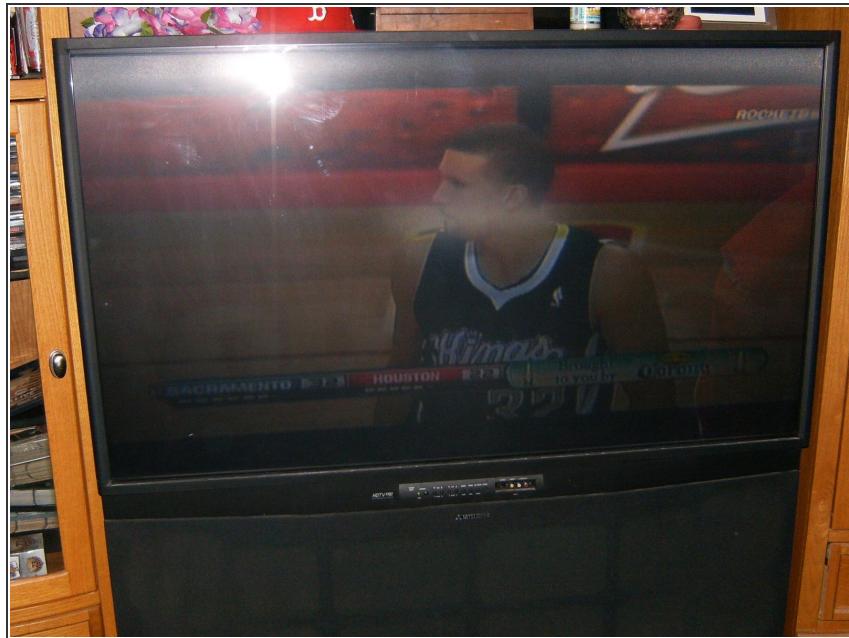
Step 7

- With the repair completed, everything should be double checked for proper soldering and proper polarity. The unit was re-assembled in reverse order. Reconnect all the wiring connectors. Double check for proper positioning and that all the connectors are properly seated.
- The TV was plugged in and after a minute of the green light flashing,.....IT WORKED. Total cost of repair was \$13 dollars for the UVK1C102MPD capacitors, which includes \$7 for shipping.
