# Repairing NEC VT700 Lamp Cover

How to repair a "Lamp cover error or lamp housing error" due to a missing part of the lamp cover.

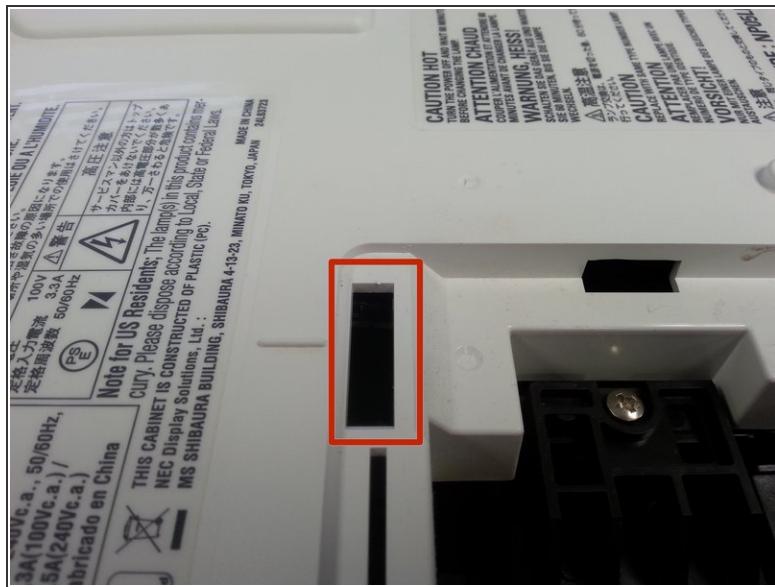
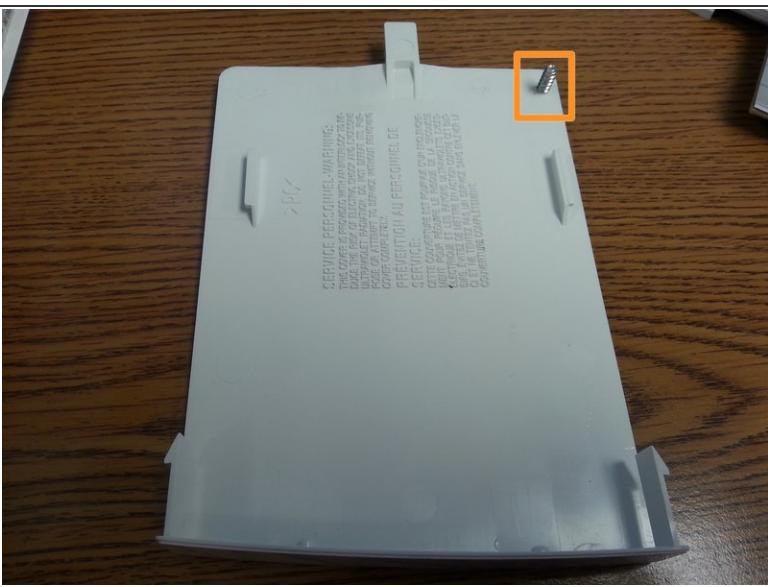
## Step 1 — The Root of the Problem

- This is the bottom of the projector with the lamp cover removed. The long rectangle shaped slot in the center of the photo has a micro switch located at the far end that would indicate the cover being in place.
- This is the inside of the lamp cover. At the marked location (sorry the repair is already in place) there should be a plastic "L" shaped extension from the cover. This would extend into the slot in the first photo and actuate the switch indicating the cover is in place. This was broken off of the cover.
