# Repairing TRITTON Kunai Right Speaker

This guide will walk you through repairing the right speaker on your headset if our troubleshooting page proved insufficient.

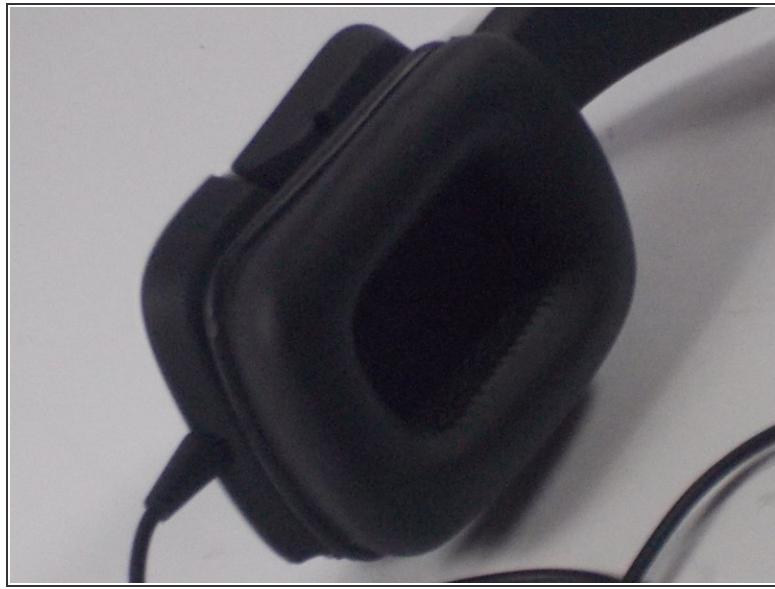
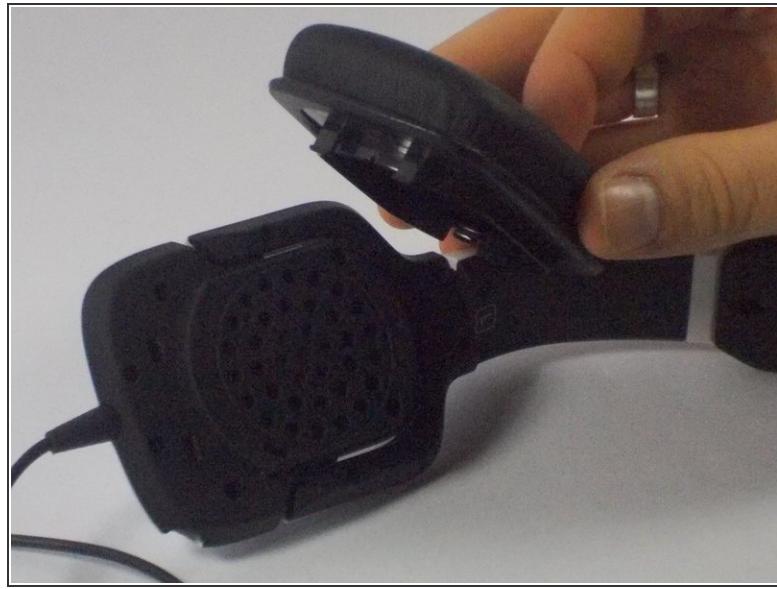
## Step 1 — Repairing TRITTON Kunai Right Speaker

- Firmly grasp the black ear cushion with one hand and the white speaker frame with the other hand.
- Forcibly pull the ear cushion and speaker frame in opposite directions, until the right ear cushion separates from the right ear frame.

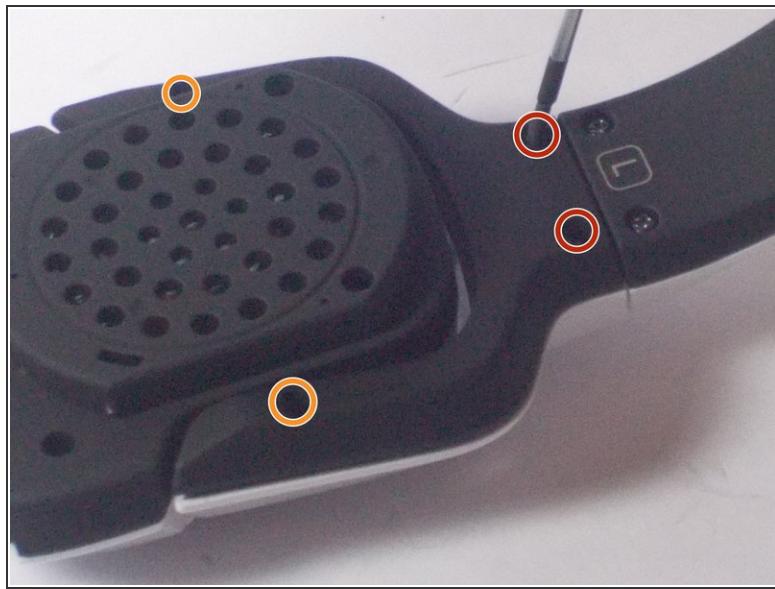
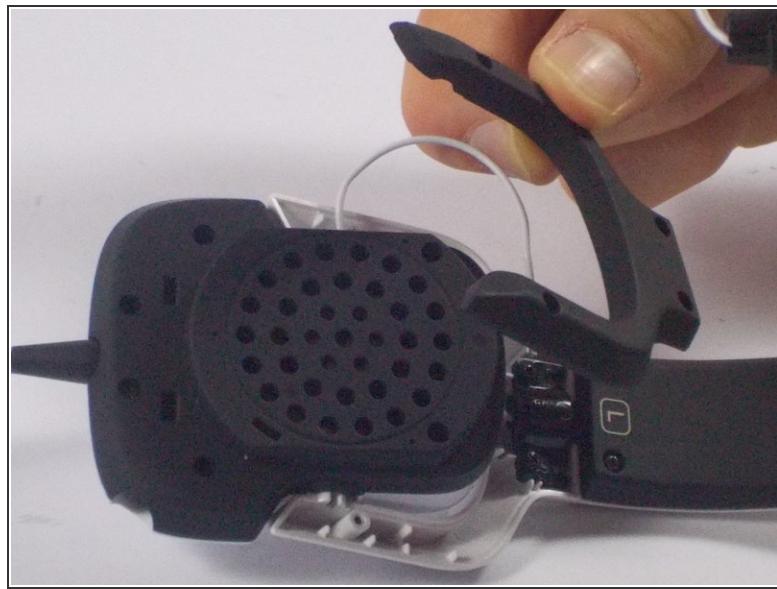
## Step 2

- Remove the two 9 mm screws indicated in red with a PH00 screwdriver.
- Remove the two 7 mm screws indicated in orange with a PH00 screwdriver.
- Separate the black horseshoe shaped frame from the right speaker frame.

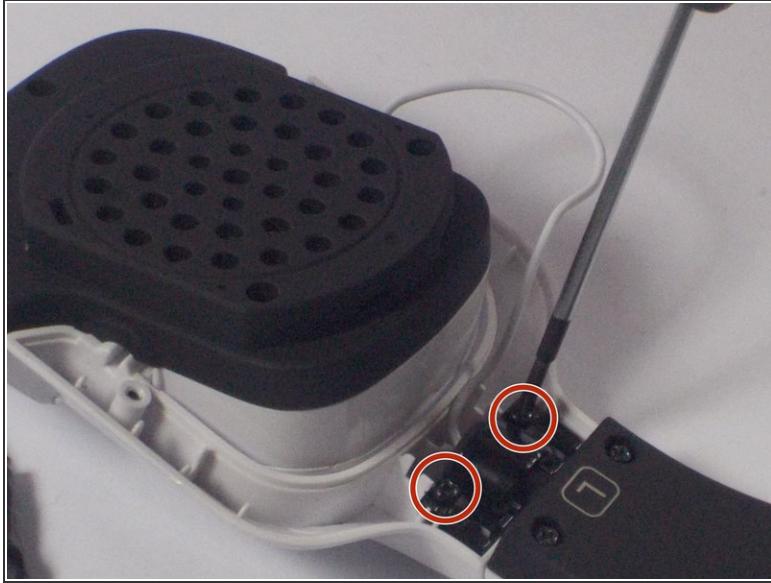
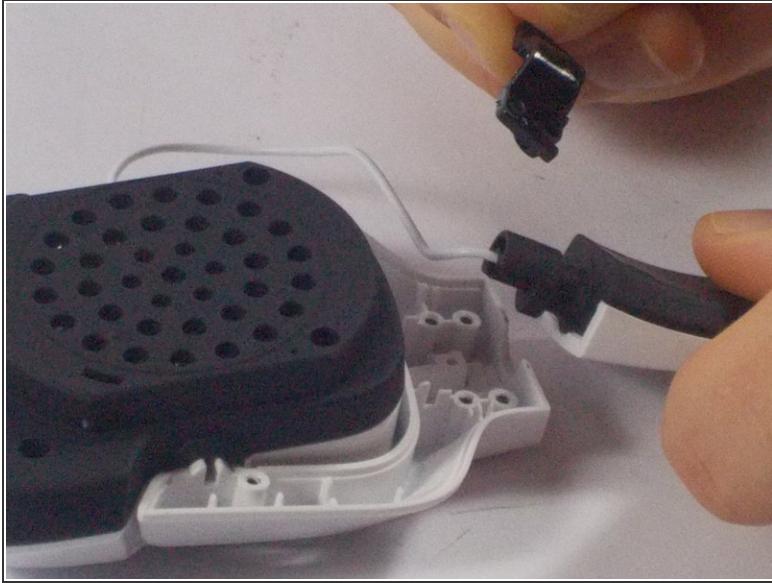
## Step 3

- Remove the two 7 mm screws indicated in red using a PH00 screwdriver.
- Separate the black bracket and then the rail adjustment from the right speaker frame.

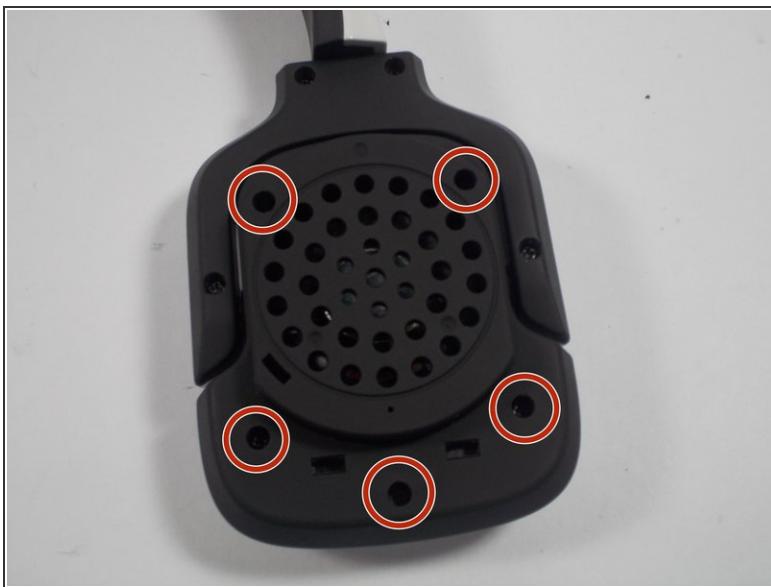
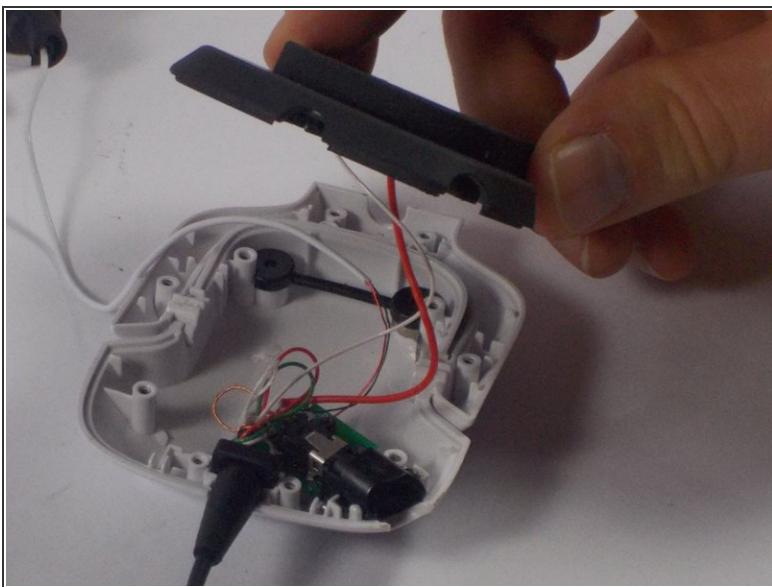
## Step 4

- Remove the five 7 mm screws indicated in red using a PH00 screwdriver.
- Separate the black speaker console from the right speaker frame.

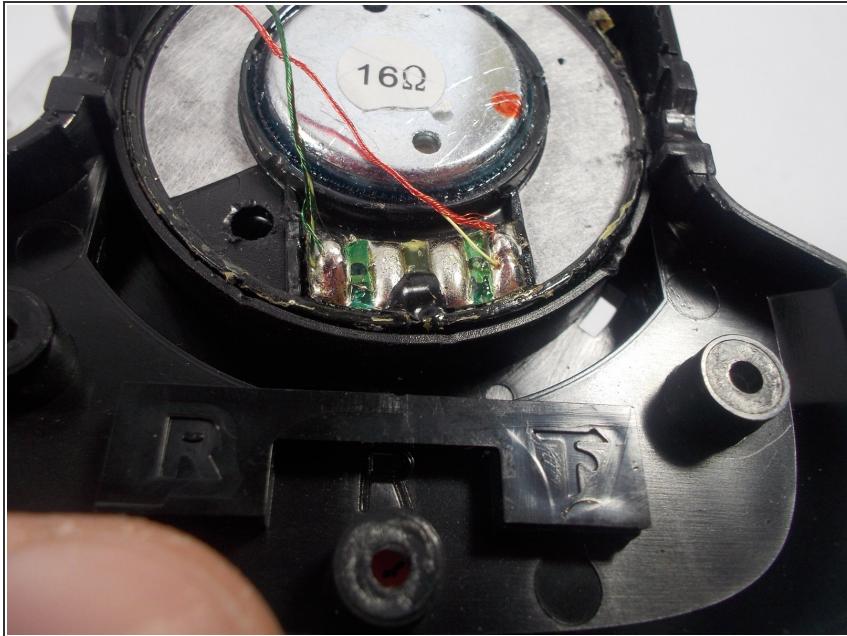
## Step 5

- Place the right speaker console face up with the four speaker terminals situated above the 16 Ohm speaker like so.
- Make sure the red wire is connected to the far right terminal and the green wire is connected to the far left terminal; if this is not the case solder your wires into place. [Here is iFixit's soldering guide](#)
- If you had to solder any wires, test your headset before moving to the next step.
- If your speaker is now working, put your headset back together. Otherwise, examine the wires for any damage or disconnections.
- Reconnect any damaged or disconnected wires and secure your wires into place with electrical tape.
- If you had to reconnect any wires, test your headset before moving to the next step.
- If your speaker is now working, put your headset back together. Otherwise, continue to step 6.

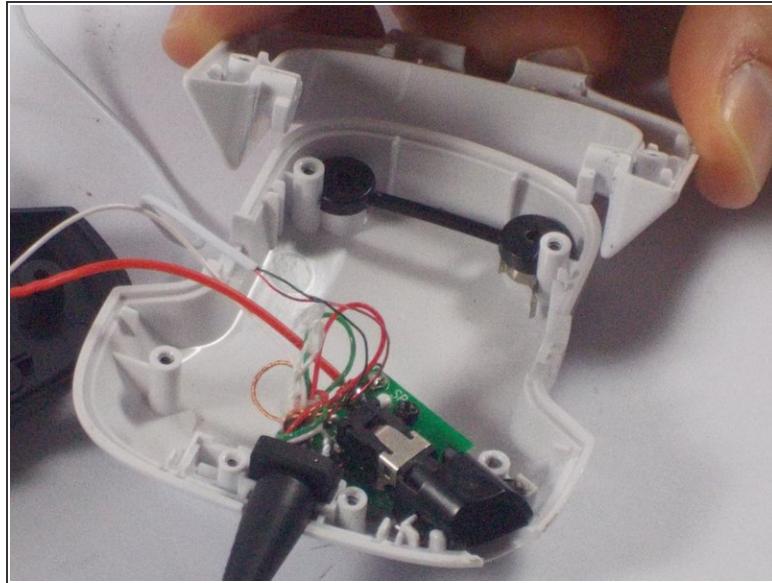
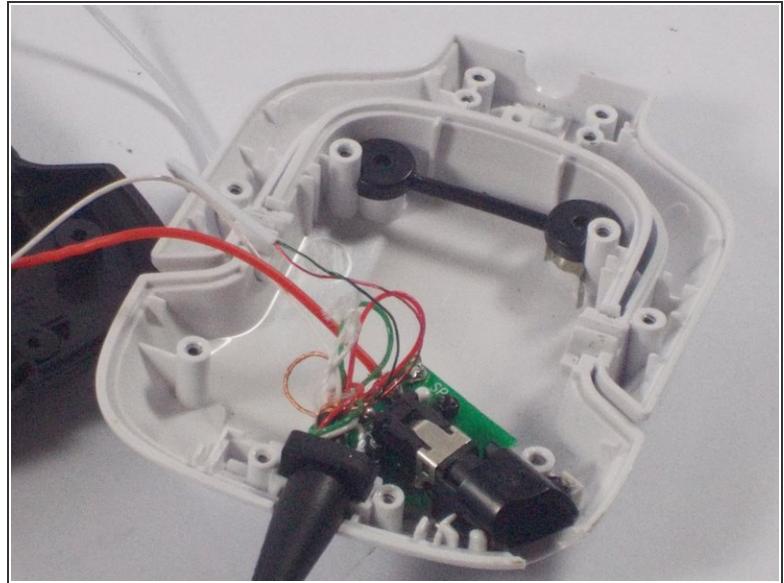
## Step 6

- Repeat steps 1 through 4 for the left speaker frame.
- The photos show the proper placement of the horseshoe shaped hinge onto the speaker frame.

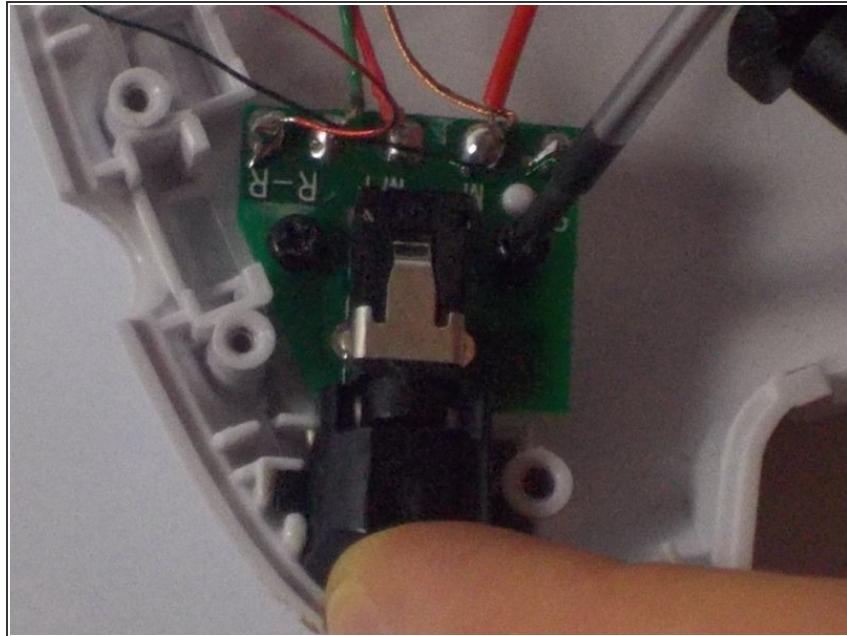
## Step 7

- Place your left speaker frame on a flat surface with the five metal terminals located on the green chip facing away from you like so.
- Make sure the green metal wire is connected to the far right terminal and the red metal wire is connected to the far left terminal. Solder the wires into place if they are not properly connected. [Here is iFixit's soldering guide.](#)
- If you had to solder any wires, test your headset before moving to the next step.
- If your speaker is now working, put your headset back together. Otherwise, examine the wires for any damage or disconnections.
- Reconnect any damaged or disconnected wires and secure your wires into place with electrical tape.
- If you had to reconnect any wires, test your headset before moving to the next step.
- If your speaker is now working, put your headset back together. Otherwise, continue to step 8.

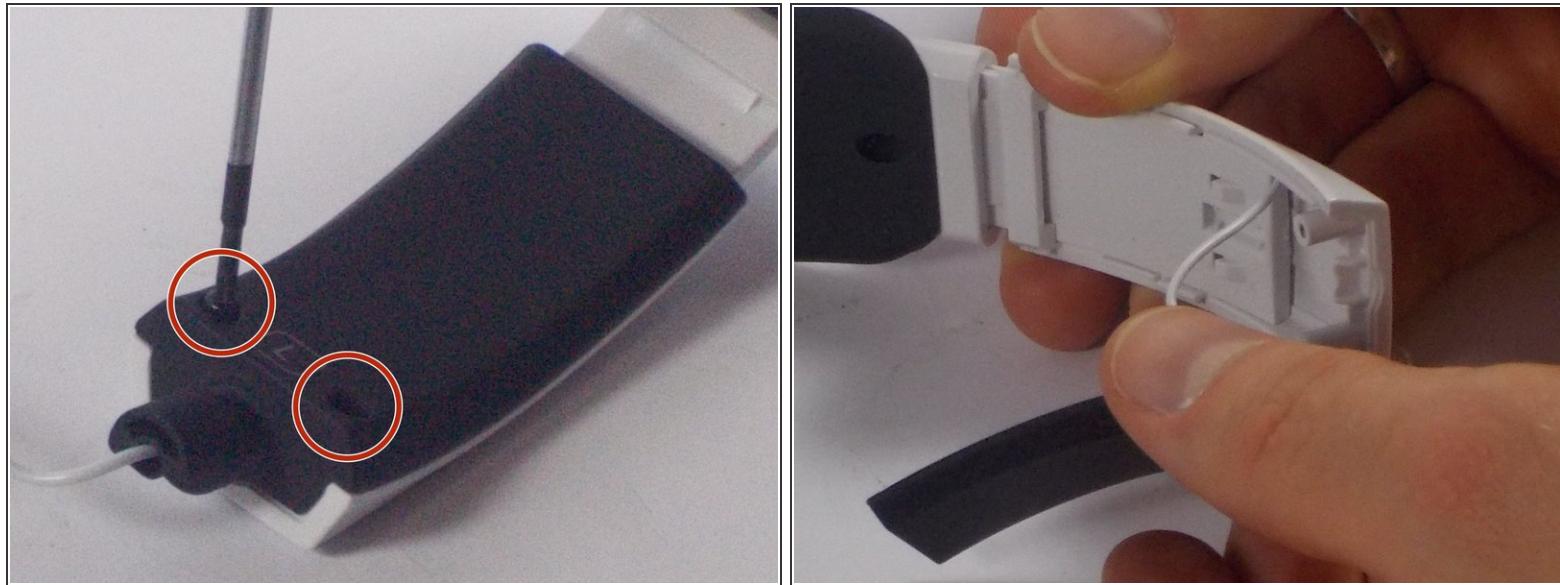
## Step 8

- Remove the two 7 mm screws indicated in red using a PH00 screwdriver.
- Forcibly pry the black rubber bracket from the white rail frame. This step causes a small metal bracket inside the rail frame to be dislodged; once this happens the black rubber bracket can be reattached, but the metal bracket cannot be put back into place.
- Complete this step for the black rubber bracket located on both the right and left sides of the rail adjustment.

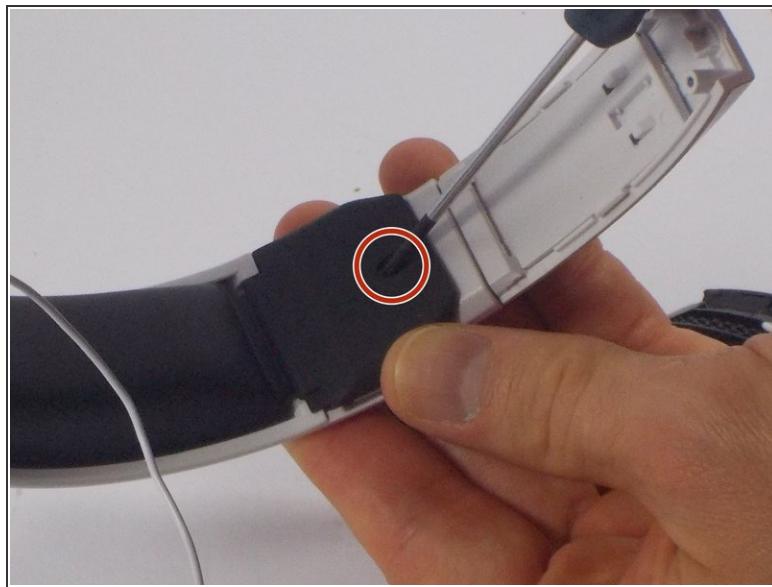
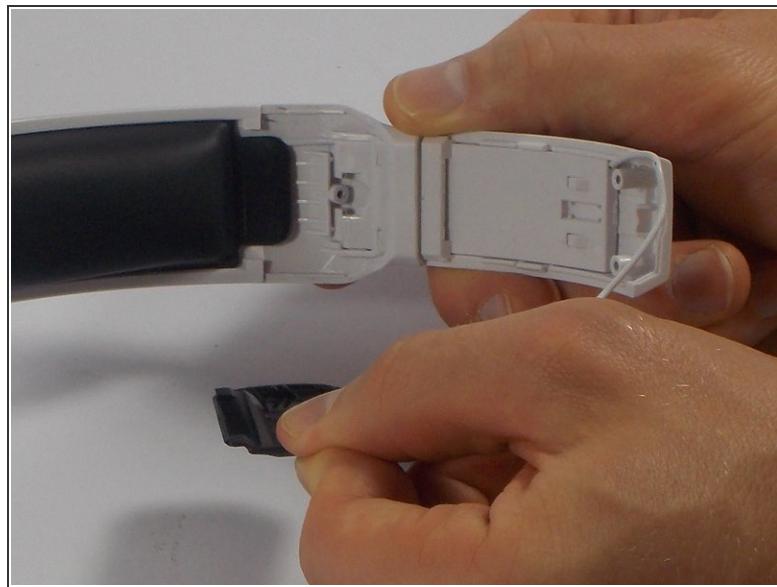
## Step 9

- Remove the 7 mm screw indicated in red with a PH00 screwdriver.
- Separate the black rubber bracket from the rail adjustment.
- Complete this step for the black rubber bracket located on the other side of the rail adjustment also.

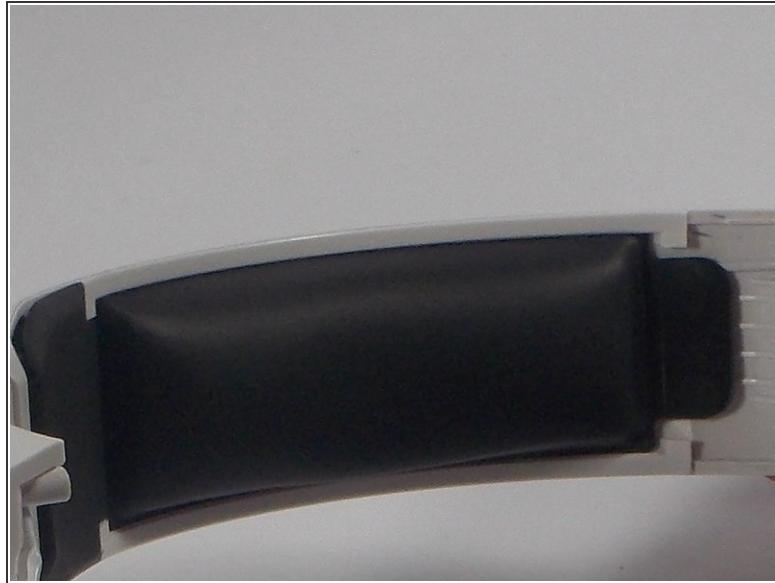
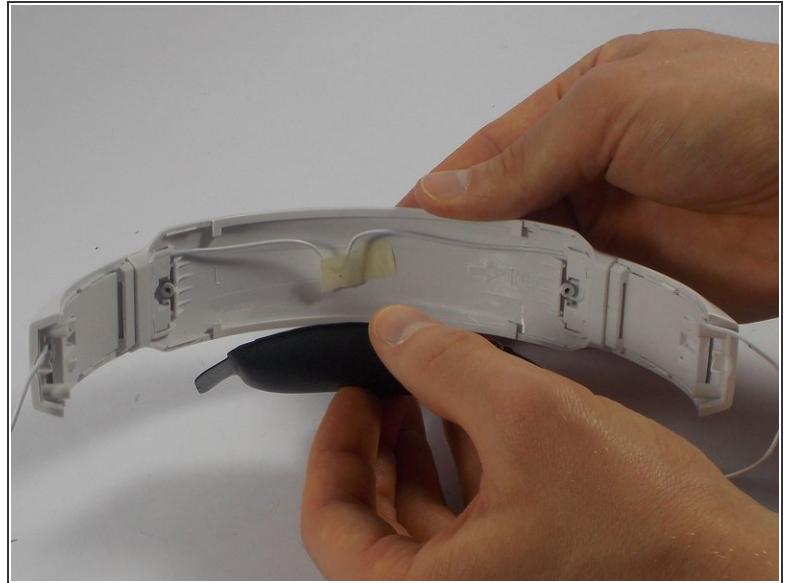
## Step 10

- Firmly grasp the black head cushion with one hand and the white rail adjustment with your other hand.
- Forcibly pull the cushion and rail adjustment in opposite directions until the cushion is completely disconnected.

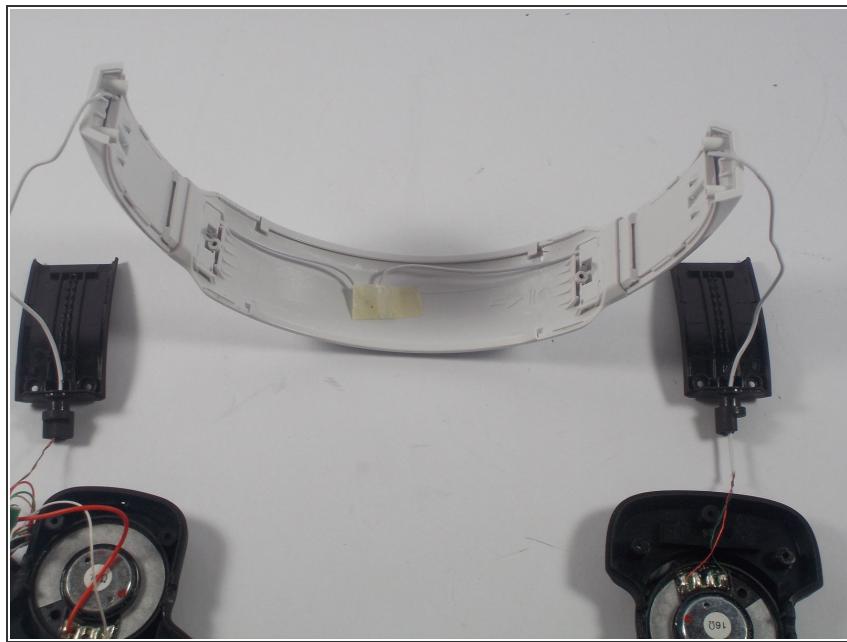
## Step 11

- Examine all of the wires for any damaged or disconnected wires.
- Reconnect any damaged or disconnected wires and use electrical tape to secure the wires into place.
- Test your speaker.
- If your speaker is now working, you can put your headset back together.
- If your speaker is still not working you need to replace the right speaker. Check out our [right speaker repair guide..](#)
