Replacement of group head valve

Replacing the group head due to it leaking water even when not in use.

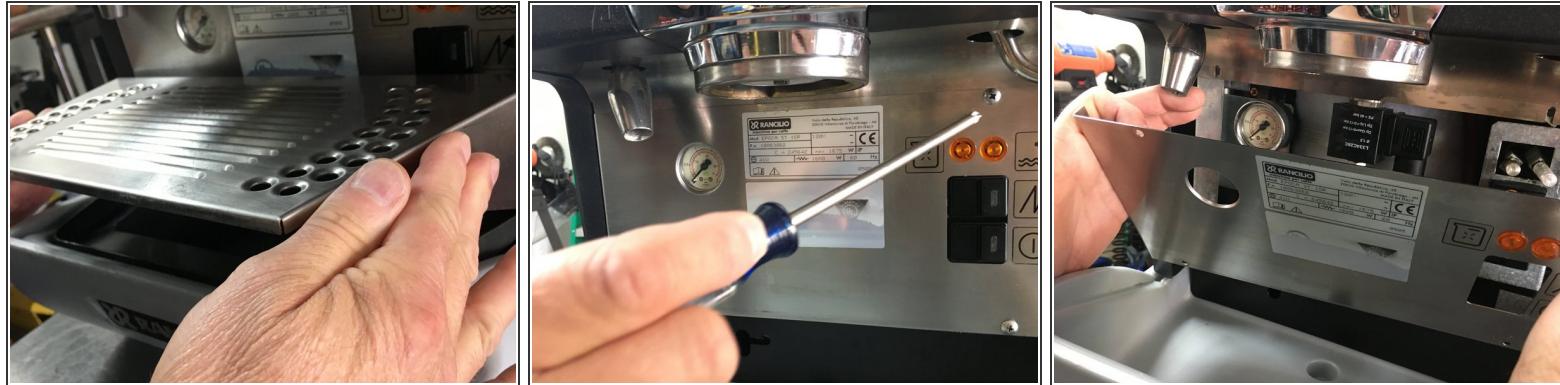
Step 1 — Removing Front Panel

- Making sure you first take out the drip tray.
- Start unscrewing the four screws on the panel. And take panel off ,should come off easily

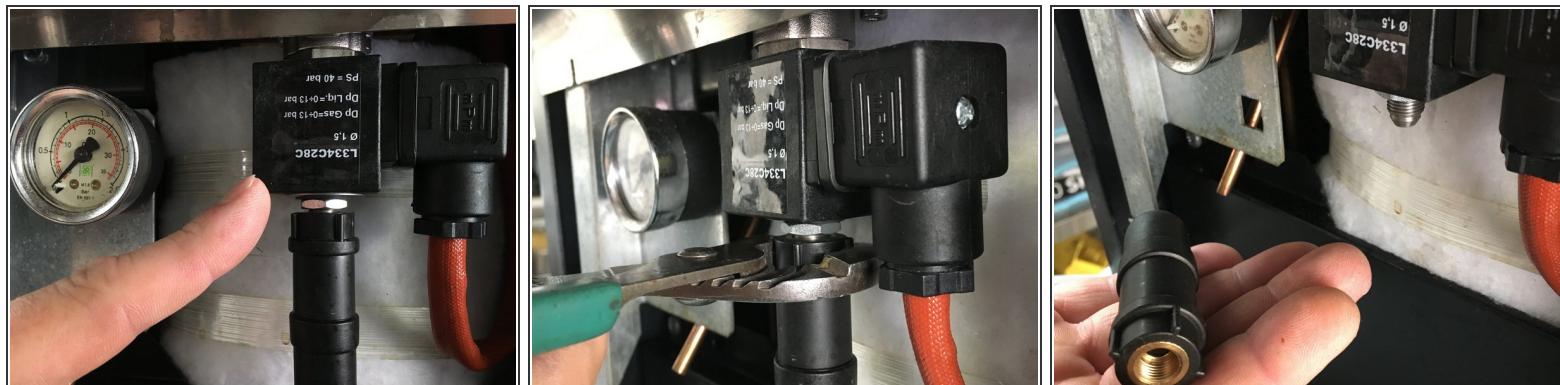
Step 2 — Unscrewing the breaker

- Start unscrewing the Disperse Flow Plastic Spout Breaker using a 3mm Allen wrench

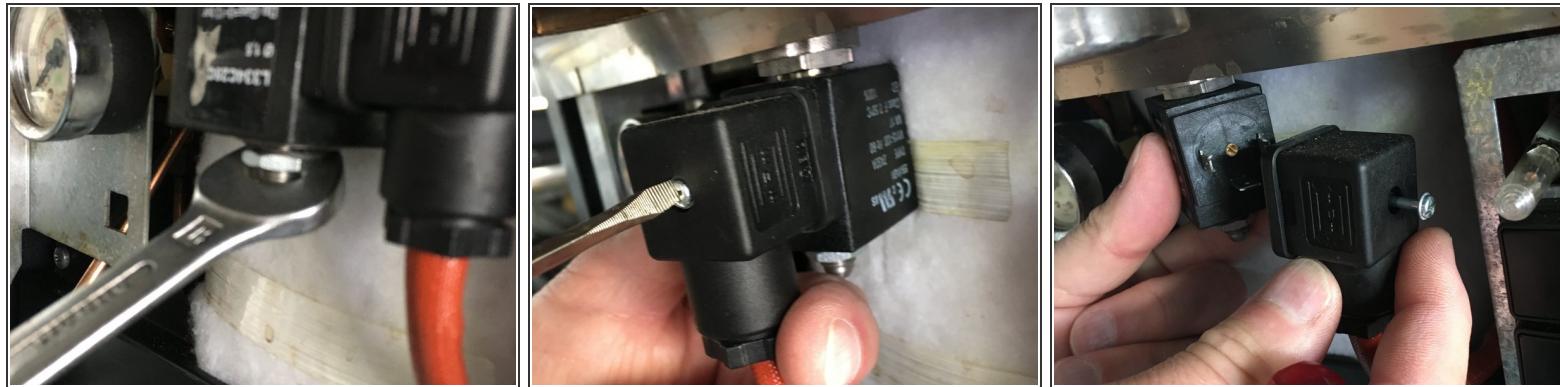
Step 3 — Removing nut and electrical connector

- First you want to remove the nut at the bottom using a 14 millimeter Wrench .
- Then you want to take the Group solenoid turn to side and unscrew electrical connector from it and pull.

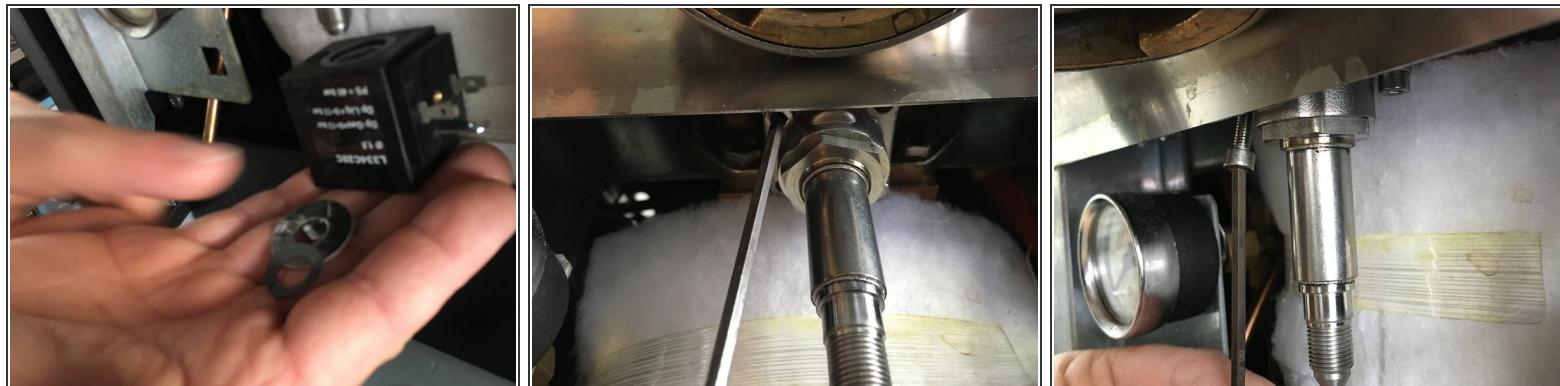
Step 4 — Taking coil off also undoing allens

- You want to start by simply taking off the coil along with the nuts and washers, then it allows access to take out the allens you just want to unscrew them with a 3mm Allen wrench

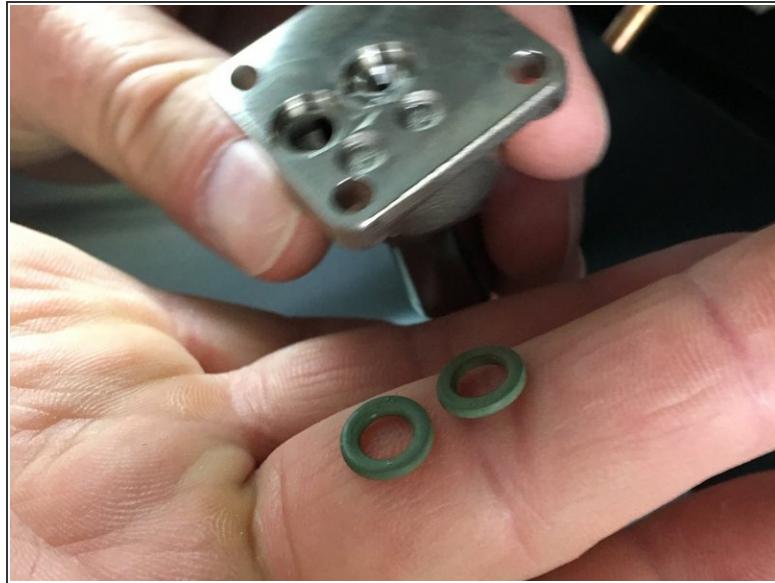
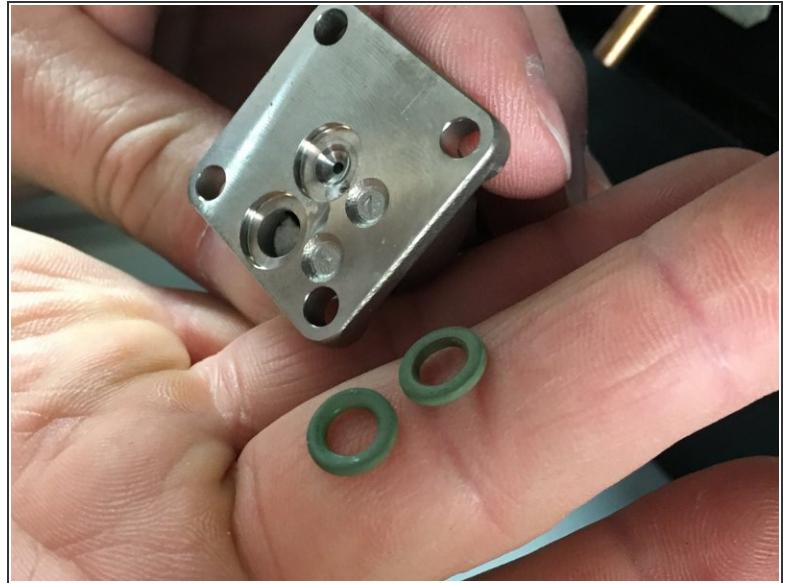
Step 5 — Take out faulty part in machine

- Finally you have reached the problem in the machine which is the solenoid
