Replacing David Clark Aviation Headset Left Dome

Here is a pretty beat up David Clark Headset. It has a broken dome on the LH side. Some rattling inside the dome is indicative of some broken parts.

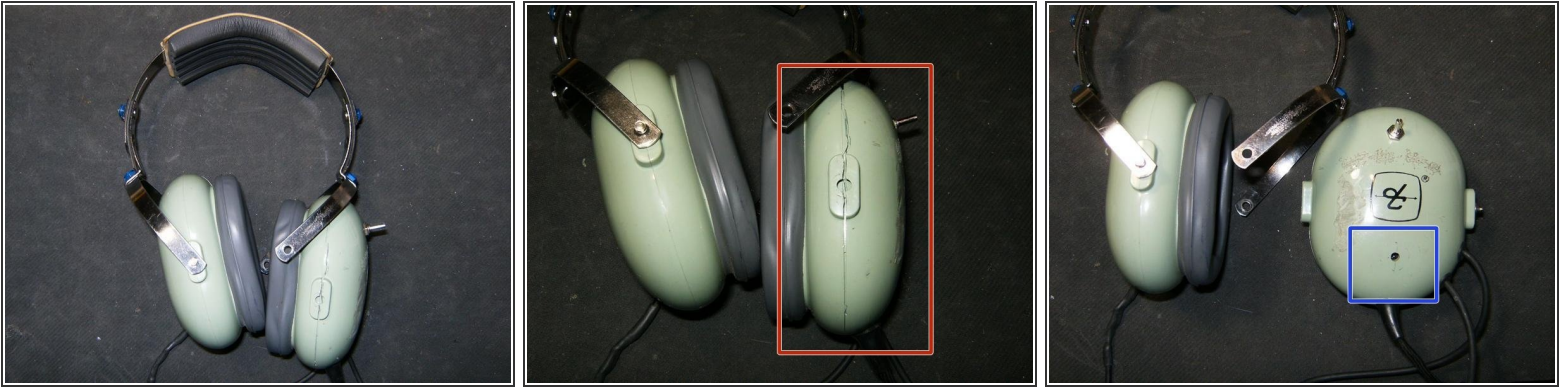
Step 1 — Left Dome

- Clearly visible damage on the left dome. Broken dome, missing retainer pin and clip as well as completely missing mic and mount as well as volume control button.
- Close up of the damaged dome.
- This is the mounting hole for the boom mic

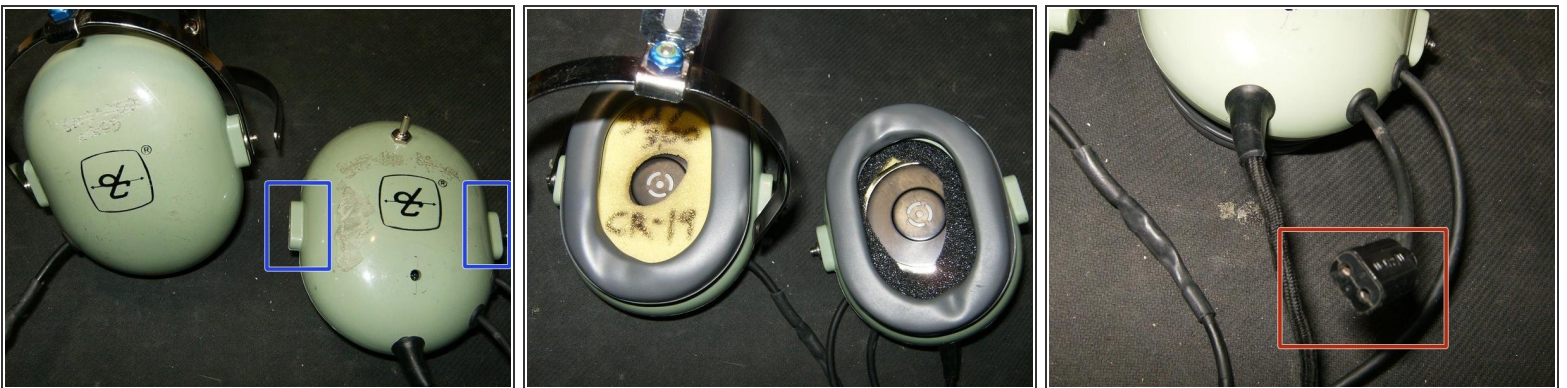
Step 2

- Since this dome does not have any of the retainer pins or clips, it simply slides out of the fork
- This view shows the well worn filters (foam)
- This is the connector for the boom mic.

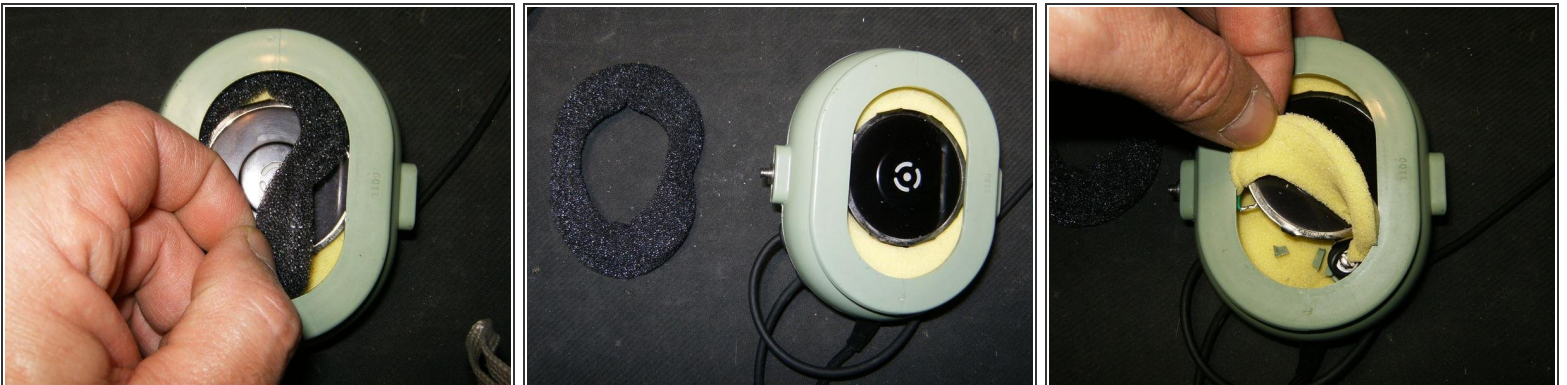
Step 4

- Remove the foam filter
- The speaker is now visible with more foam filters
- Remove the next filter

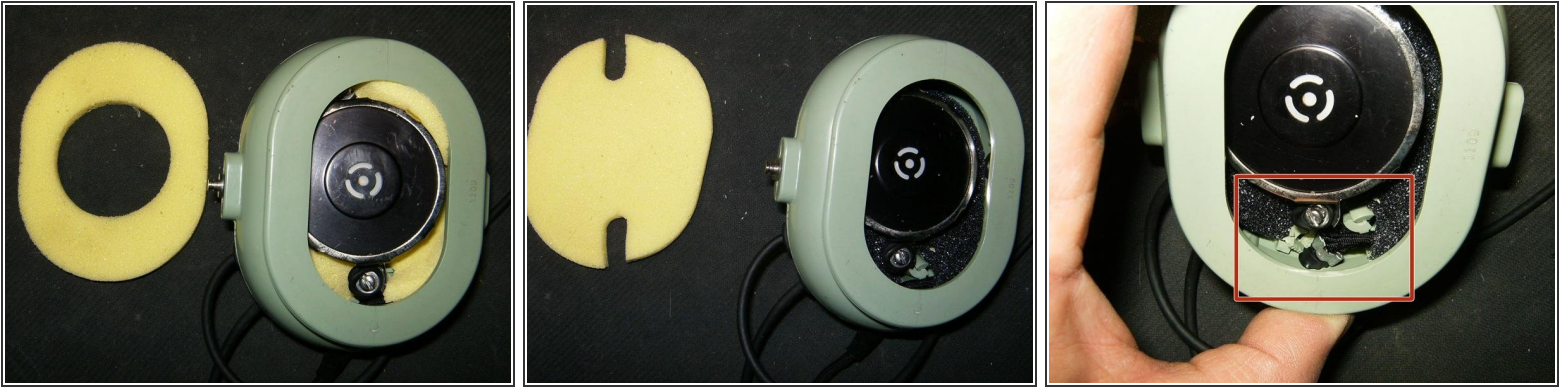
Step 5

- one more filter removed shows the screws for the speaker.
- Remove the next filter. Notice the different shapes of the filters.
- After the filter removal, inside damage of the dome becomes visible. In this case the standoff for the speaker screw was broken off.

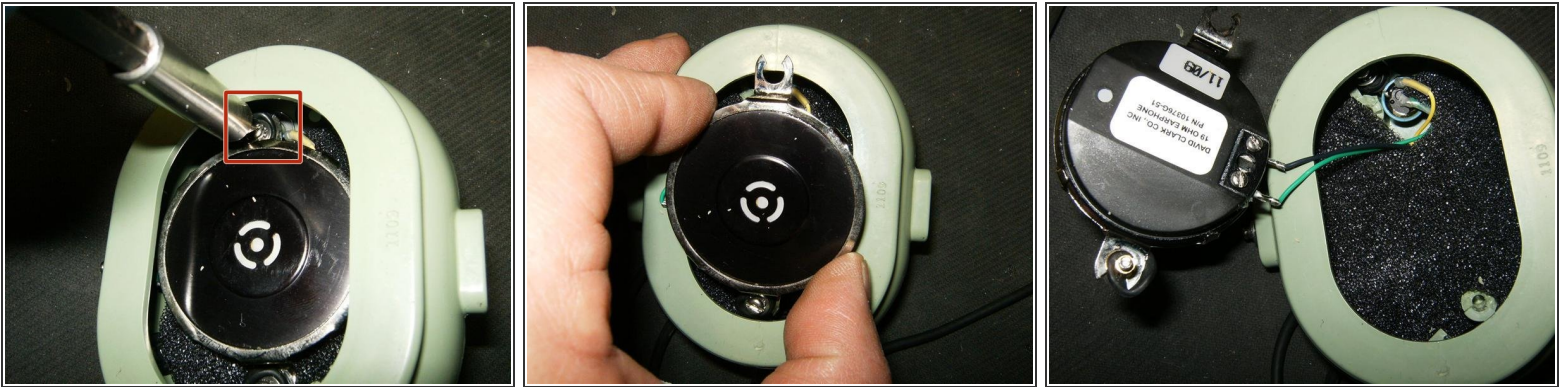
Step 6

- Remove the mounting screw for the filter.
- Lift the speaker out of the dome. The wires are still attached, so do not try to pull to hard.
- Flip the speaker over to reveal the wire connection and the last filter. Originally this headset will only have three different foam filters

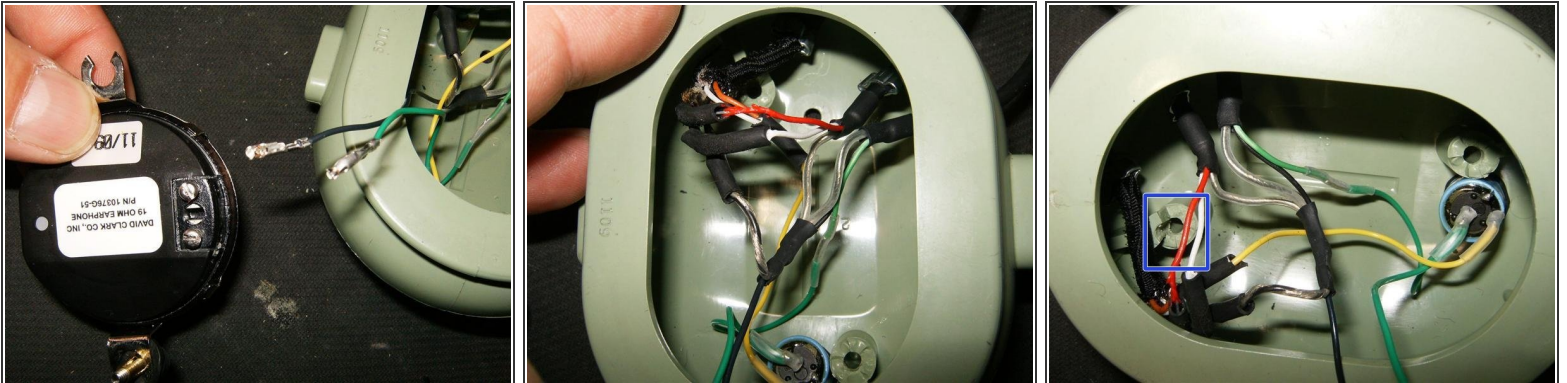
Step 9

- Remove the speaker
- More views of the wiring.
- Here is the broken standoff with the missing plastic.

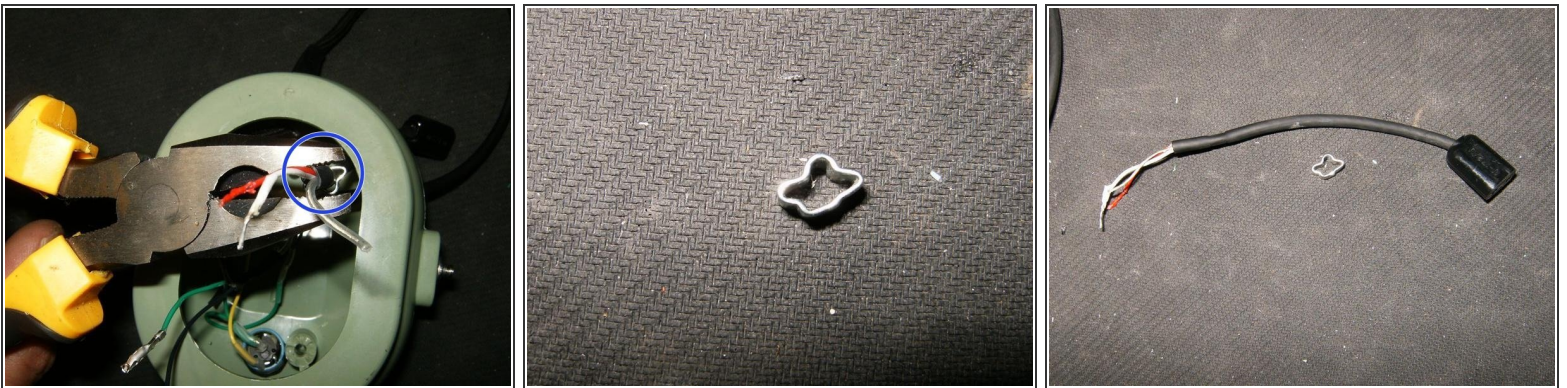
Step 11

- Squeeze the cord clip with a pair of pliers.
- Remove the cord clip
- Remove the mic cable

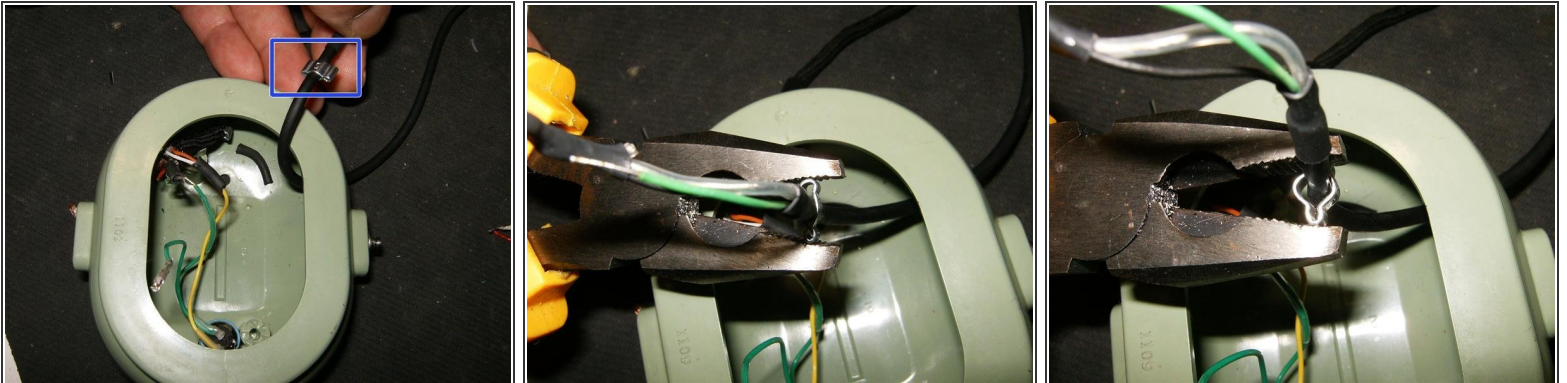
Step 13

- Pull the crossover cable toward the inside of the dome to gain access to the cord clip
- Place a pair of pliers on the outside tabs of the cord clip
- by squeezing the pliers shut, the cord clip will expand and can then be easily removed.

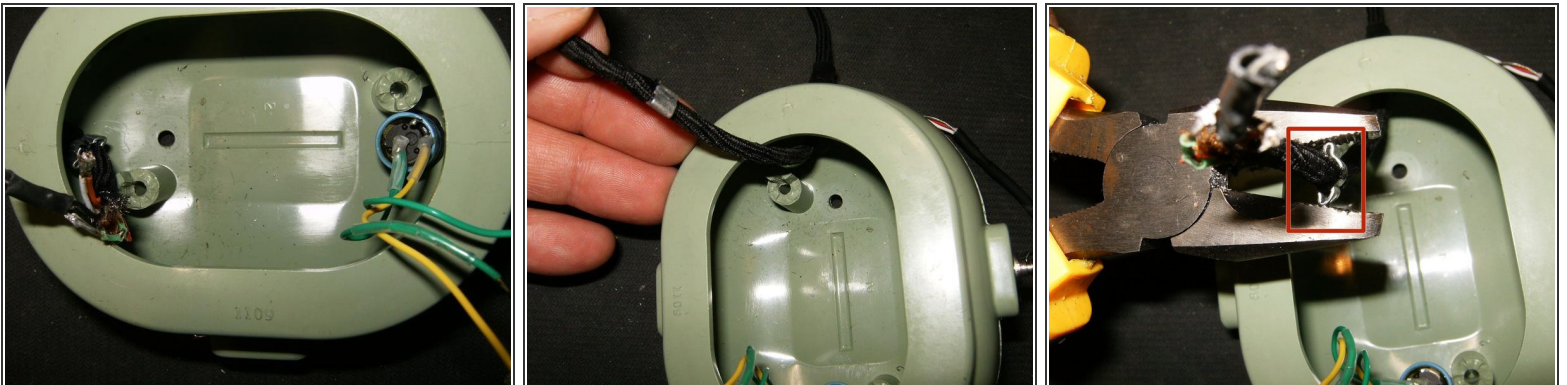
Step 15

- Volume control and main cable are now disconnected .
- Pull the main cable into the dome to get access to the cord clip.
- Place a pair of pliers on the long tabs of the cord clip,

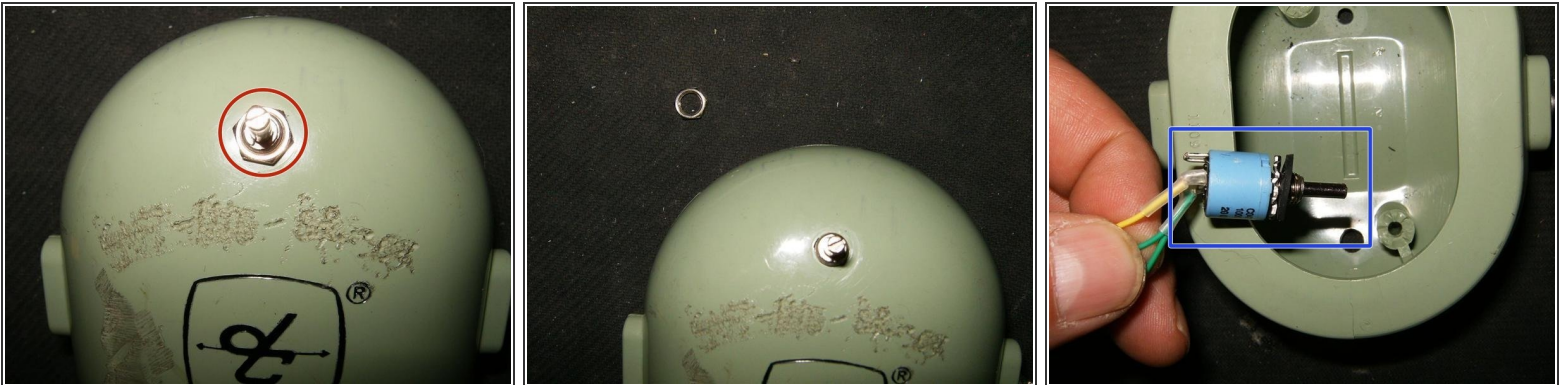
Step 19

- The speaker control potentiometer is held in place with a 5/16 hex nut.
- remove the hex nut.
- Remove the volume control from the inside of the dome.
