Ridgid GEN5X R8653 Base Assembly Replacement

This guide shows you how to replace a circular saw base that may be damaged or warped.

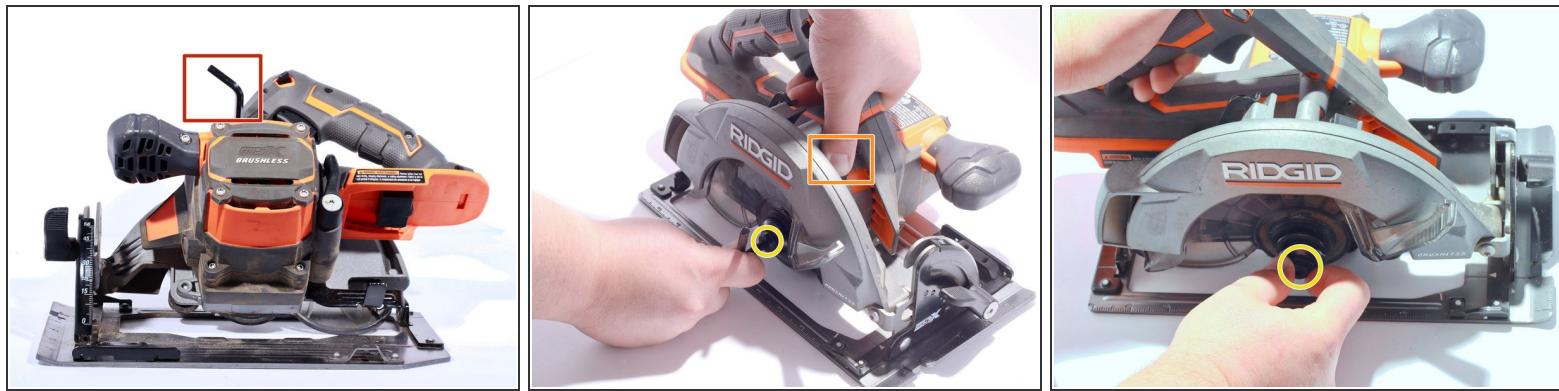
Step 1 — Base Assembly

- Remove the supplied Allen wrench from it's nesting space in the front of the handle.
- Depress and hold the spindle lock button located between the handle and blade shroud.
- Using the supplied 6mm Allen Wrench, unscrew the bolt securing the blade and remove the blade.

⚠ Always disconnect battery and use gloves when working with the saw blade. Failure to do so may result in damage or injury!

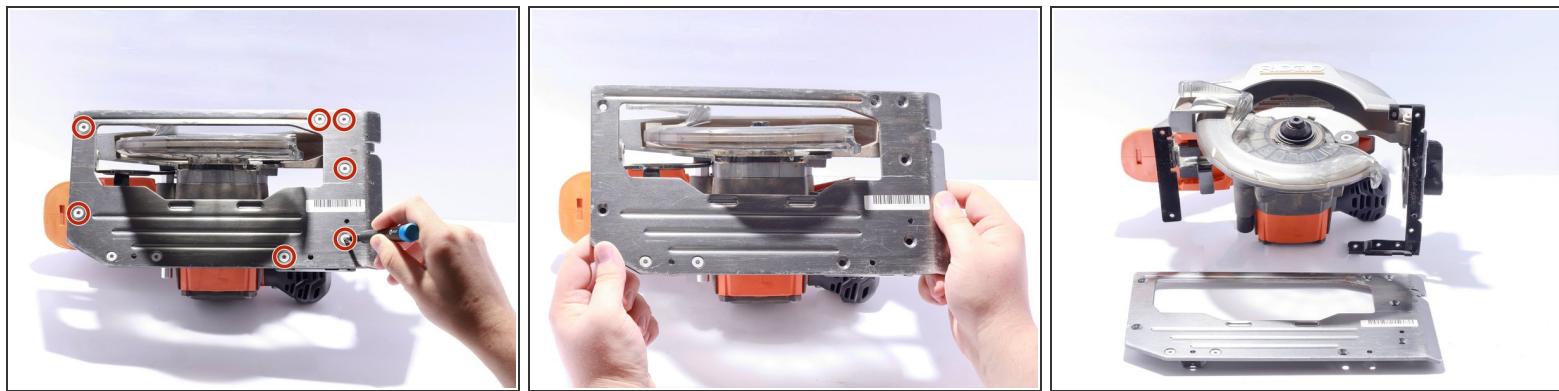
Step 2

- Remove seven 6mm T20 Torx screws located around base of saw.
- Pull base assembly away from saw.

i These screws are very tight and need significant force to be removed.

To reassemble your device, follow these instructions in reverse order.
