# Rowenta silent force extreme RO5931 main brush Teardown

The brush on the main head of this vacuum can wear with use or a inner-broken plastic piece may hinder the button of the brush to lower the brush properly.

The push button did not lower the brush properly : a broken plastic inner-piece was hindering the lowering of the brush. This guide explains how to tear down the brush and put the broken piece away.

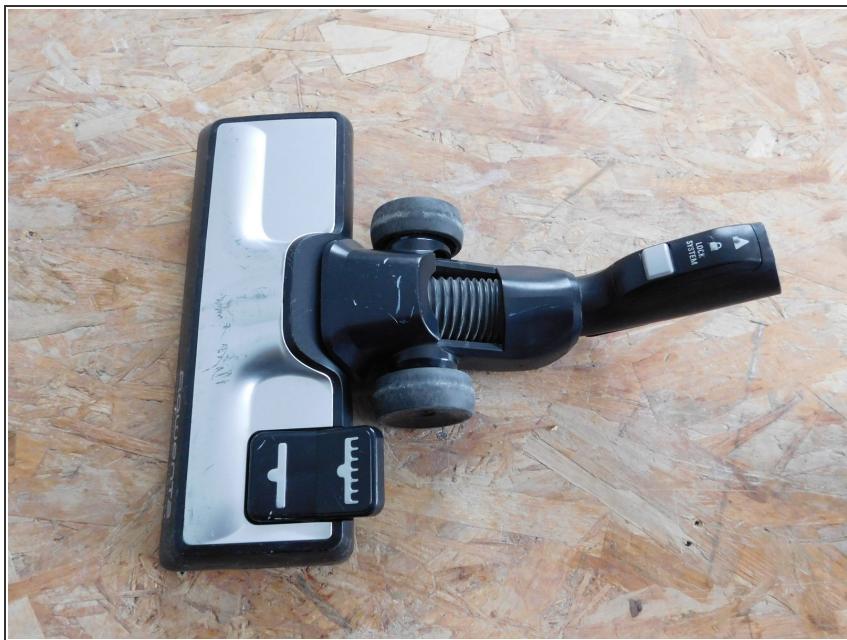
## Step 1 — Unplug the vacuum cleaner

- Turn off the vacuum and unplug it from the outlet.
- Unmount the main brush head from the cleaner pipe.

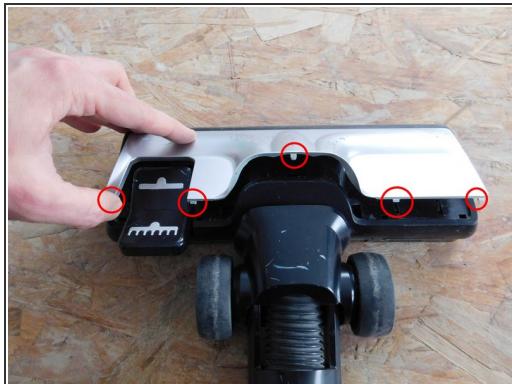
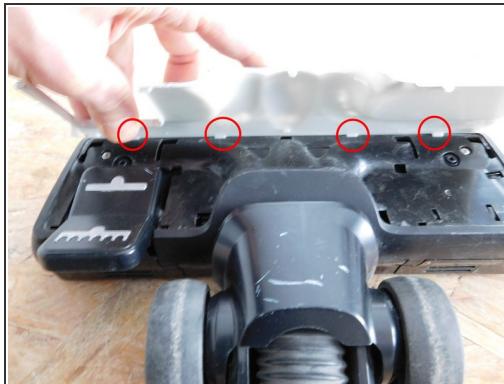
## Step 2 — Remove the top cover

- Unsnap the clips of the top cover with a small slot screwdriver.
- Remove the top cover of the brush.

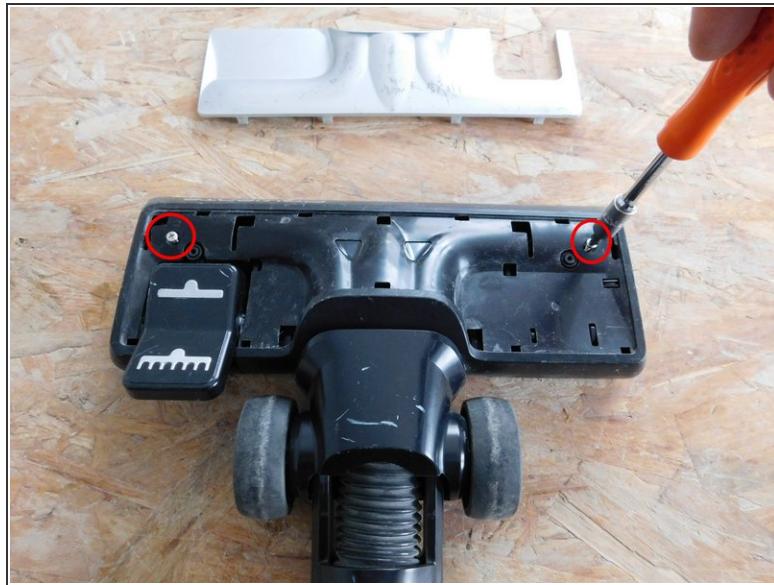
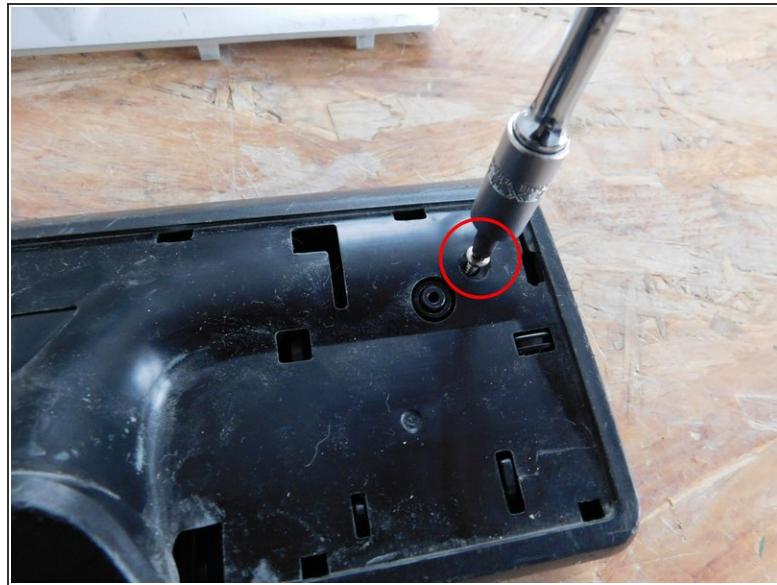
### Step 3 — Unscrew the two top Philips screws

- Unscrew both Philips screws from the top of the brush.

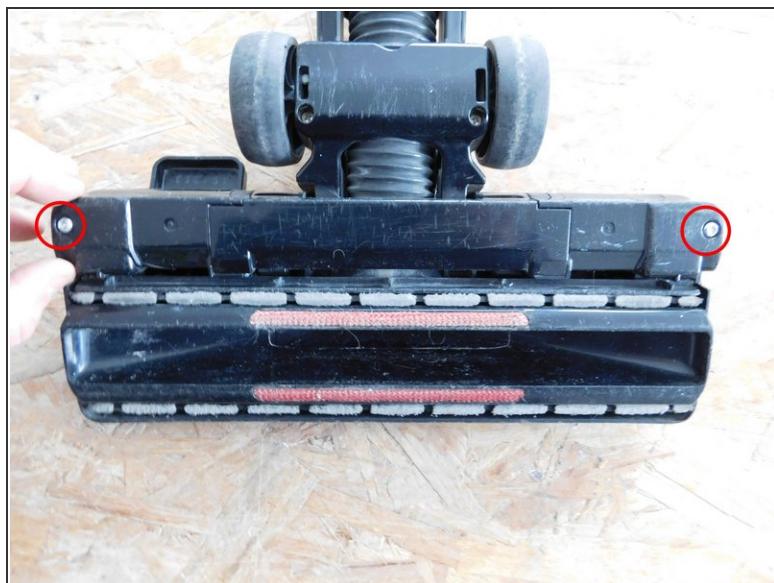
### Step 4 — Unscrew security torx screws

- Unscrew both security torx screws.
