Ryobi P235 Direction of Rotation Selector Replacement

How to replace a Ryobi P235 direction of rotation selector.

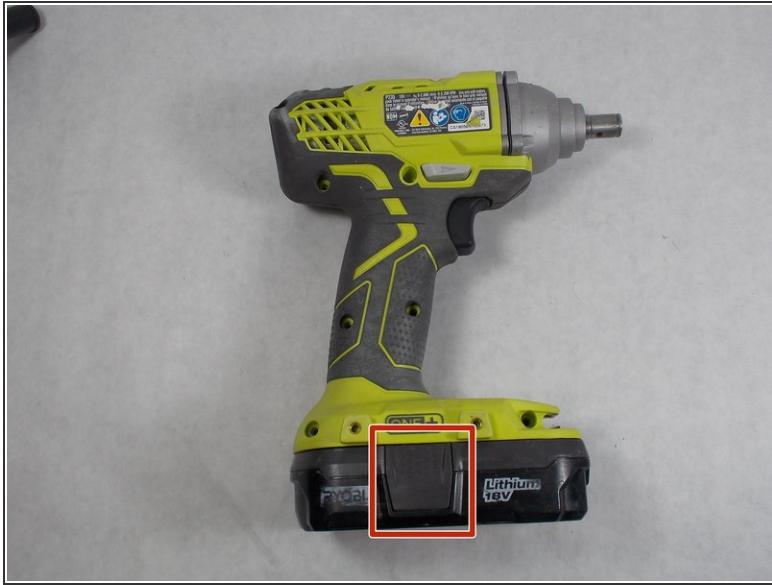
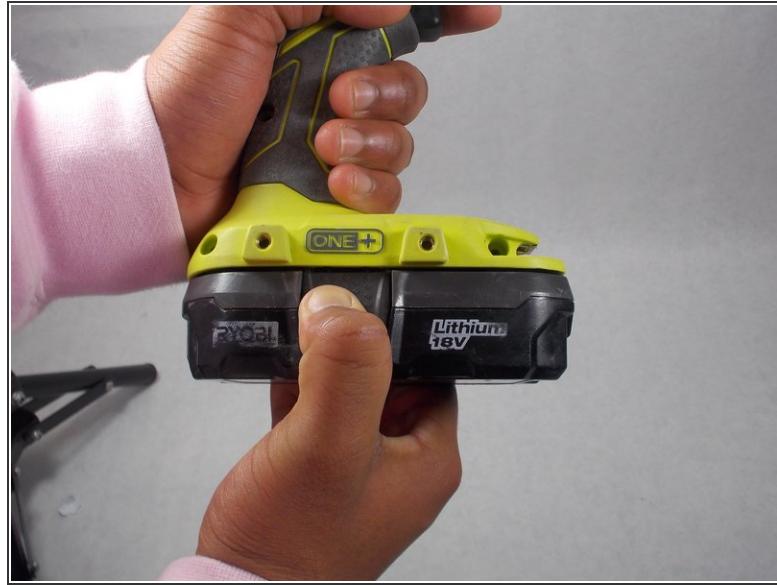
Step 1 — Battery

- Push in both push tabs on the battery at the same time.
- They are located below the green housing and are in the middle on both sides of the battery.

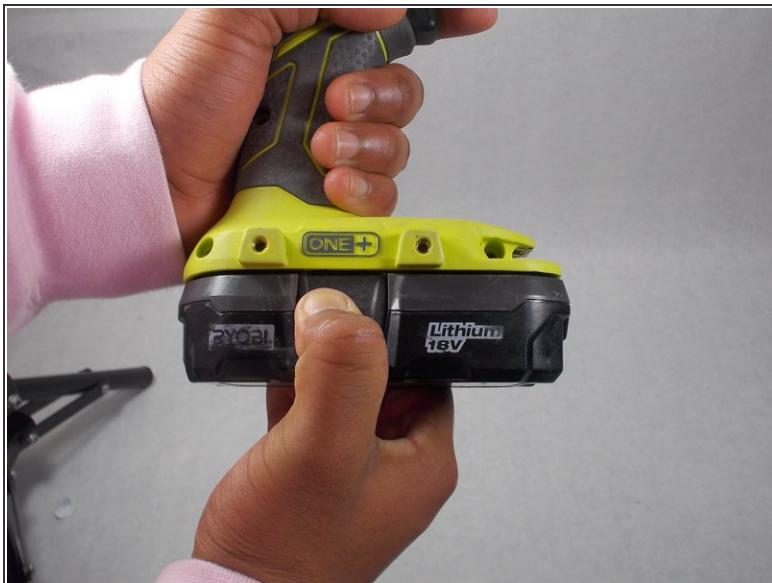
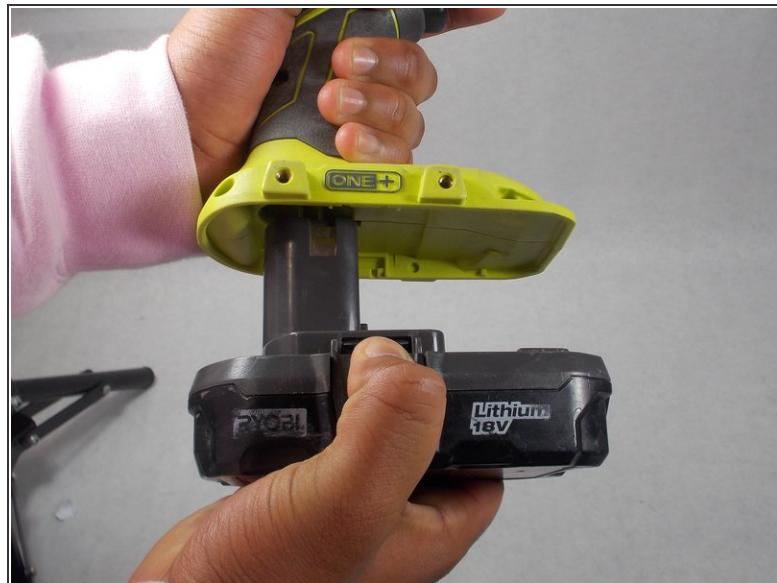
Step 2

- Pull the battery away from the drill housing while holding in both tabs.

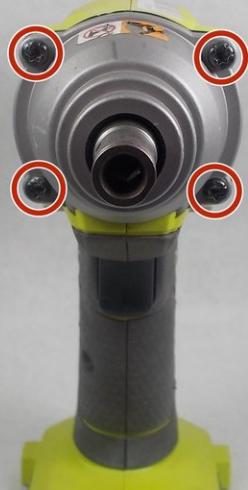
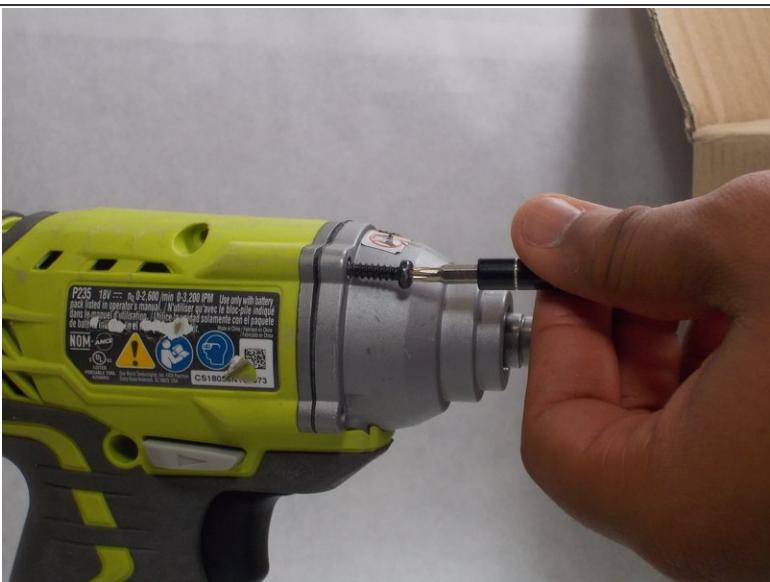
Step 4

- Use a T20 Torx screwdriver to remove the four 25.4 mm screws that secure the front of the housing.

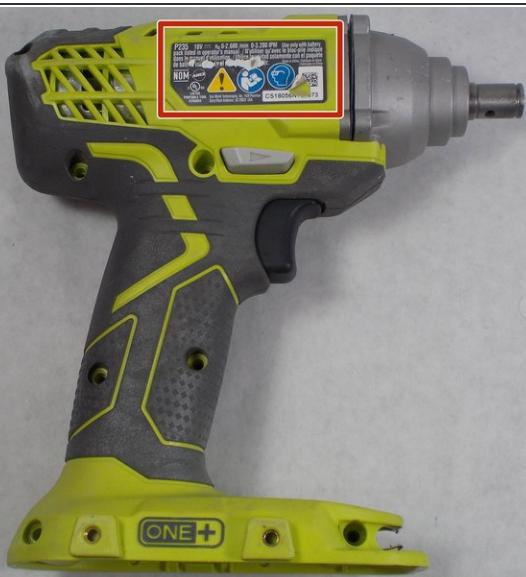
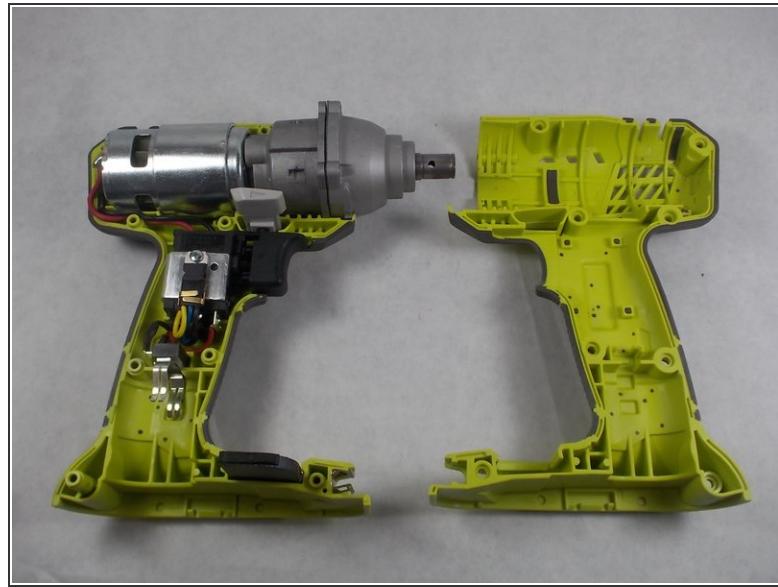
Step 5

- Open the housing with the data label facing up.

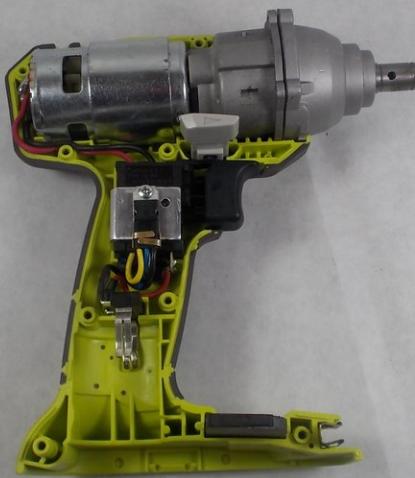
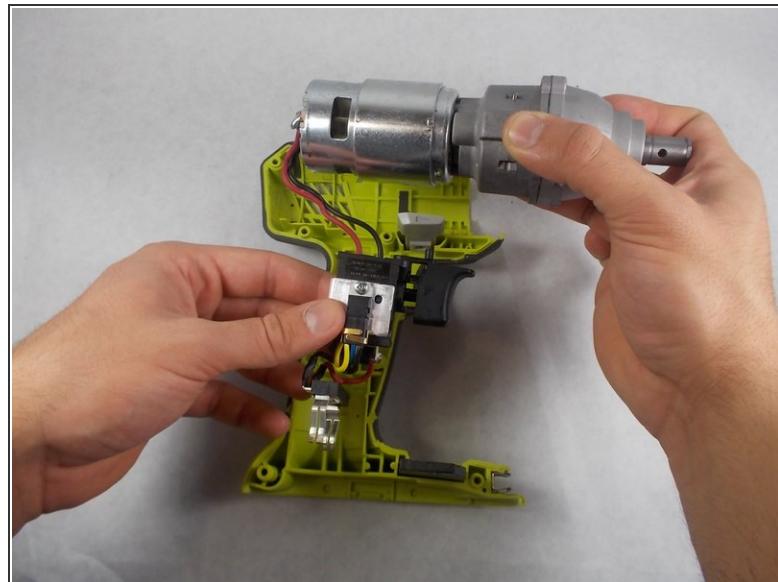
Step 6

- Lift the internal components out of the housing.

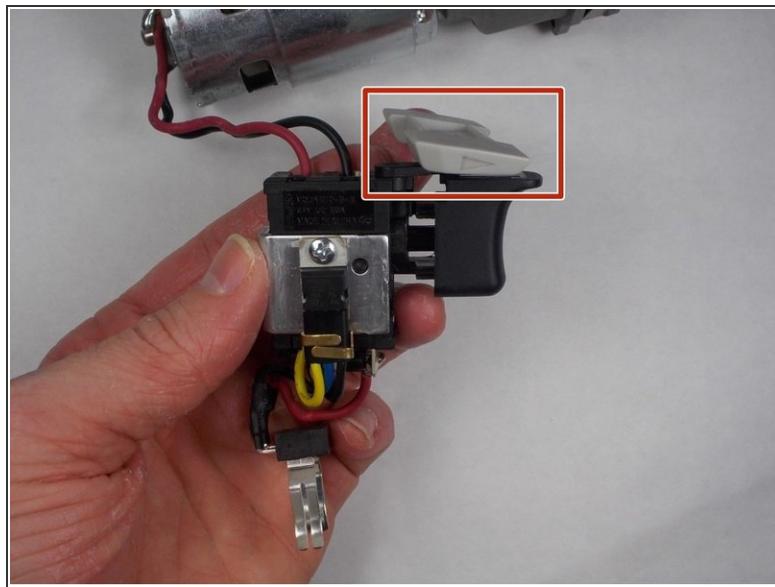
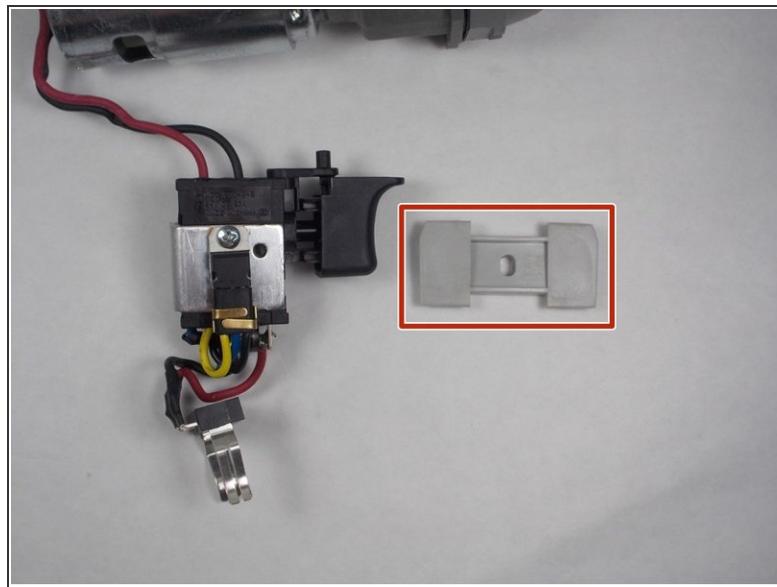
Step 7

- Remove the gray plastic forward/reverse selector.

To reassemble your device, follow these instructions in reverse order.
