Ryobi P271 Magnet Replacement

This guide shows how to replace the magnet in the Ryobi P271.

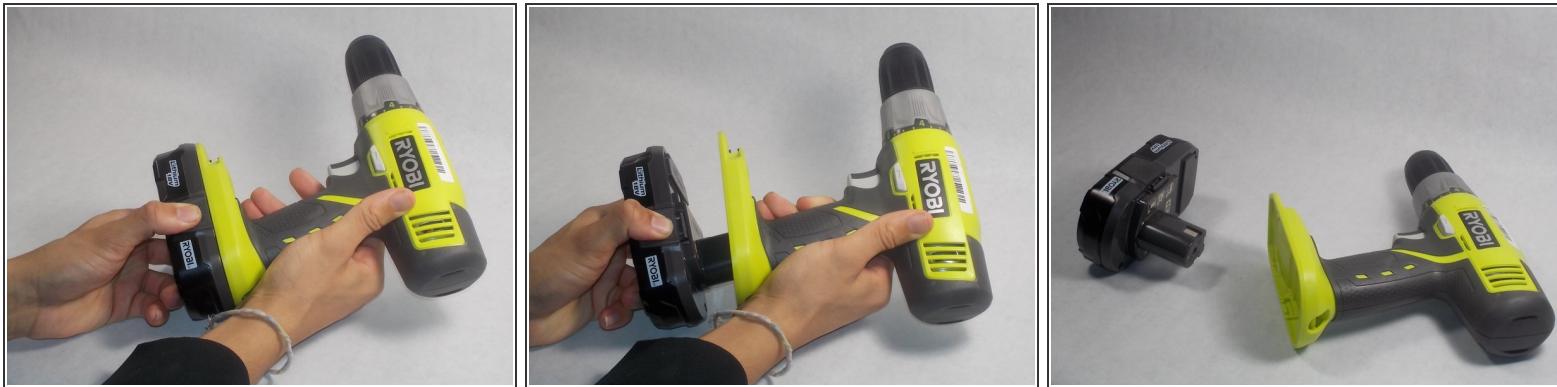
Step 1 — Battery

- Detach the battery unit from the drill body by pressing the battery release buttons on both sides of the unit and pulling outwards.

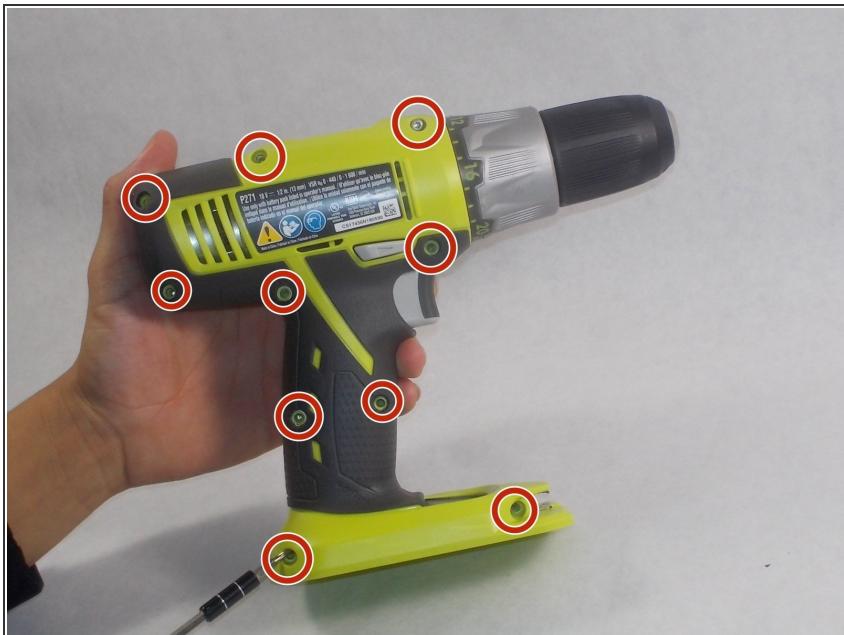
Step 2 — Magnet

- Remove all ten screws from the drill's casing to gain access to the interior.

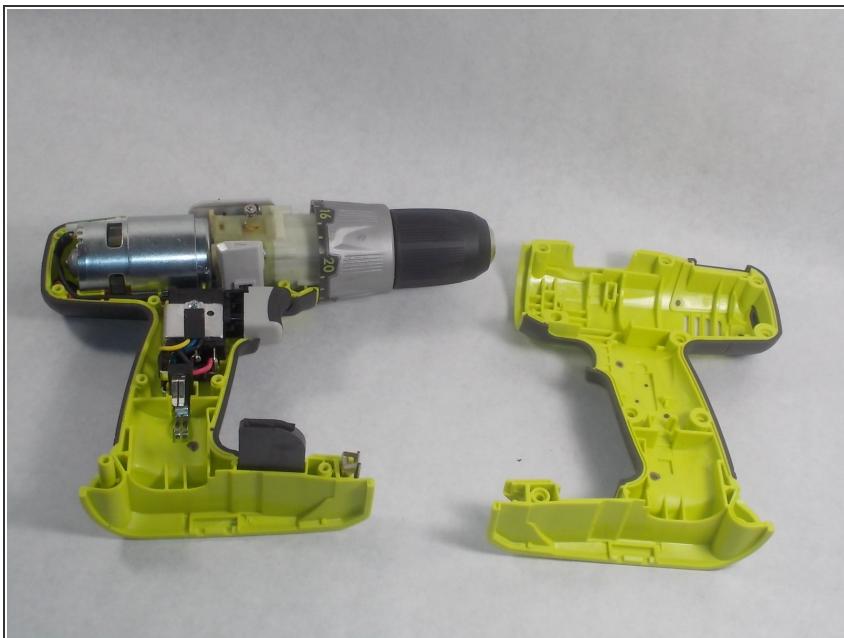
Step 3

- Using your hands, lift and remove the right cover of the drill body off from the left side and place it down.

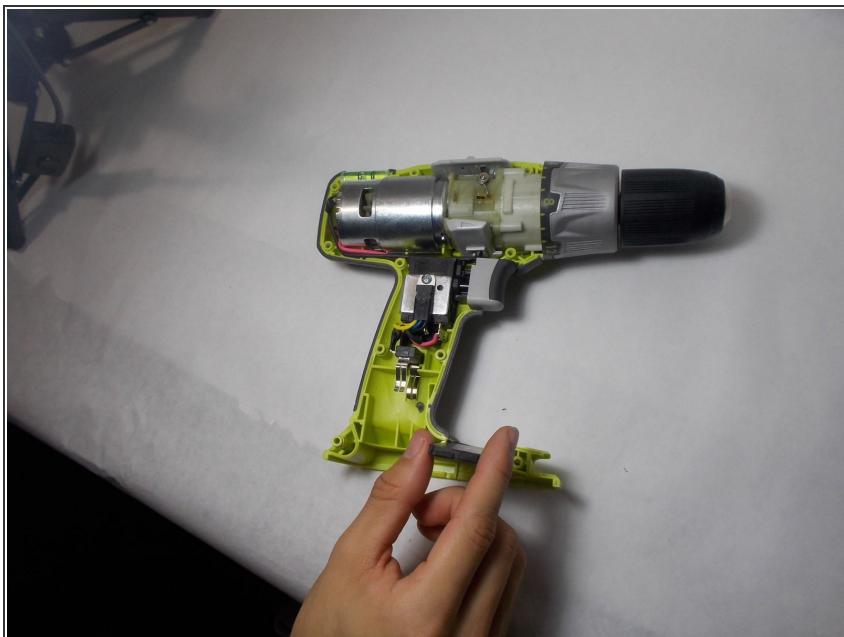
Step 4

- Carefully slide the magnet from its holder.

To reassemble your device, follow these instructions in reverse order.
