# Ryobi RJ1861V Assembly Bar Bearing Replacement

Over time the assembly bearing can become worn, cracked, or stuck, this guide shows users how to replace a bad bearing.

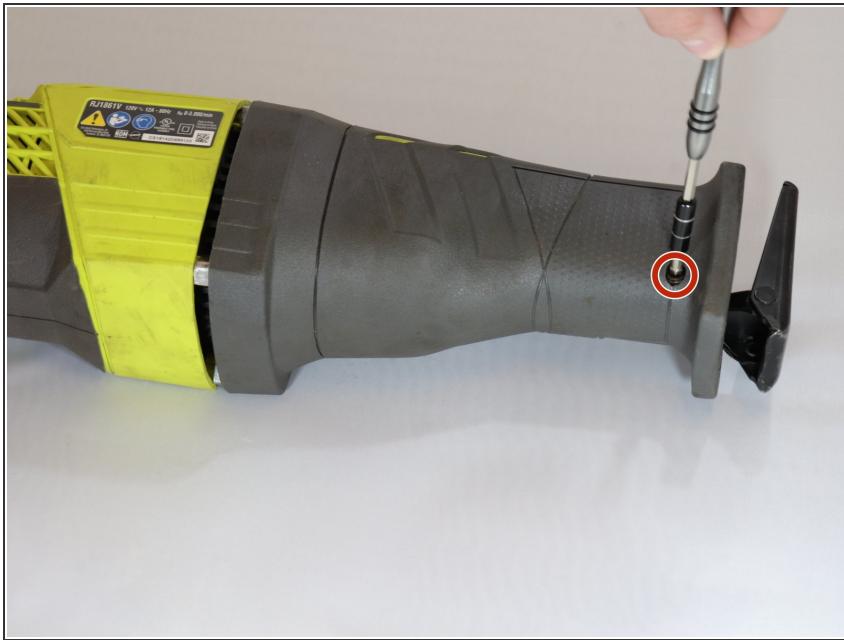
## Step 1 — Saw Bar Assembly

- Unscrew the screw holding the shoe in on the back side:
  - One 8 mm Torx T5 screw

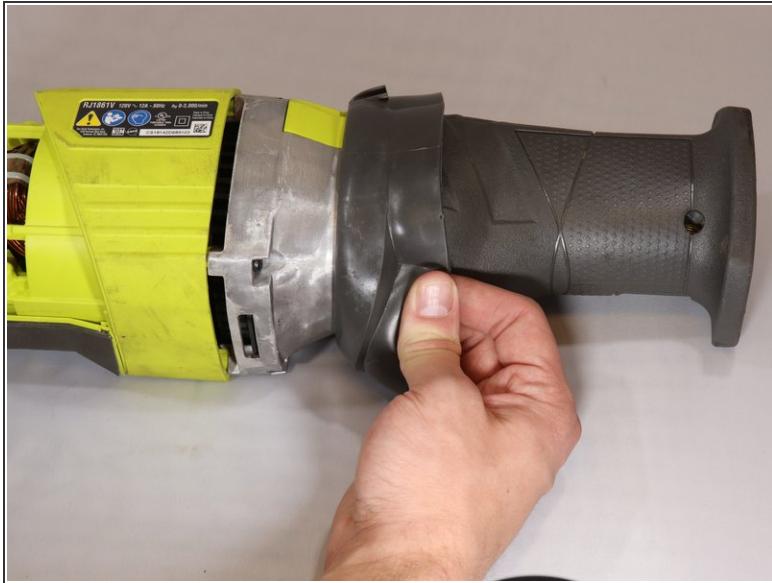
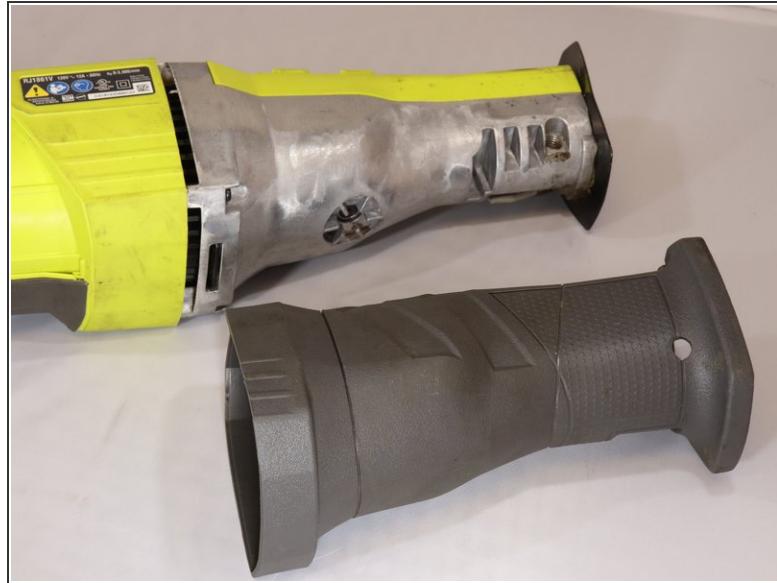
## Step 2

- Begin to remove rubber sleeve. You may have to use some force as it has a tight fit.
- Indicated in the photo below is the rubber sleeve removed.

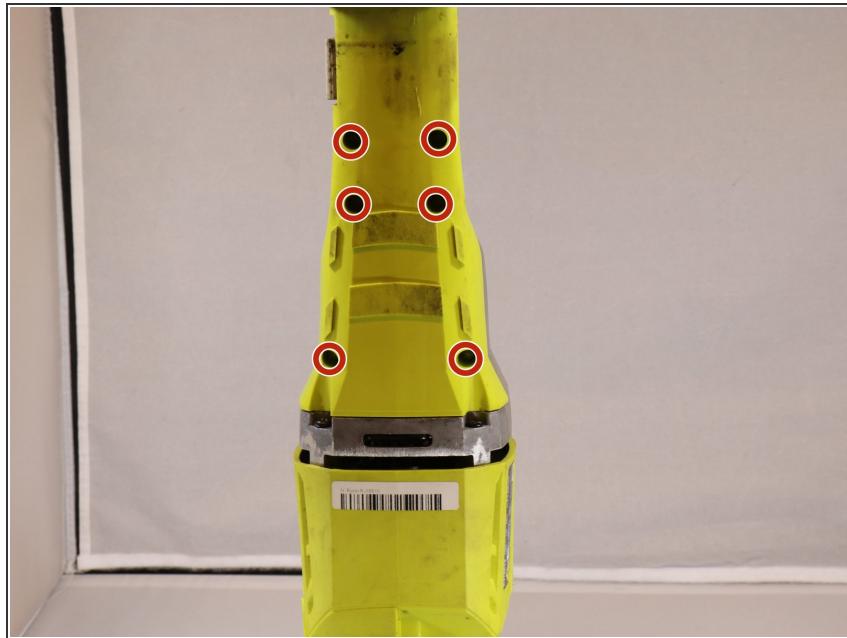
## Step 3

- After sleeve is removed begin to remove the six screws on the back of the device.
- Six Torx T5 Screws

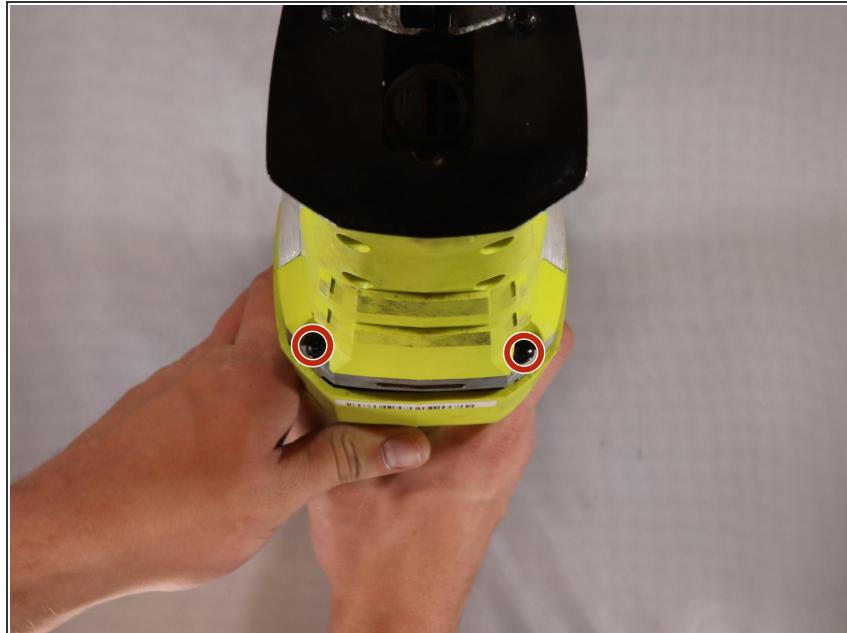
## Step 4

- Using a screw driver begin to unscrew the 4 screws on the top. There will be two screws on each side of the device.
- Four Torx T5 Screws

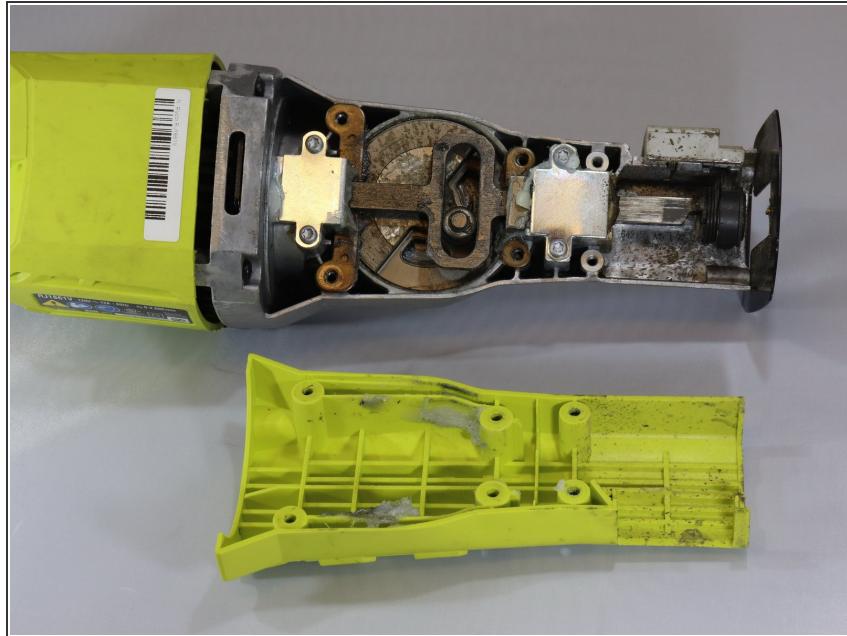
## Step 5

- Remove the backside panel to expose the internal components.

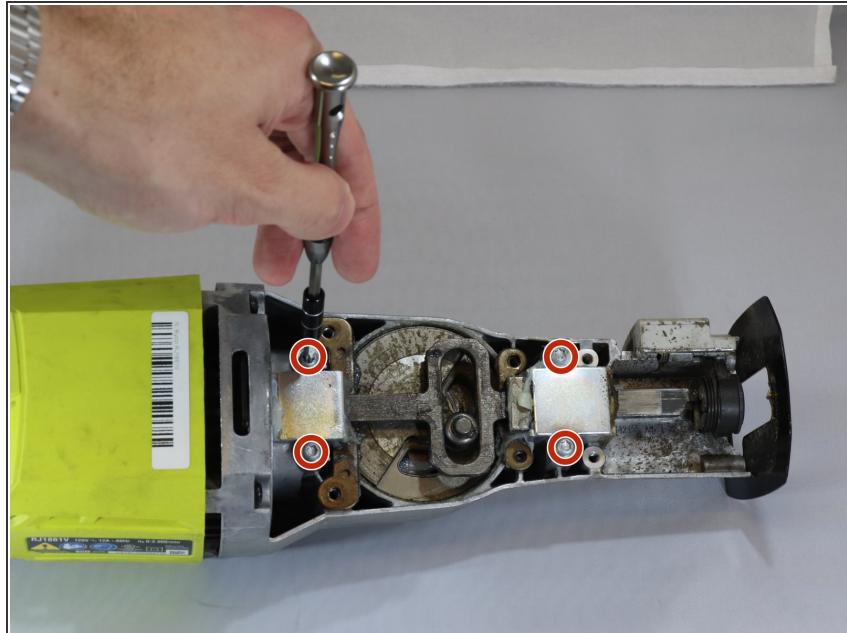
## Step 6

- Unscrew the four T5 Torx screws that are holding the assembly bar in place.

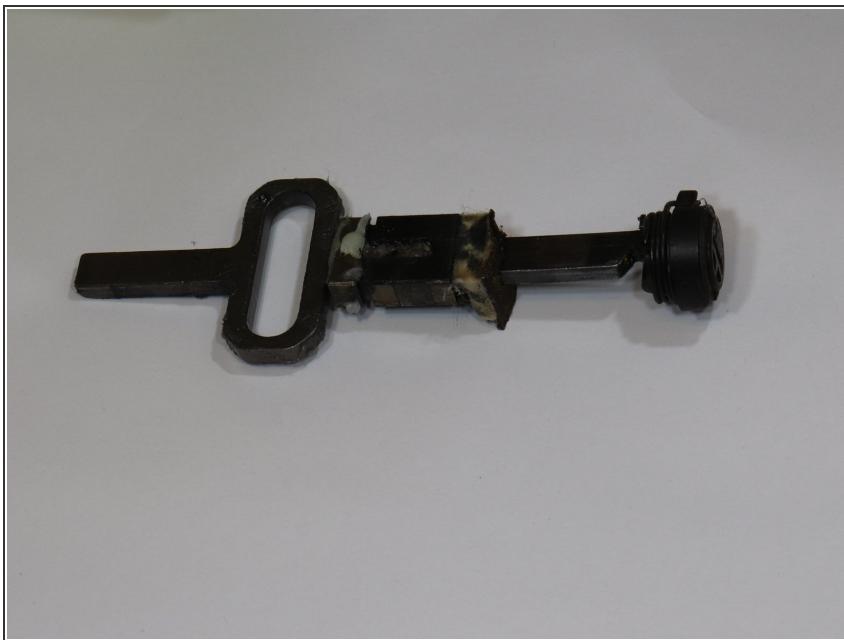
## Step 7

- After all screws removed, the assembly bar can be removed and replaced with ease.

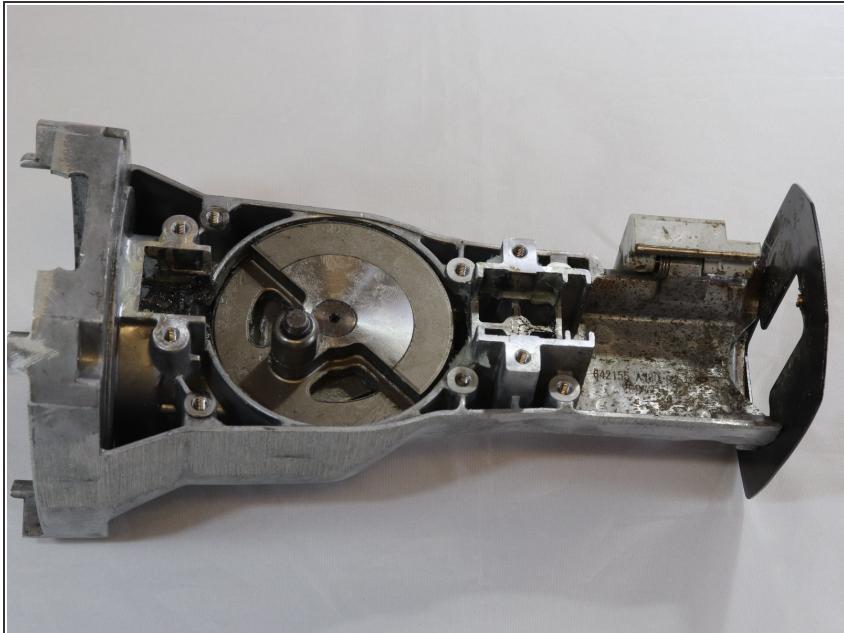
## Step 8 — Assembly Bar Bearing

- Begin with the top of the device facing up.

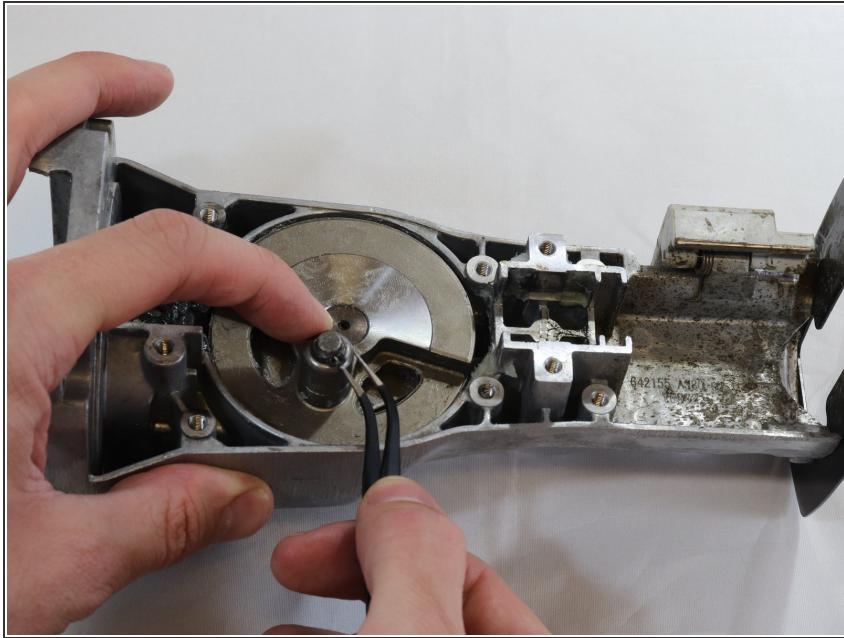
## Step 9

- Insert needle nose pliers to remove the retaining pin at the top of the bearing.

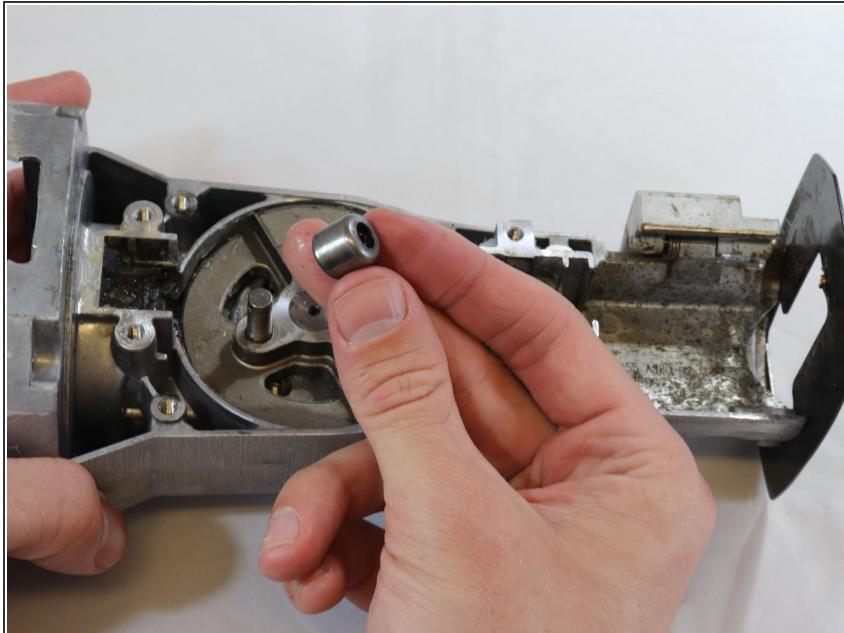
## Step 10

- Once the retaining pin has been removed, pull off the damaged bearing and insert a new one.

To reassemble your device, follow these instructions in reverse order.
