Ryobi RS290G Bearing Cap Assembly Replacement

How to replace Ryobi RS290G bearing cap assembly.

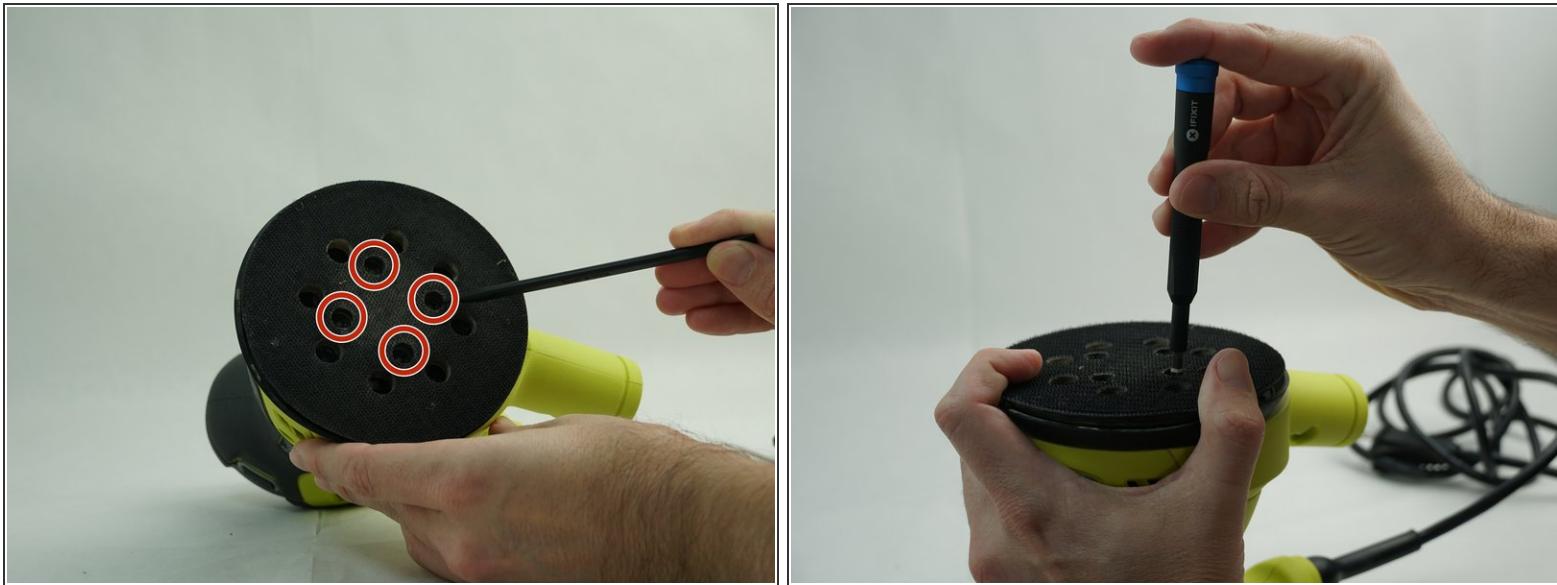
Step 1 — Bearing Cap Assembly

- Using a TR20 Torx security screwdriver, remove the four 6mm screws.
- Make sure to hold the backing pad firmly to prevent spinning.

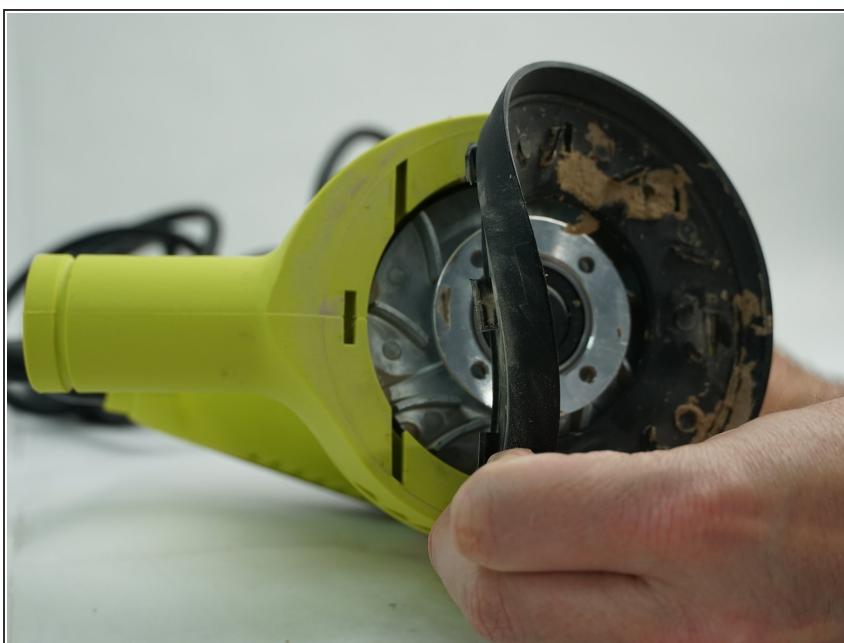
Step 2

- After removing the backing pad, carefully pull on the rubber brake to remove it from the housing assembly.

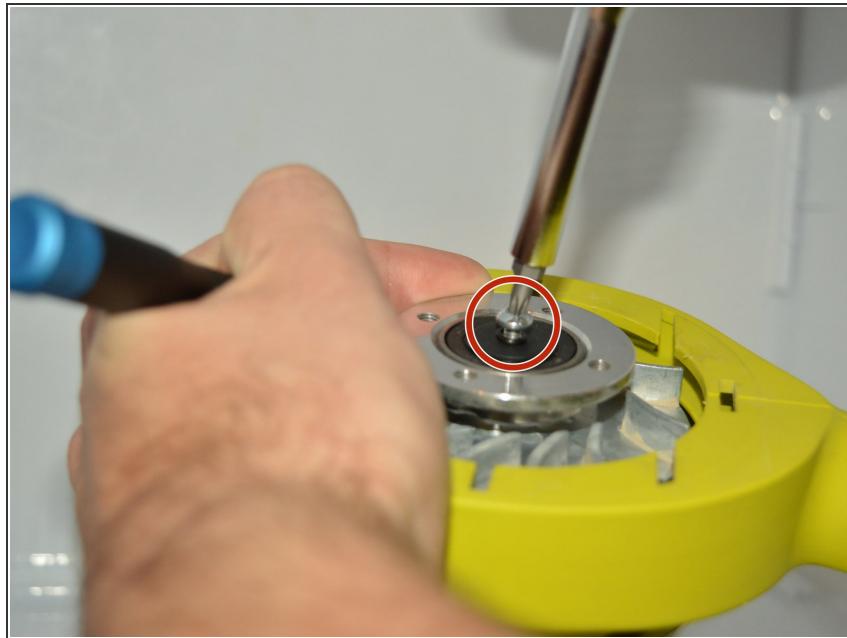
Step 3

- Using a TR 20 Torx security screwdriver, remove the single 3mm screw in the center of the bearing cap assembly.
- ⓘ* Make sure to use pliers or another tool to prevent the fan from spinning, and use a torque wrench or torque screwdriver as the screw is secured with Loctite (a compound to prevent it from loosening).

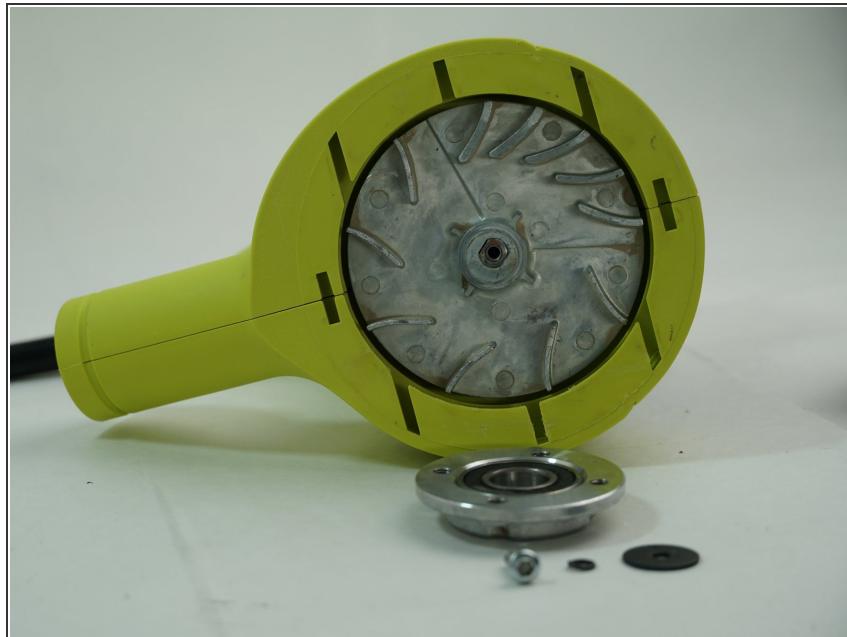
Step 4

- Remove the bearing cap.
- ↗* You may keep the spring washer and washer for reuse if they are not worn/damaged.

To reassemble your device, follow these instructions in reverse order. Make sure to tighten down properly to avoid loose or traction pad issues.
