Samsung Galaxy Tab 8.9 Charging Port Replacement

Use this guide to replace the charging port in your Samsung Galaxy Tab 8.9.

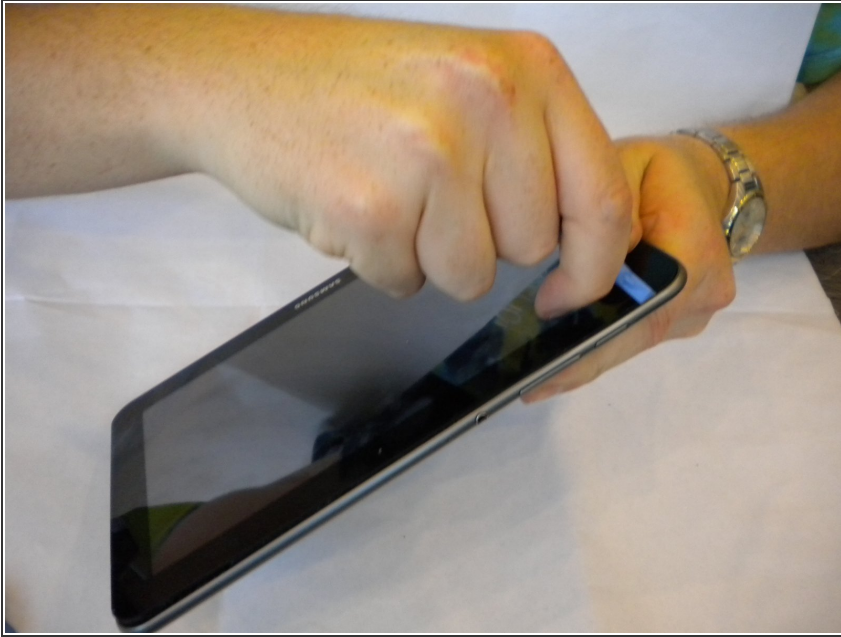
Step 1 — Insert Opening tool

- Insert a plastic opening tool between the back cover and screen of the Samsung Galaxy Tab 8.9 (as indicated in the photograph).

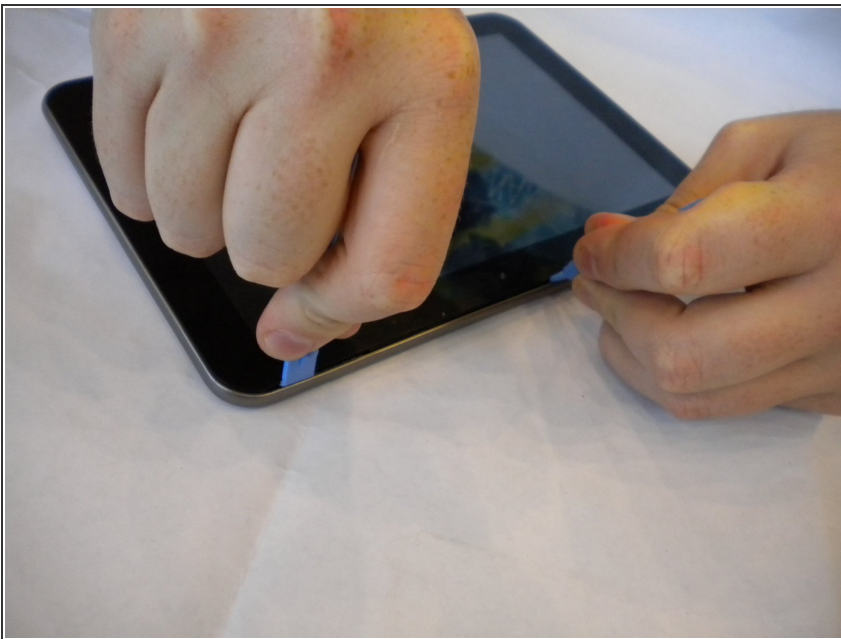
Step 2 — Insert second tool

- Insert a second plastic opening tool 6 cm (~2.4 inches) away from the first tool.

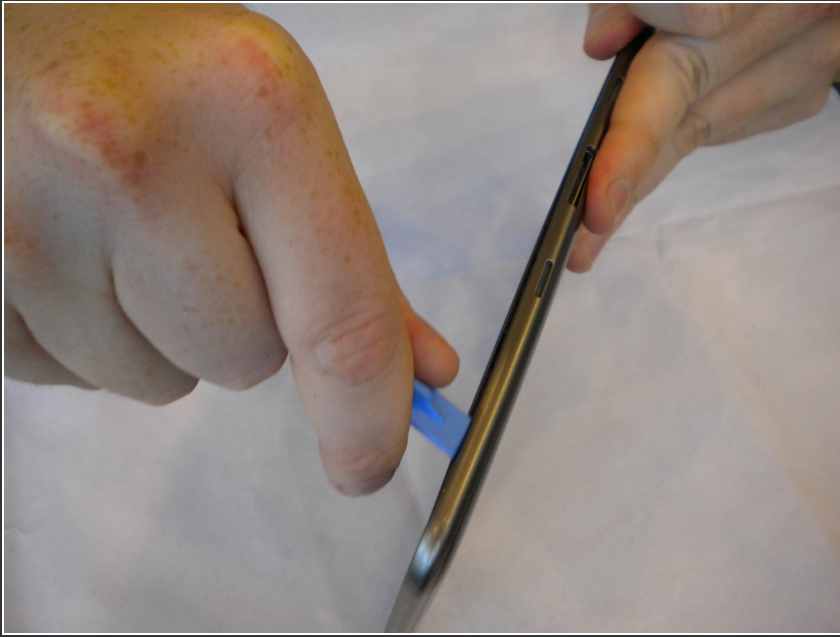
Step 3

- Slide the second plastic opening tool along the edge of the device to separate the back cover.

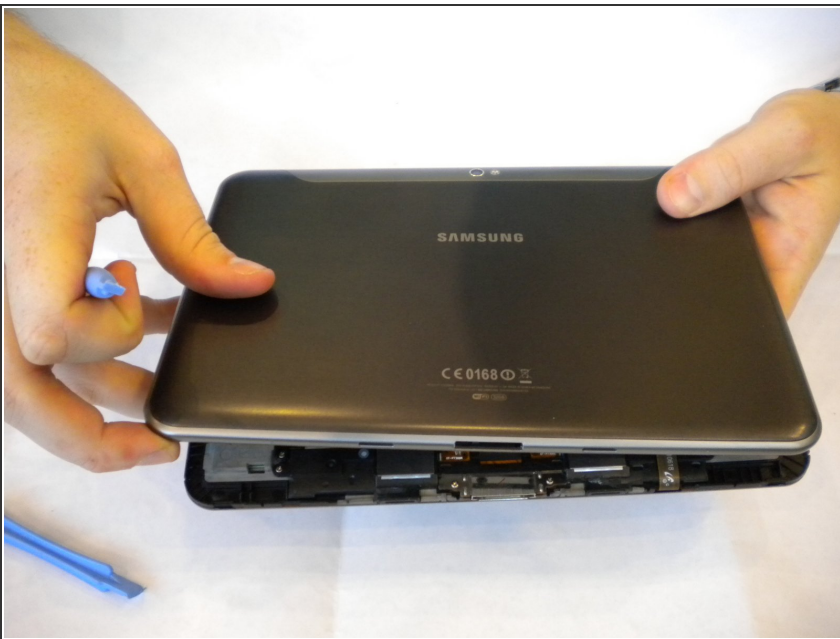
Step 4

- Using your hands, remove the back cover.

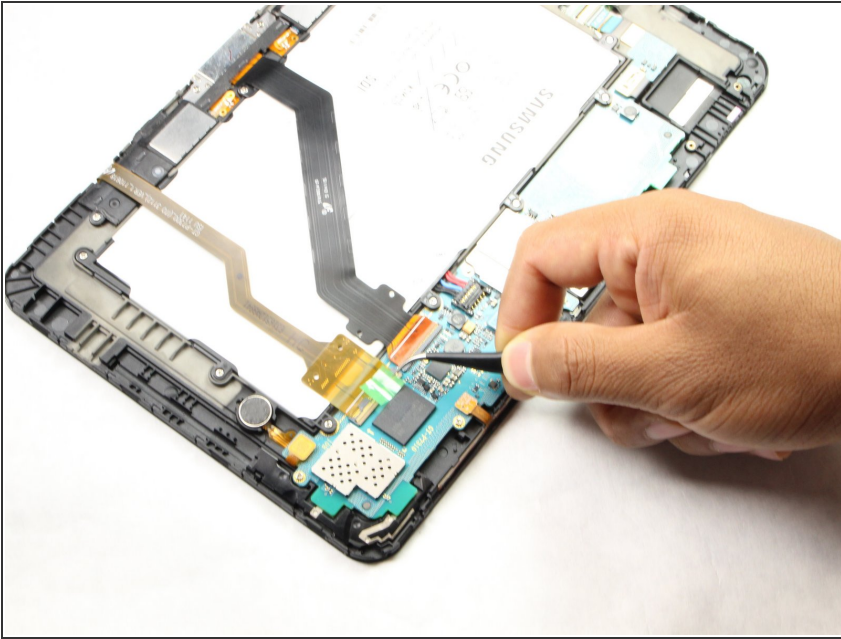
Step 5 — Charging Port

- Using tweezers, peel away the green tape located on top of the two flexible ribbon cables.

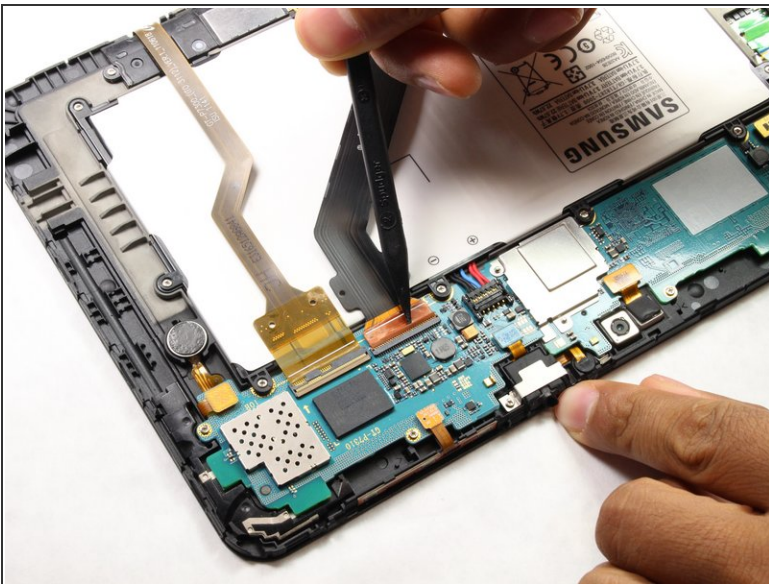
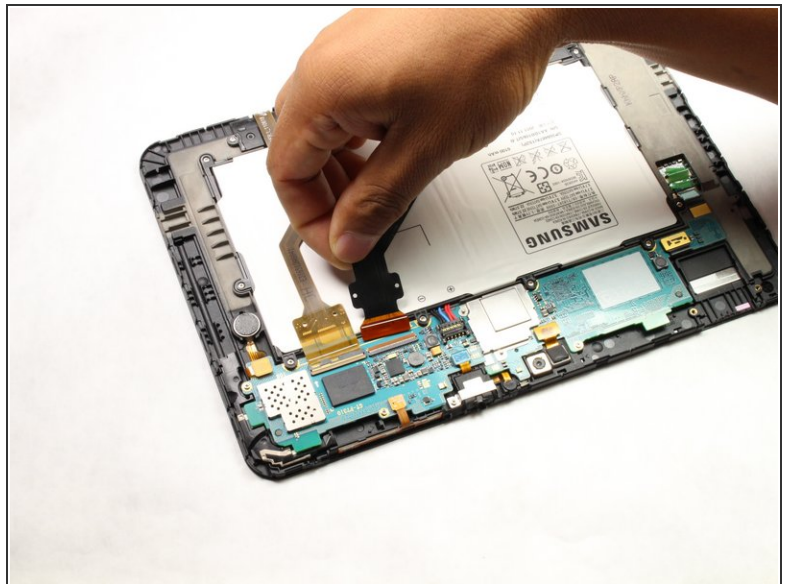
Step 6

- Insert a spudger under the orange tab.
- Pry open the tab to disconnect the black flexible ribbon cable from the motherboard.

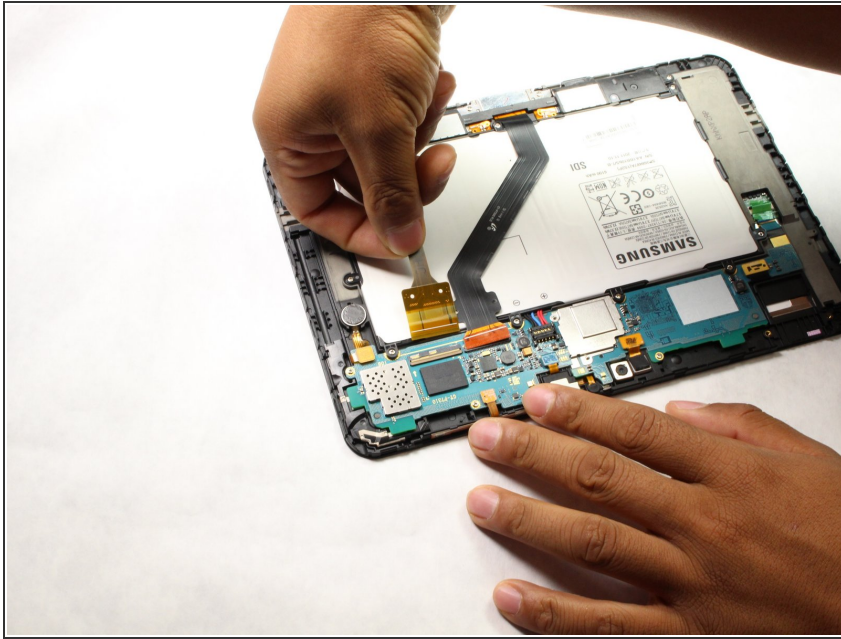
Step 7

- Slide out the yellow flexible ribbon cable to disconnect it from the motherboard.

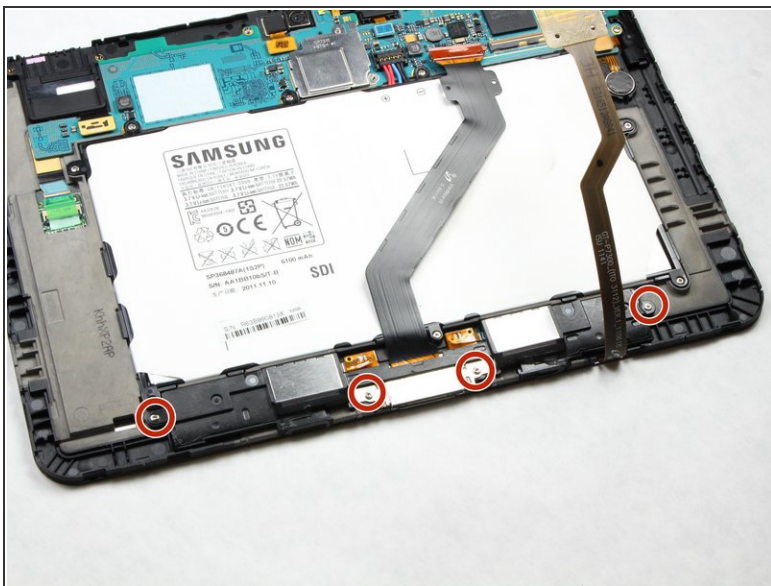
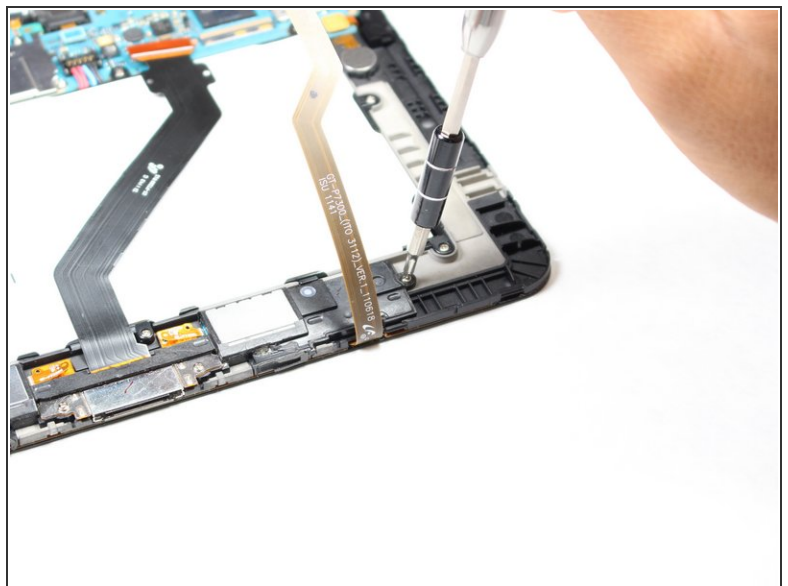
Step 8

- Using a Phillips #00 screwdriver, unscrew the 4 screws (3mm) that are holding the charger port and speaker support.

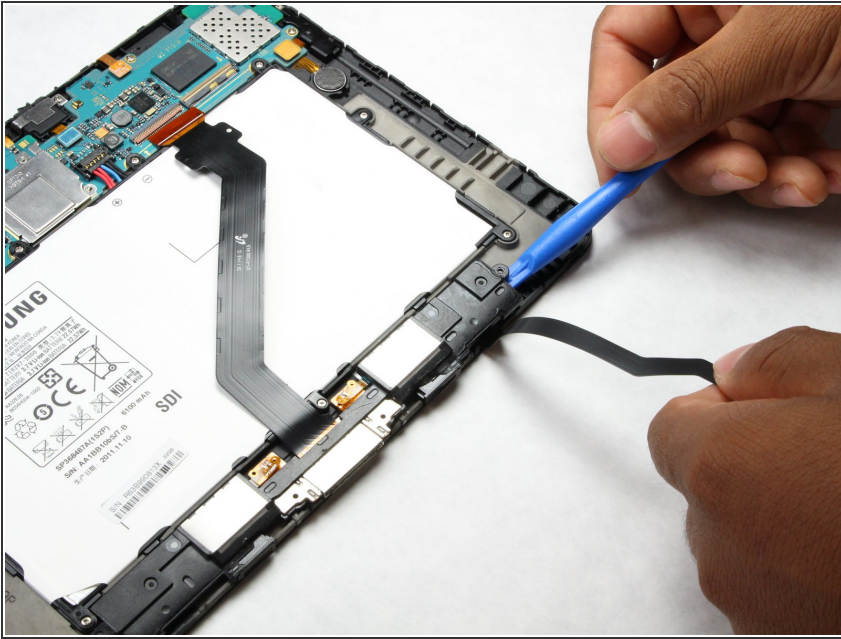
Step 9

- Insert opening tool to pry support from the housing.

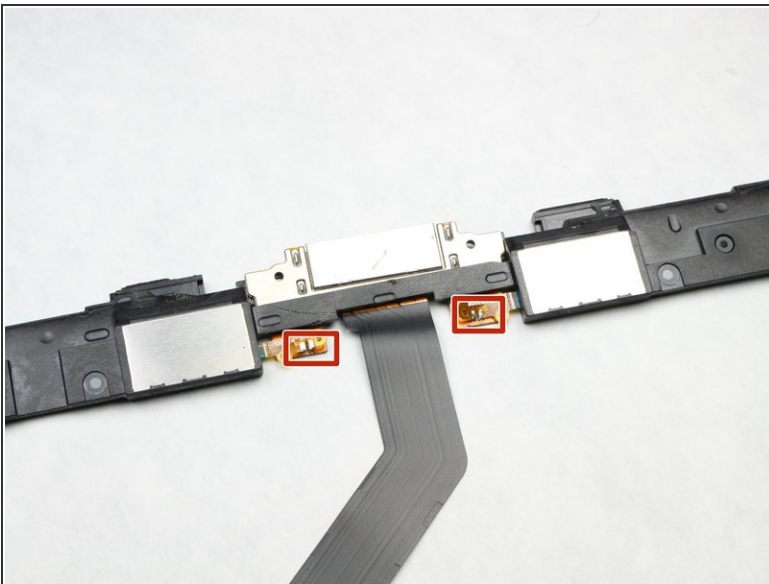
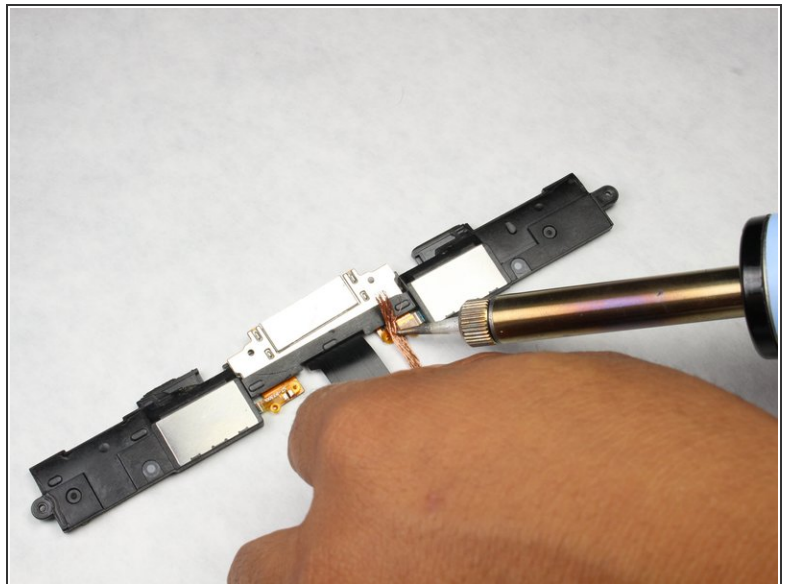
Step 10

- Desolder the two connections to separate the speakers from the charger port.

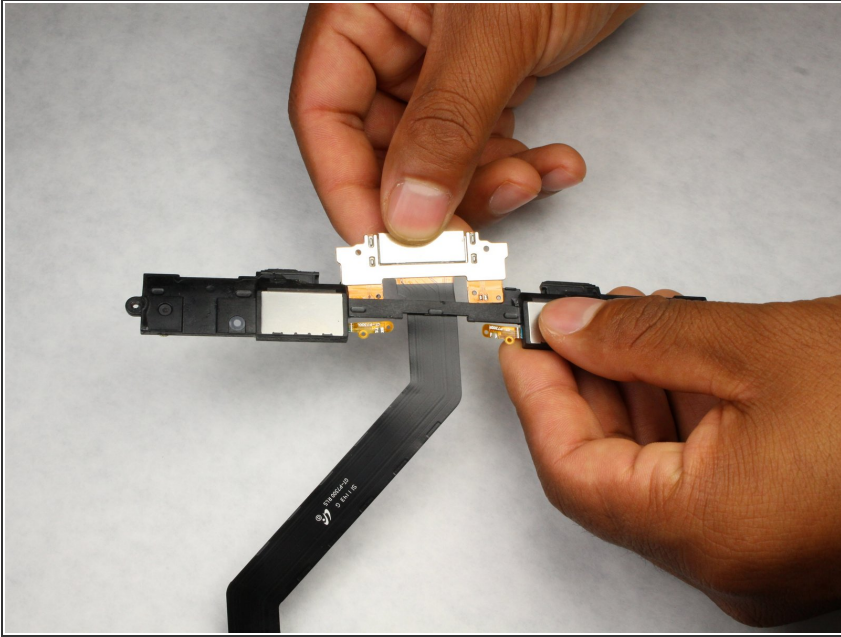
Step 11

- Separate charging port from speaker assembly.
