Samsung Galaxy Tab S3 Repairability Assessment

Repairability assessment for the Samsung Galaxy Tab S3 performed on April 10, 2017.

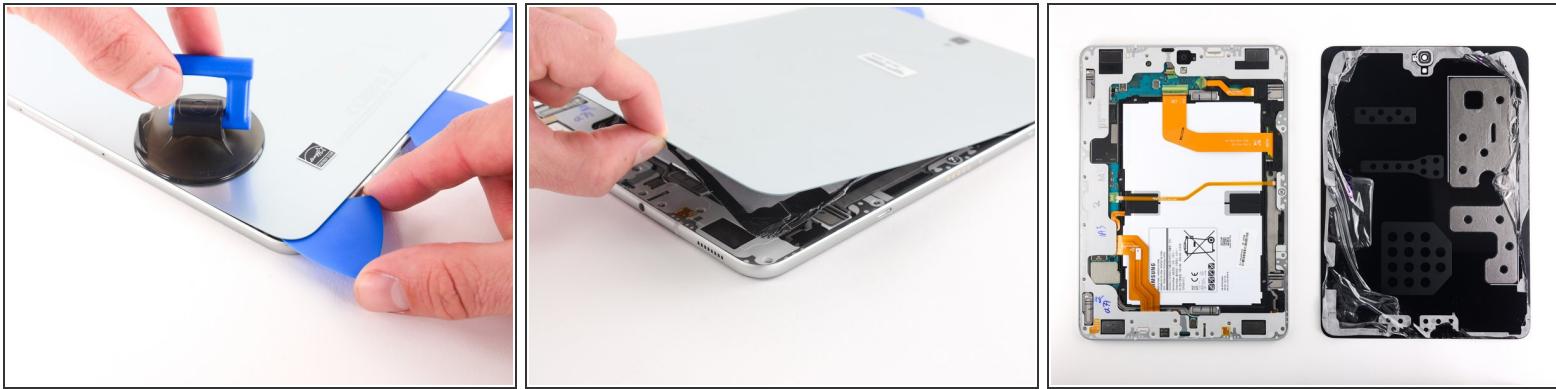
Step 2

- The rear glass panel is secured in place by a large amount of adhesive.
- In order to separate the adhesive, the rear panel needs to be heated, pulled up by a suction cup, and split with opening picks.
- The removal process was tedious, challenging, and new adhesive will be needed to replace the panel.
- At this point, nothing can be removed other than 8 screws that secure the two parts of the midframe.
- Although the battery is visible, it cannot be disconnected as the midframe sits above its connector. This makes repairs risky, as power is still supplied to the motherboard.

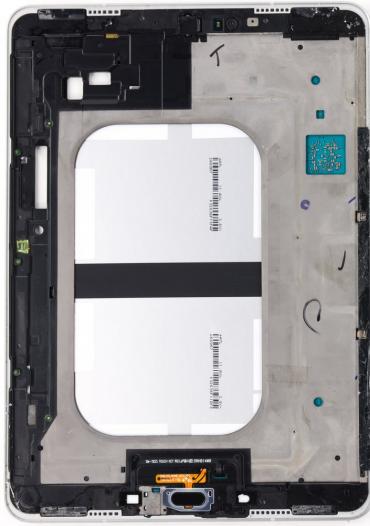
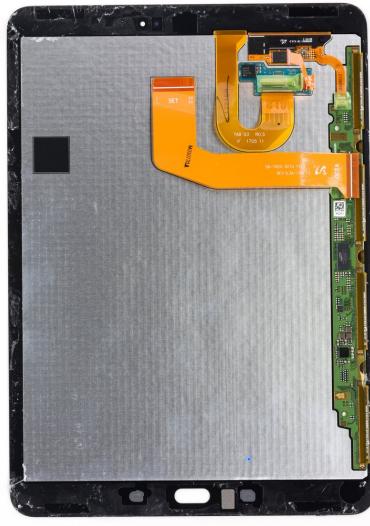
Step 3

- After removing the screws from the rear, the front panel must be removed.
- Like the rear panel, the front panel is secured by a large amount of adhesive and requires heat, suction cup, and opening picks to separate.
- There are components on the display that could be damaged in the removal process.
- There are some display cables that could be damaged if the front panel is ripped off too aggressively.

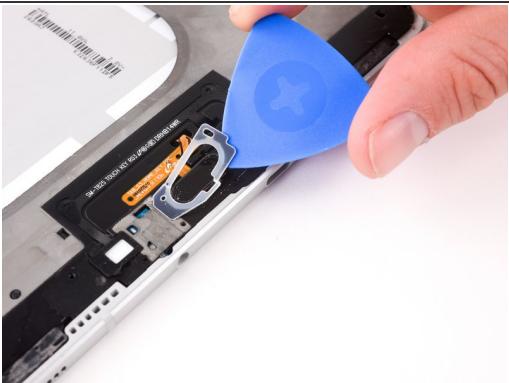
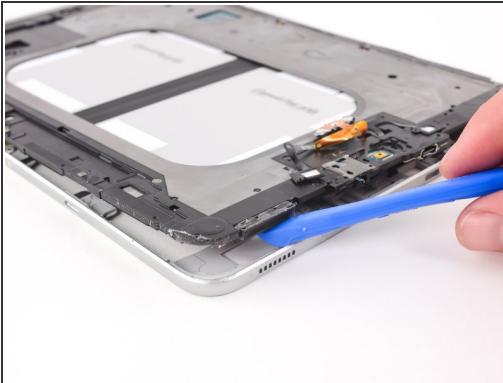
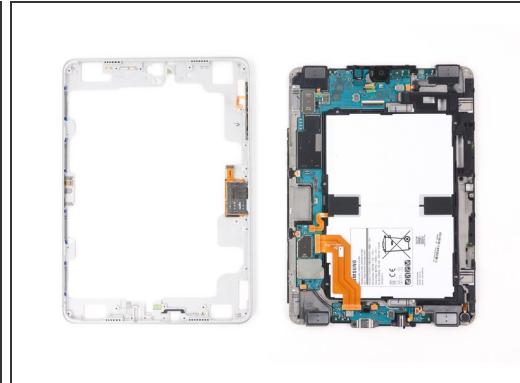
Step 4

- Removing the home button is challenging, as there is a delicate acrylic slot glued around the button. It is almost impossible to remove this non-destructively.
- With all the screws removed, the midframe can separate into two different pieces by unseating clips that hold them together.

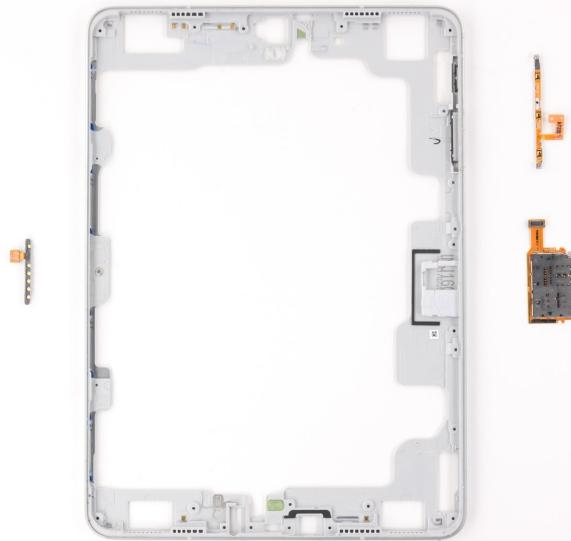
Step 5

- One piece of the midframe houses the microSD slot, the volume buttons, and copper pads.
- The microSD slot is secured by friction, where the volume button and copper pads are secured by a small amount of adhesive.

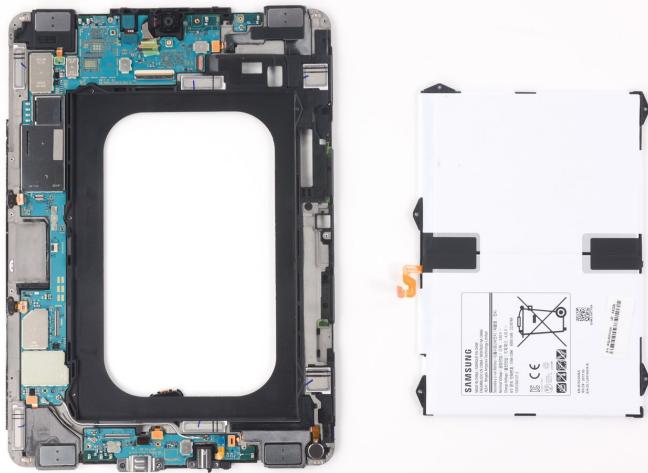
Step 6

- The battery can *finally* be removed. After the large amount of adhesive encountered thus far, it is a relief to find the battery is not secured by adhesive.
- There are five Phillips screws holding the battery in its place. The battery can be lifted out of its slot on the midframe after the screws are removed.

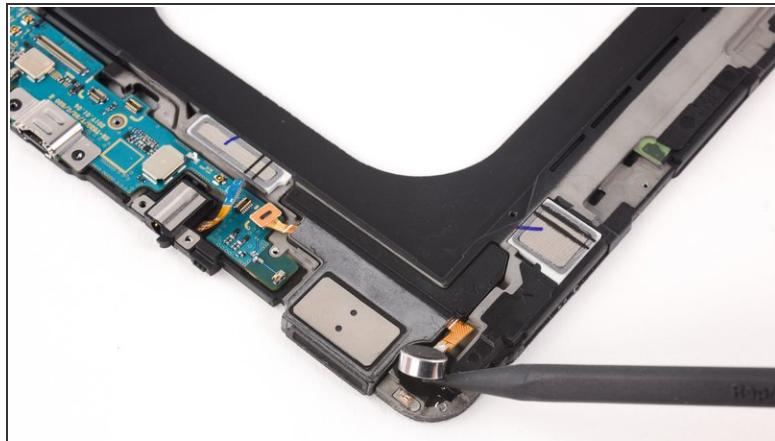
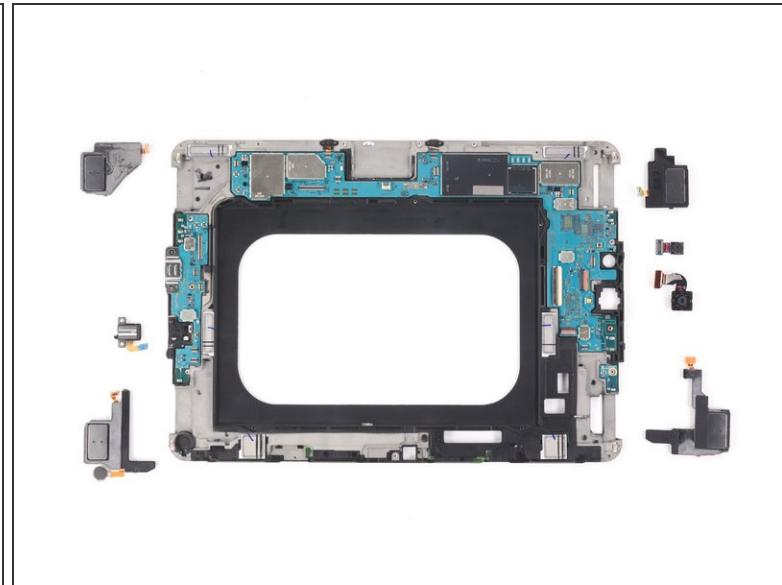
Step 7

- The haptic feedback vibrator is soldered to a speaker that is held in place by adhesive.
- There are four speakers that are all mounted to the midframe with adhesive. Prying with a spudger can free them.
- The cameras are connected to the motherboard with press connectors, and are secured by friction.
- The headphone jack is modular and held in place by the screws that secured the midframe. This is a good design feature as headphone jacks undergo wear and are more likely to need replacement.

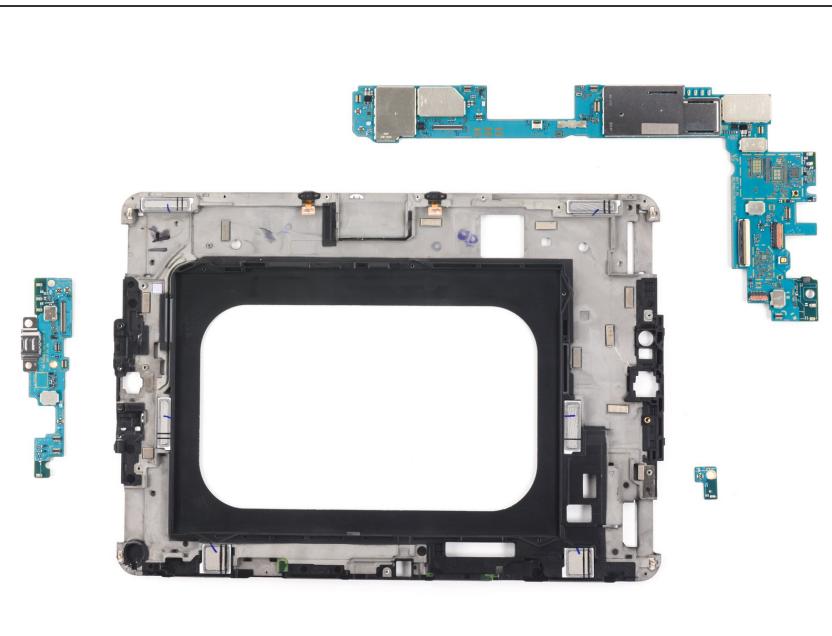
Step 8

- The motherboard, daughterboard, and extra antenna board were held in place by the two parts of the midframe.
- The boards can be removed with the speakers removed and all the connectors disconnected.

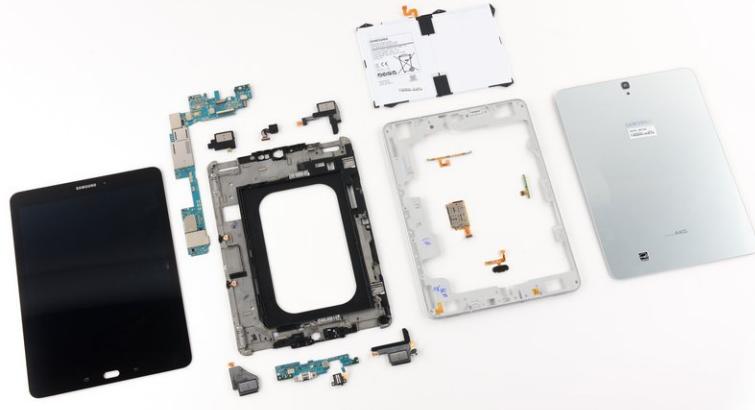
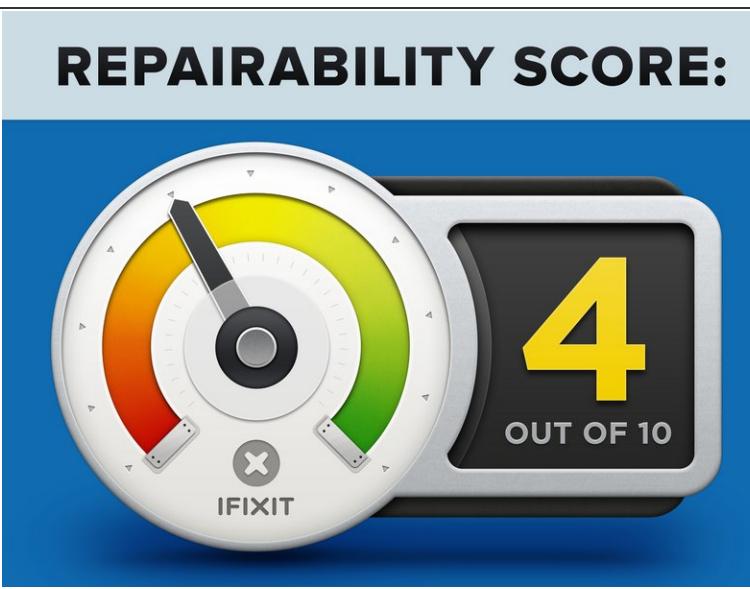
Step 9

- The Samsung Galaxy Tab 3 earns a repairability score of **4 out of 10** (10 is best).
- Many components (including the headphone jack, speakers, and micro SD slot) are modular and can be replaced.
- All screws are Phillips #00 screws.
- The battery is held in place by screws, not adhesive. It is very difficult to access, however.
- In order to repair or replace anything, both the front and rear panel need to be removed.
- The front and rear panel are secured in place with a lot of adhesive, and are extremely hard to remove.
