Samsung LA40R81BD 40in LCD TV Main Board EEPROM Replacement

If your Samsung TV has power problems, cycling, slow start up, clicking relay or similar and replacing the electrolytic capacitors did not resolve the problem then this is the next step.

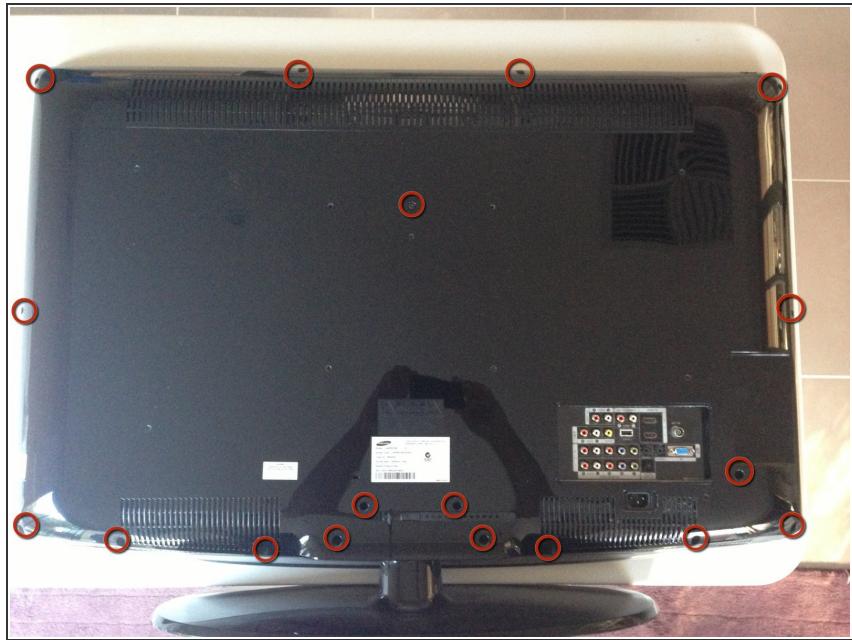
Step 1 — Rear Cover

⚠️ Unplug power cable and all AV cables from rear of TV and carefully lay TV face down on a clean flat working surface ensuring that you don't damage the LCD screen.

- Using a Philips driver remove the 18 screws from the rear panel.
- Gently lift the rear cover off the TV. You may need to wiggle the cover a little however there are no clips holding the cover on so it should come off easily if you have fully unscrewed all 18 screws.

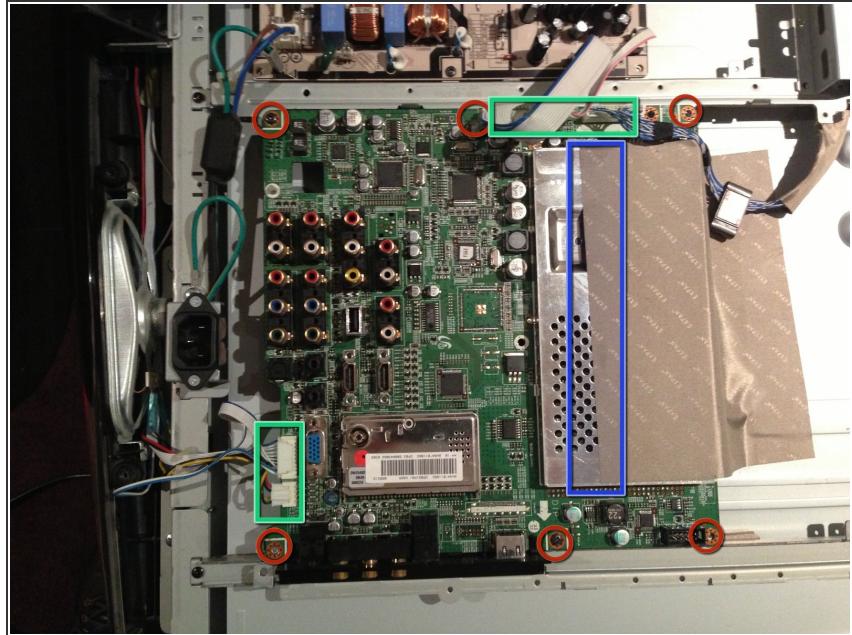
Step 2 — Main Board

- Gently peel away the conductive fabric from the metal cover on the board
- Remove 5 connectors from the board
- Remove 6 screws from the perimeter of the board.
- Lift the main board away from the chassis ensuring you don't snag or catch any of the cables.

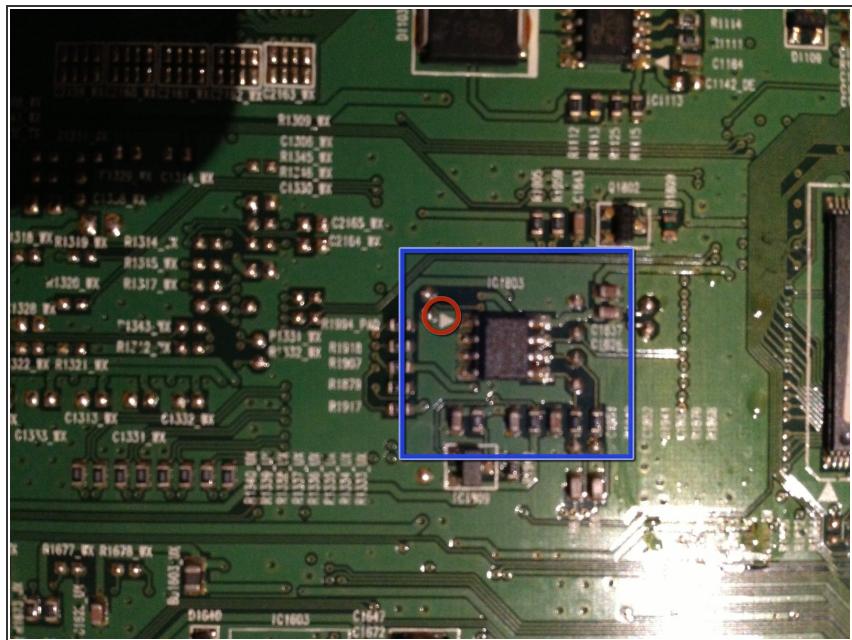
Step 3 — Replacing faulty EEPROM on main board (Clicking relay symptom part 2)

- Turn the main board over to expose the side that was facing the chassis and locate IC1803 (24C256 integrated circuit).

ⓘ The IC 1803 designation and location on the board is specific to the LA40R81BD model TV.

⚠ Carefully remove the old EEPROM being careful not to damage the copper pads or tracks on the board

- Use solderwick to carefully clean the pads where the old EEPROM was mounted
- Install the new EEPROM ensuring you orient pin 1 of the new device with the correct location on the board.

ⓘ I used an [AT24C256C-SSH-B 8SOIC](#) integrated circuit. There are a number of compatible devices but be sure to get the correct lead spacing to fit the board.

⚠ Check the solder joints with a magnifying glass to ensure there are no bridges between the EEPROM pins before you reassemble and power up the TV

When you power up the TV it may cycle a few times before turning on normally. This is due to the EEPROM being blank and default data being written to it. This is normal. You will need to reset all customised parameters and the date/time in the main menu.
