# Siemens Surpresso brewing unit maintenance

Replace the gaskets in the Siemens Surpresso brewing unit

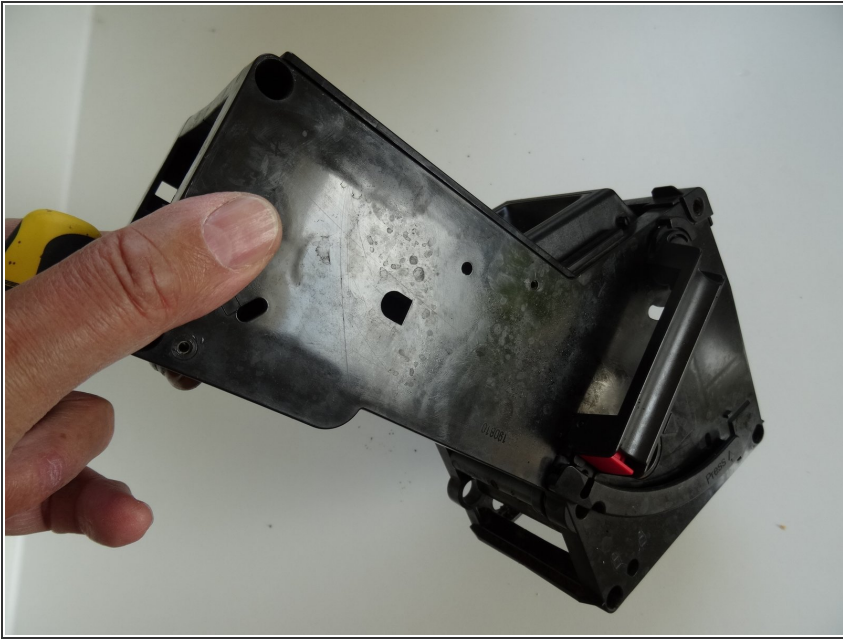
## Step 1 — Brewing Unit maintenance

- Remove the brewing unit from the device.

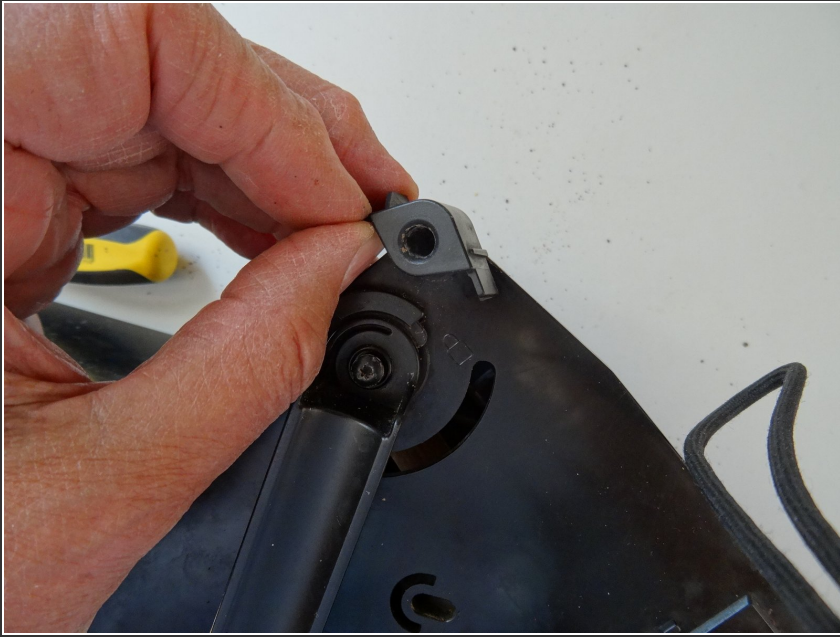
## Step 2

- Take off the cap covering the screwhole in one corner. The sense of this cap cannot be clearly seen, perhaps it should be an obstacle for thoughtless repairmen.

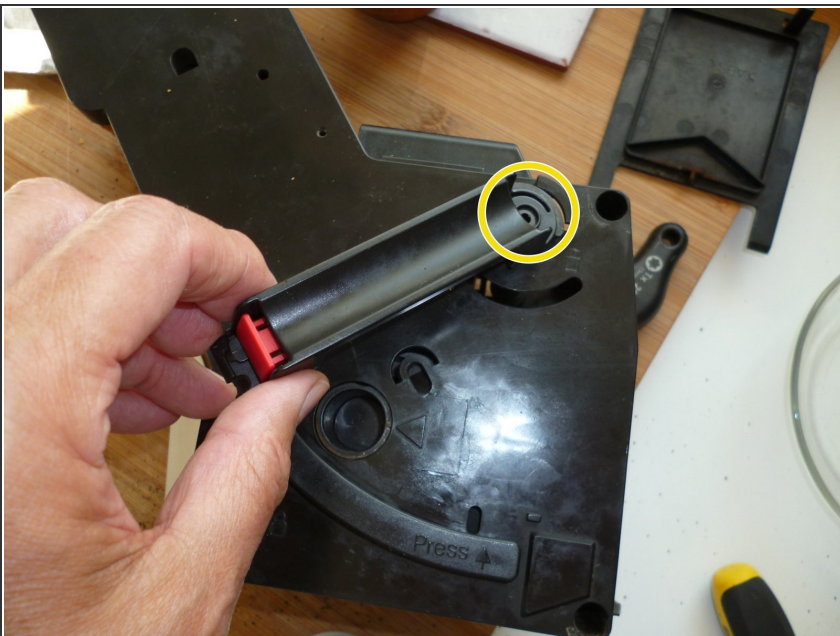
## Step 3

- Remove the single black Torx T10 screw fixing the opening handle.
- Using a certain amount of force pull the opening handle out of the guidance near the red button.
- Rotate the handle 90 degrees counterclockwise, then lift it off.

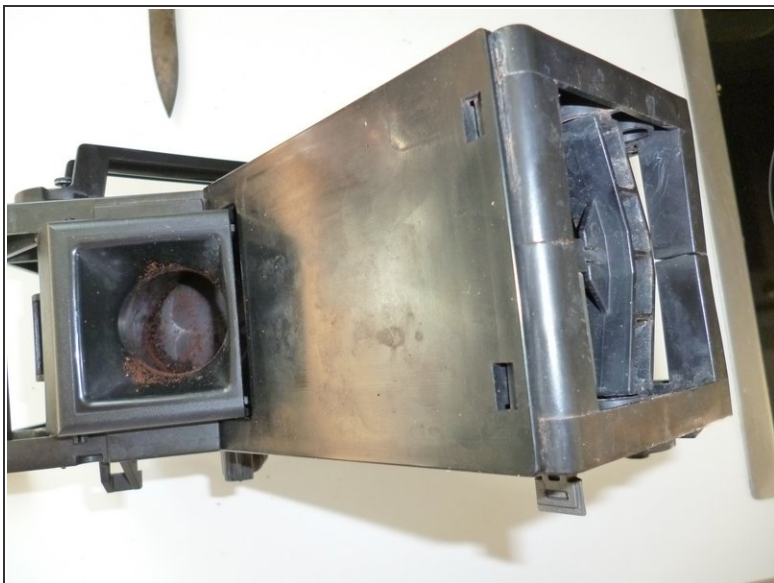
## Step 4

- Unclip the upper protection panel, then remove it by lifting it up.

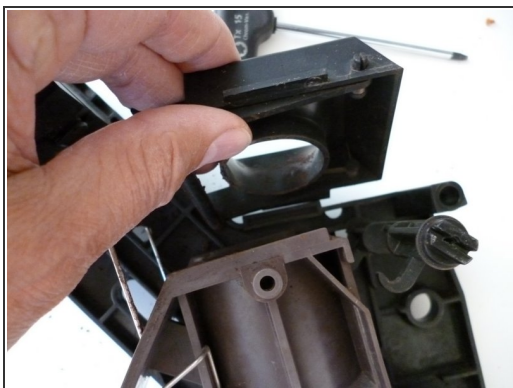
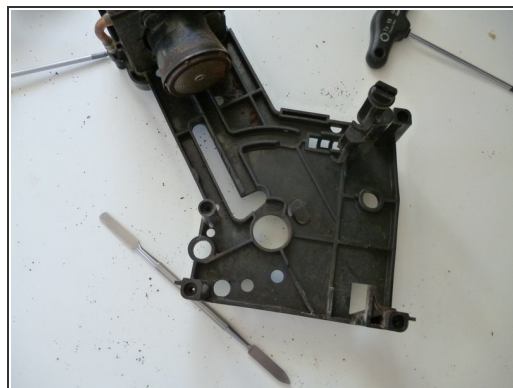
## Step 7

- Remove the funnel.
- Rotate the lower piston counterclockwise and lift it off.
- Lift off the upper piston. There is still a hose connecting the piston to the coffee outlet. In top there is also the downholder of the brewing unit.
- ❗ Sometimes this downholder is torn and the coffee leaks out of the brewing unit and does not fill your cup. Inspect the downholder for cracks. You can fix this using a special repair kit.

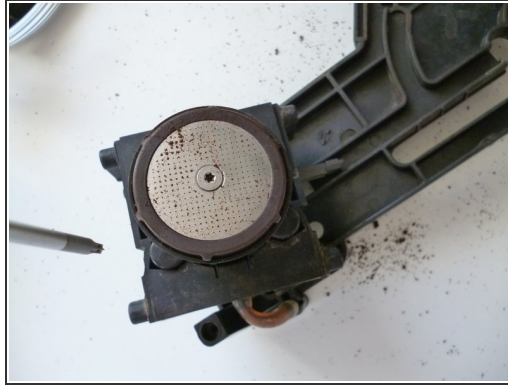
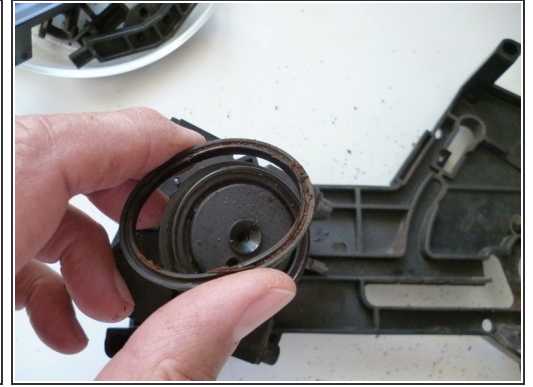
## Step 8

- Remove the hose connecting the upper piston and the coffee outlet.
- Remove the upper piston.
- Remove the Torx T20 screw from the screen of the upper piston.
- Take off the cover of the gasket and the gasket.
- Replace the gaskets of the upper piston, the coffee outlet and water connector.
- Clean thoroughly all parts. Use food-proof silicone grease to lubricate the gaskets.

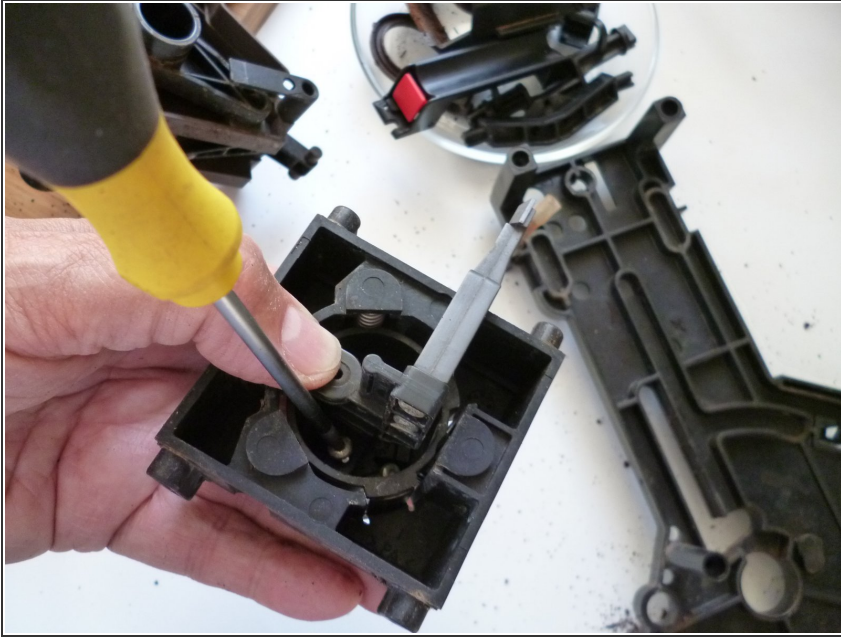
## Step 9

- ① The crema-valve is located in the interior of the upper piston. It is fixed by two Torx T10 screws.
- Remove both screws. Lift off the valve. Inspect it and clean it.
- Note: there is another gasket on the shaft of the lower piston. Replacing it is difficult.
- Lubricate all sliding parts with food-proof silicone grease. Verify the smooth operating of the brewing unit.
