# Sony Ericsson xPeria Active Headphone Jack Replacement

This guide will walk you through the steps to replace a faulty headphone jack on your Sony Ericsson Xperia Active cellphone.

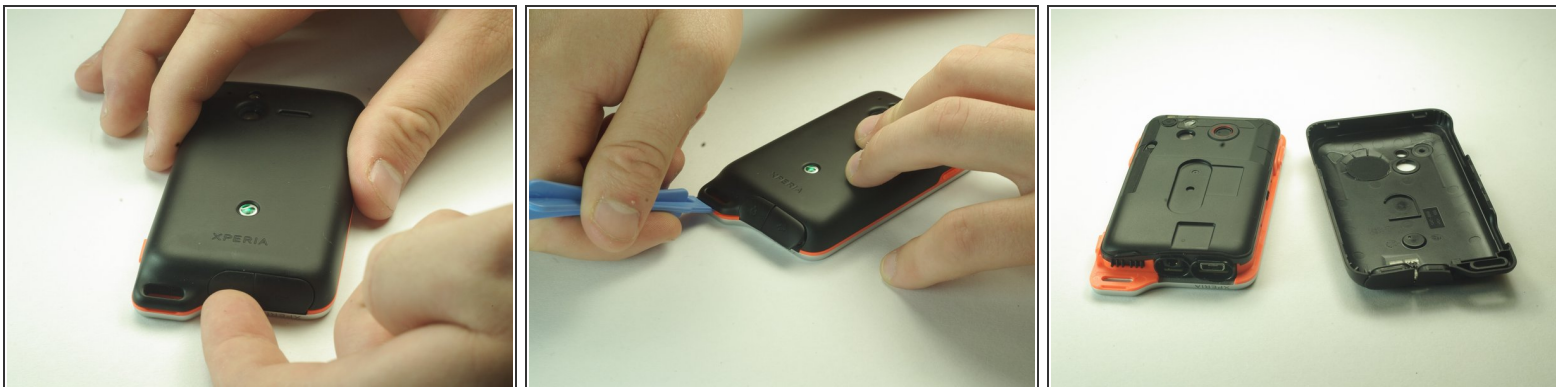
## Step 1 — Remove the back cover.

- Open the flaps and remove the back cover using the plastic opening device.

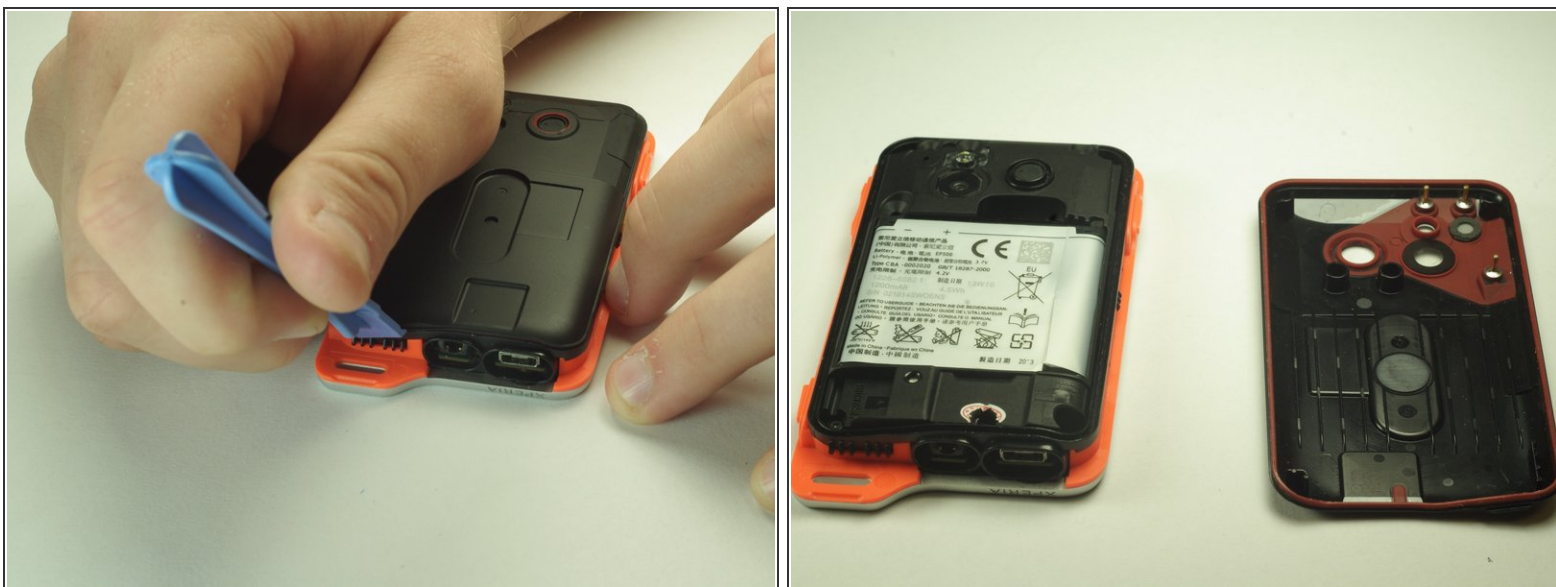
## Step 2 — Remove inside plastic battery cover.

- Remove the battery shield with the plastic opening device.

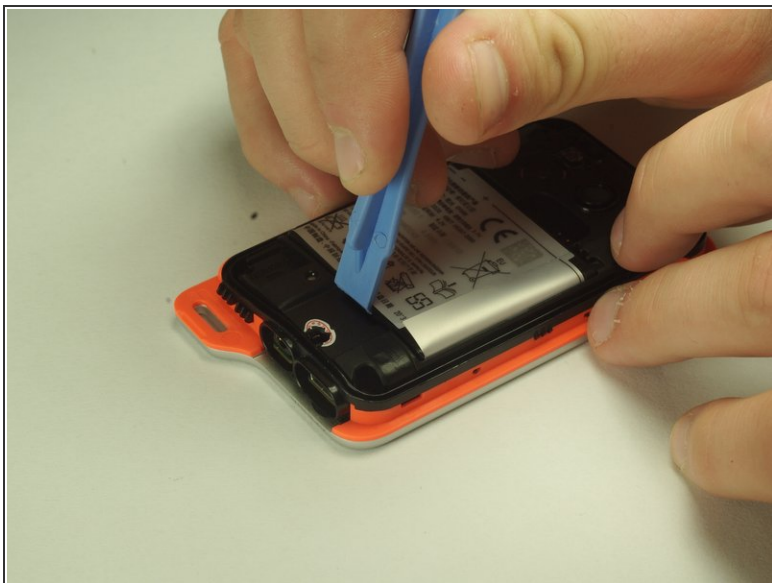
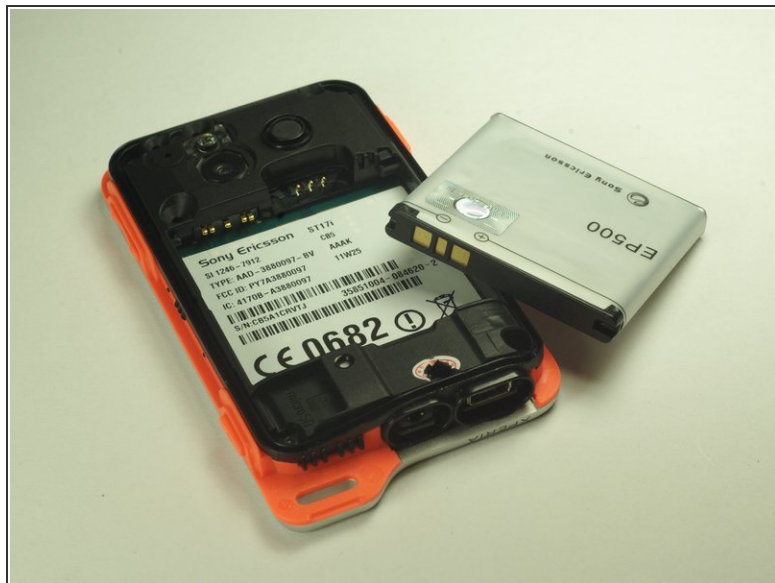
### Step 3 — Remove the battery

- Remove the battery.

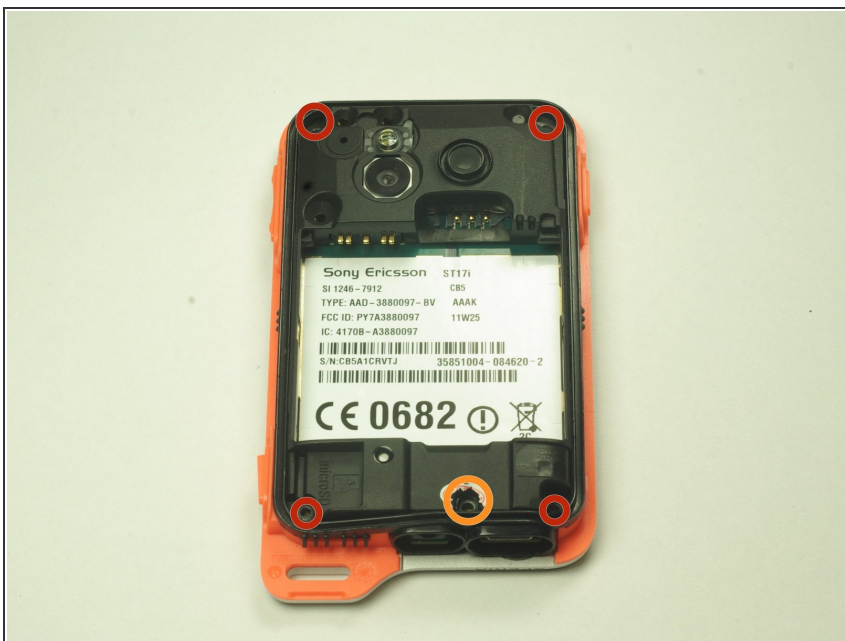
### Step 4 — Unfastening The Motherboard Cover

- Unscrew the 5mm screws with the T5 head.
- Unscrew the 6mm screw with the T6 head.

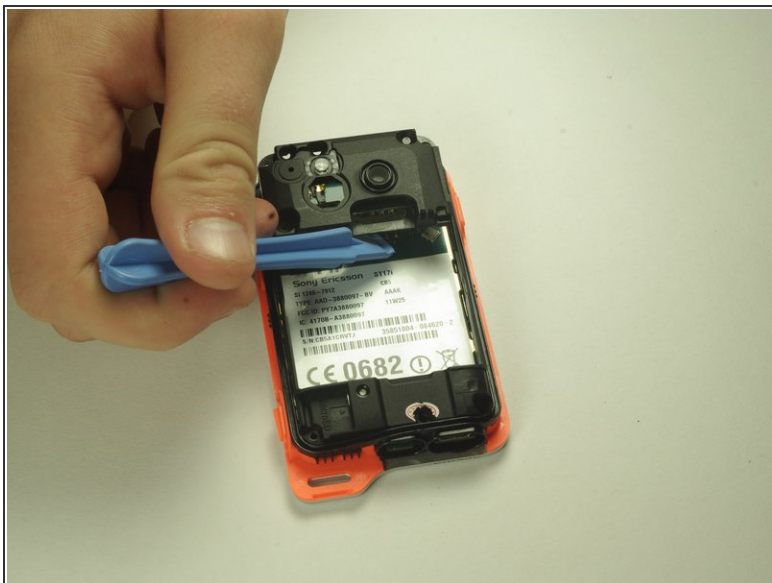
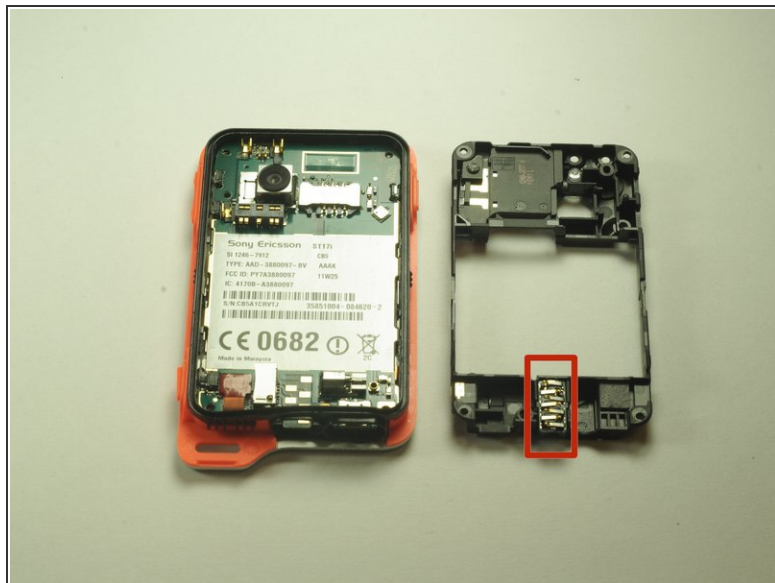
## Step 5 — Removing The Motherboard Cover

- Remove the black cover with the plastic opening tool.
- Remove the headphone jack from its slot.
