Sony TCM-919 Cassette-Corder Microphone Replacement

This guide aims to instruct Sony TCM-919 owners concerning the replacement of a faulty microphone in this cassette-corder.

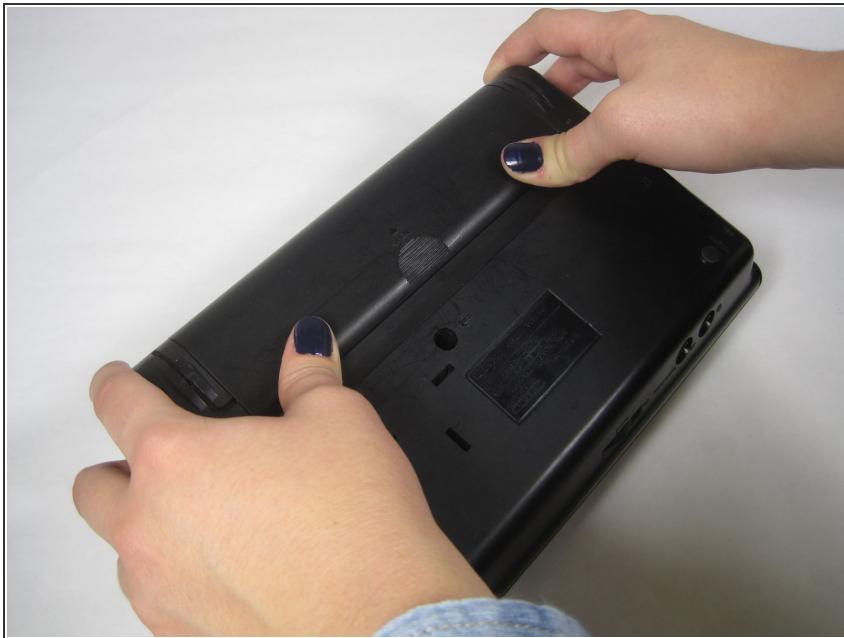
Step 1 — Remove battery Cover

- Turn the device around so that the back cover is facing upward. Use your thumbs to press down firmly and then push the battery door cover open.
- Remove any batteries.

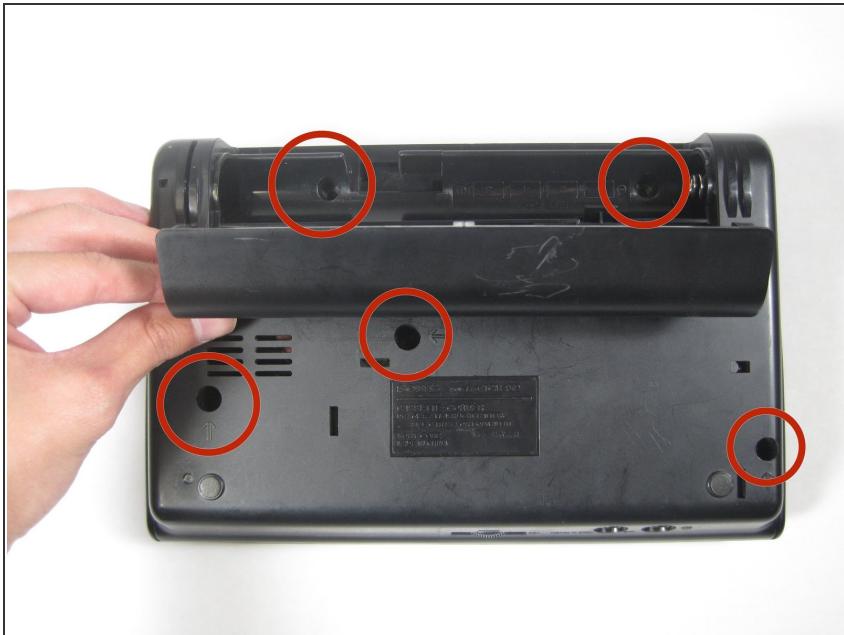
Step 2 — Remove Back Casing

- Remove the 5, 5.95mm screws as indicated in the picture using the Phillips head screwdriver.

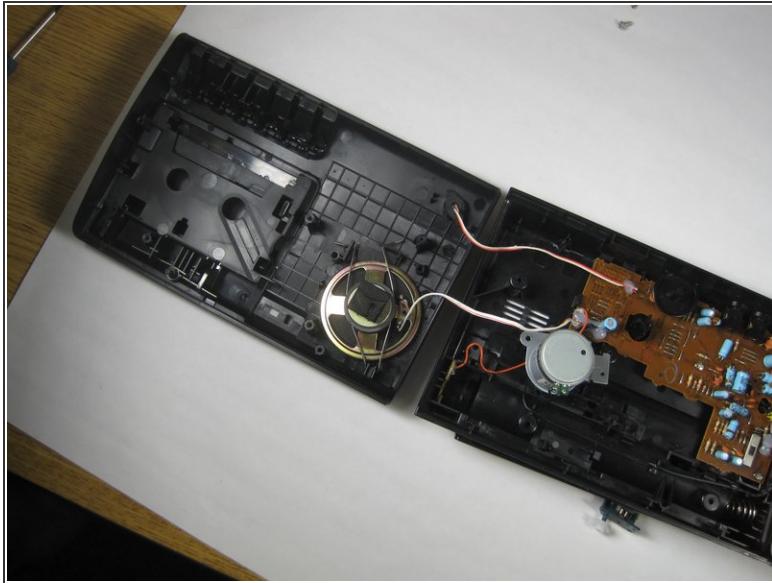
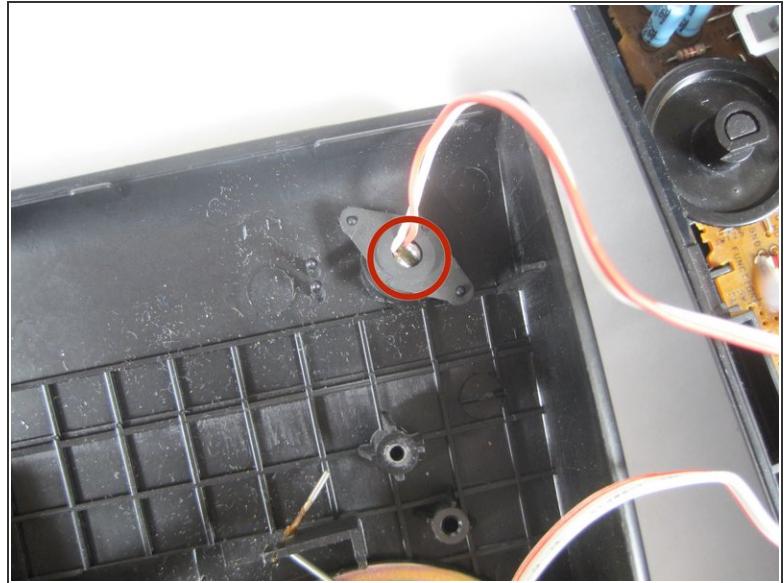
Step 3 — Desolder Microphone Wires

- Look to the back of the top cover.
- Desolder the two wires connected to the microphone using the soldering station.

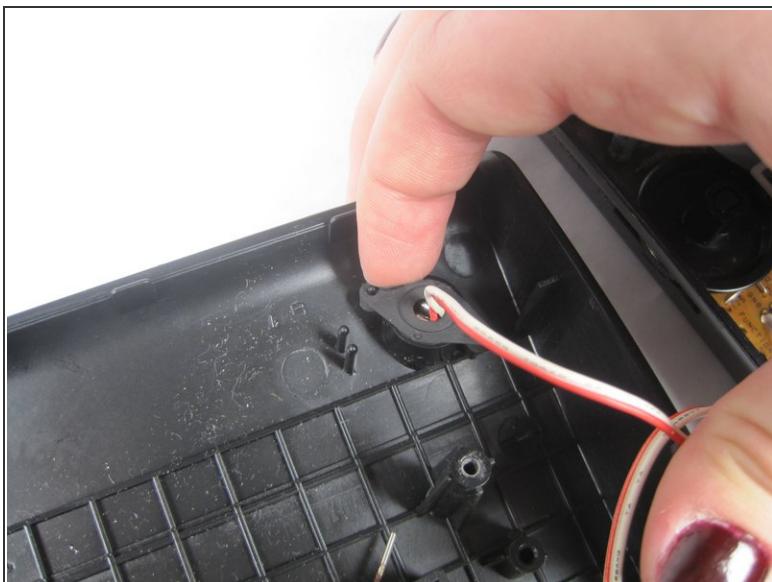
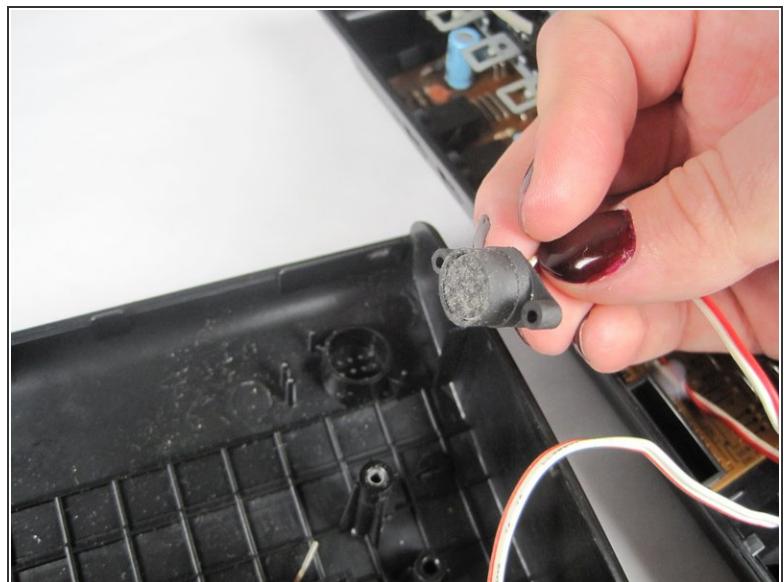
Step 4 — Remove Microphone

- Gently remove the rubber top from the two plastic knobs that hold the microphone in place.
- Remove the microphone by pulling up.
