Sony Vaio PCG-61211L Key Replacement

A key on the keyboard can get dislodged or not register at times, when this happens please refer to our easy to use guide to solve this problem.

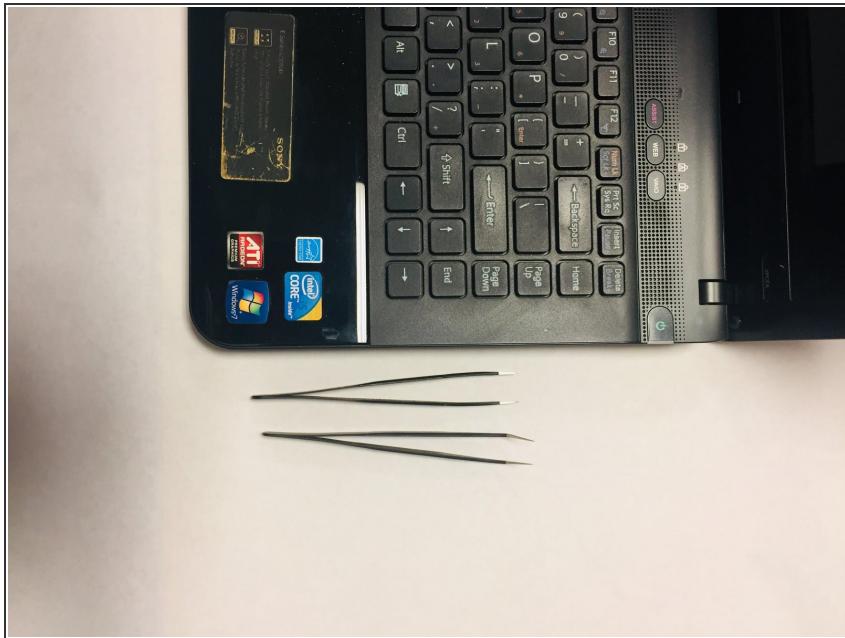
Step 1 — Key

- Use a pair of tweezers like the one shown in the picture.

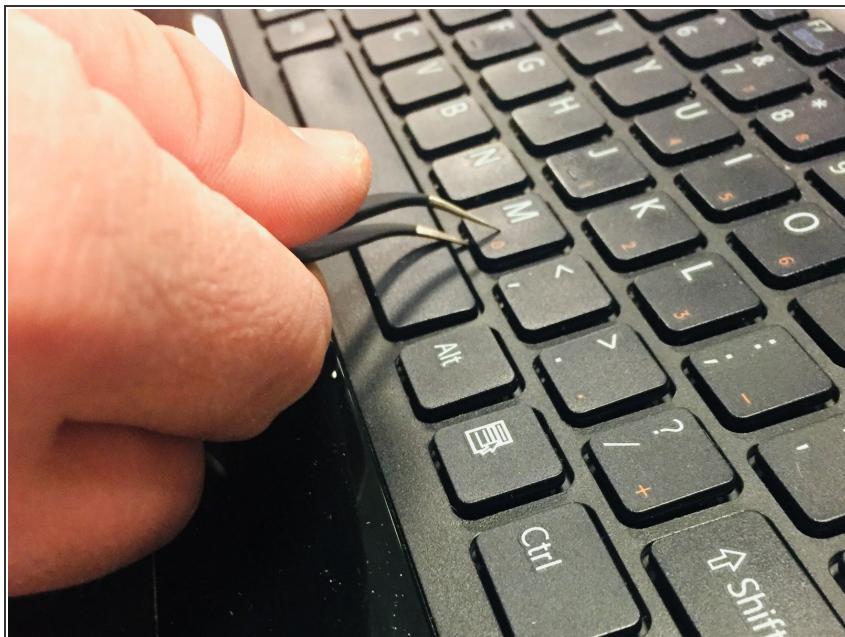
Step 2

- Use the tweezers to get under the key piece on the keyboard as shown in the picture.

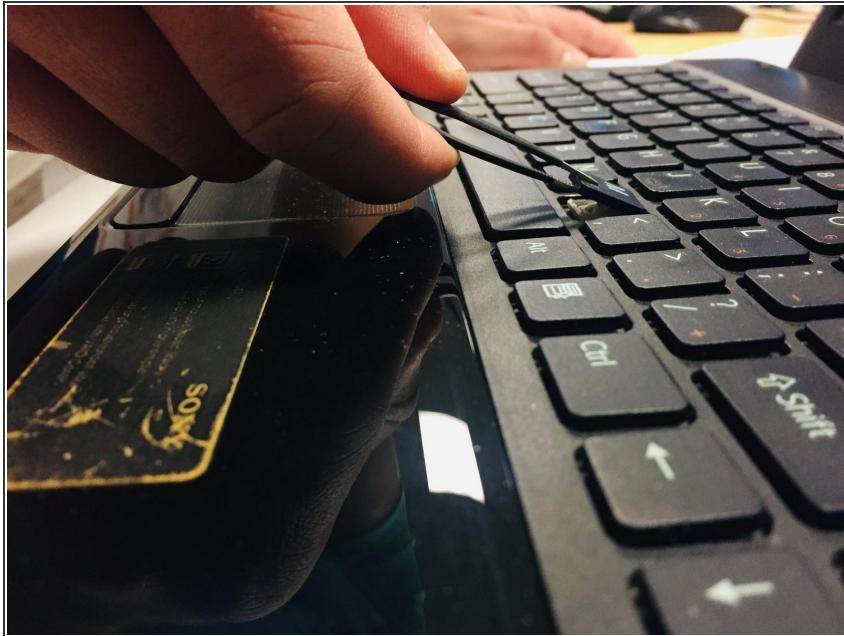
Step 3

- Carefully lift the key piece upward to remove it completely.

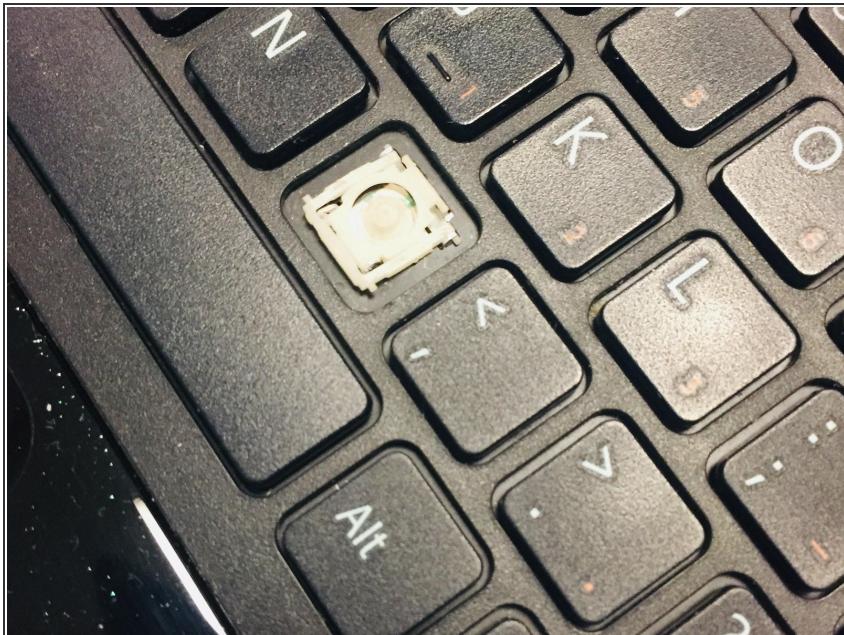
Step 4

- After the key is removed, you should be able to see the part underneath the key where it can be replaced.

To reassemble your device, follow these instructions carefully in reverse order.
