Sony Vaio PCG-981L Floppy Drive Replacement

The purpose is to open up the floppy drive so that you can check for any connection failures or damages.

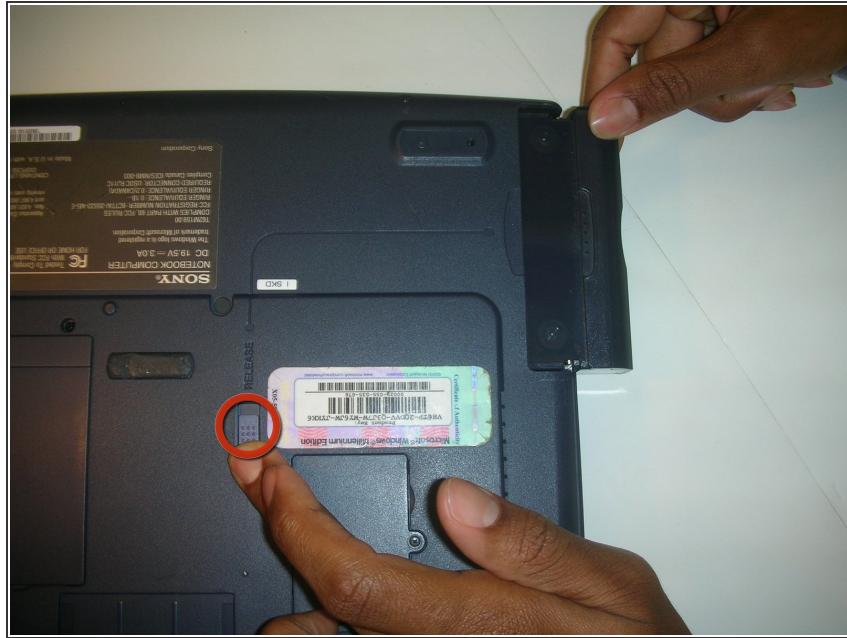
Step 1 — Floppy Drive

- Turn the computer over so that its underside is facing up. Then slide the blue floppy drive release button down and pull the floppy drive out of the laptop.

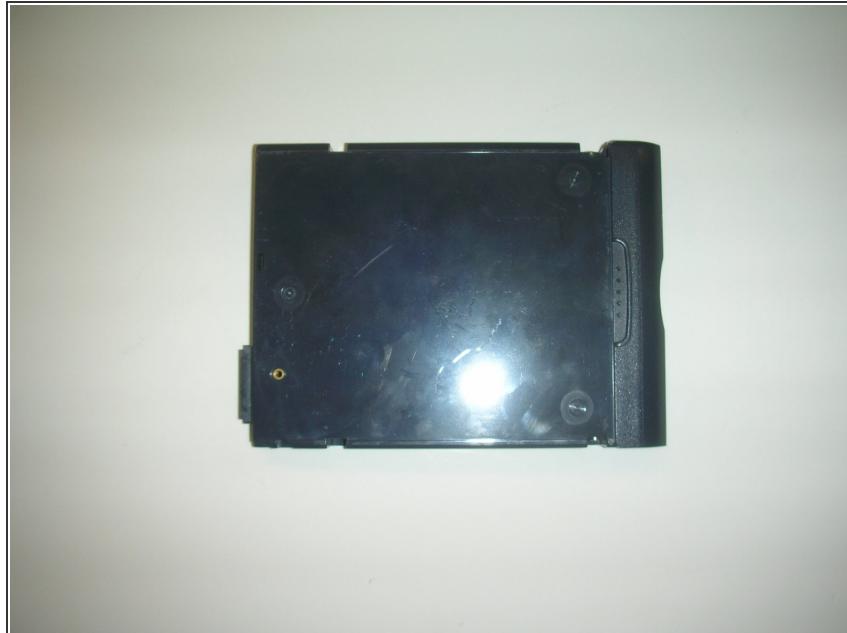
Step 2

- Completely remove and isolate the floppy drive from the laptop.

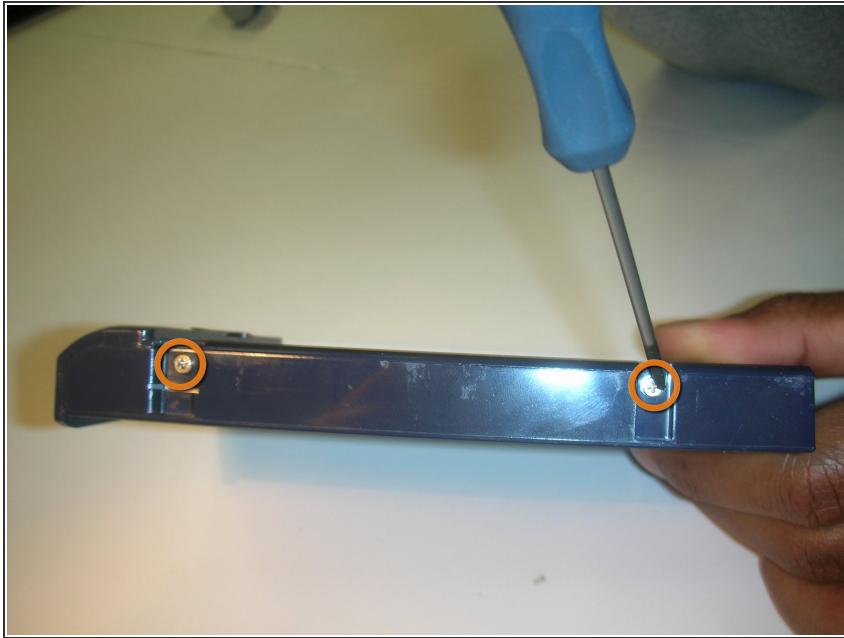
Step 3

- There are two screws on each side (total of four screws) of the floppy drive. Remove these screws.

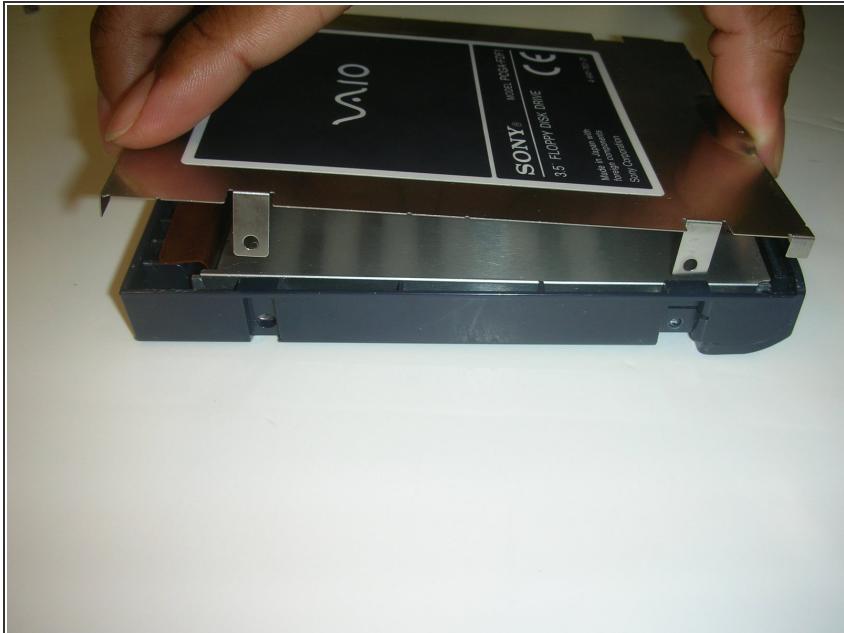
Step 4

- Once you have removed the screws, you can remove the floppy drive core from its casing as shown.

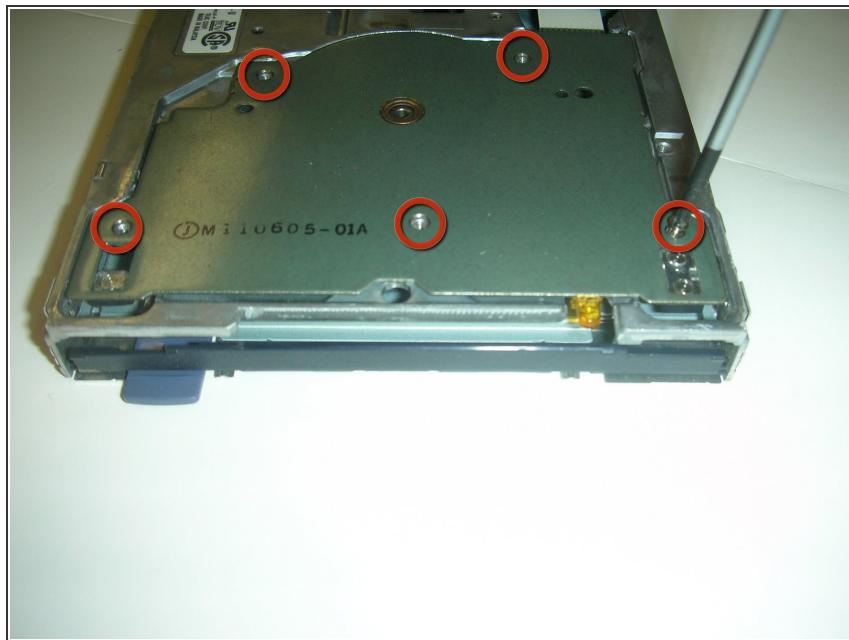
Step 5

- After you have removed the floppy drive core from its casing, unscrew these five screws shown.

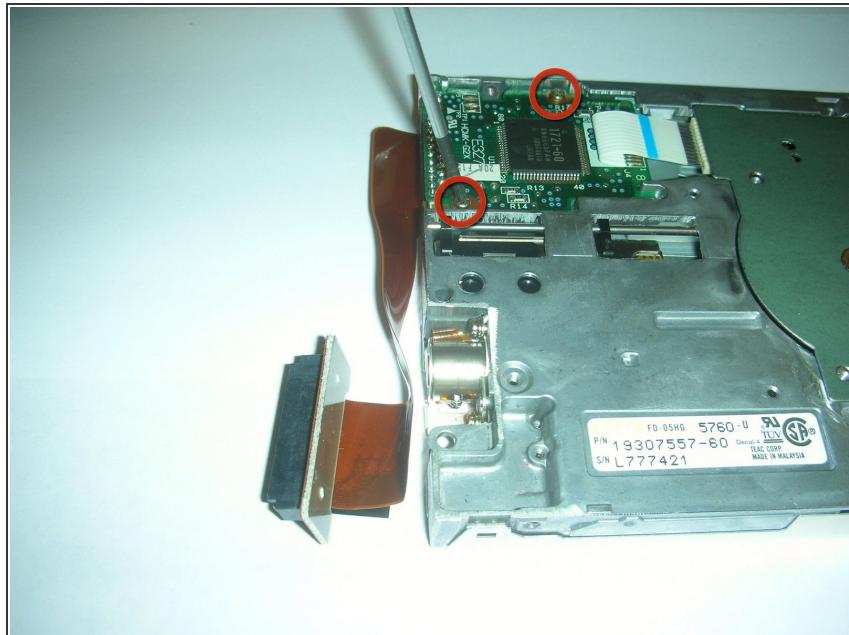
Step 6

- Remove the two screws holding part of the floppy processing unit.

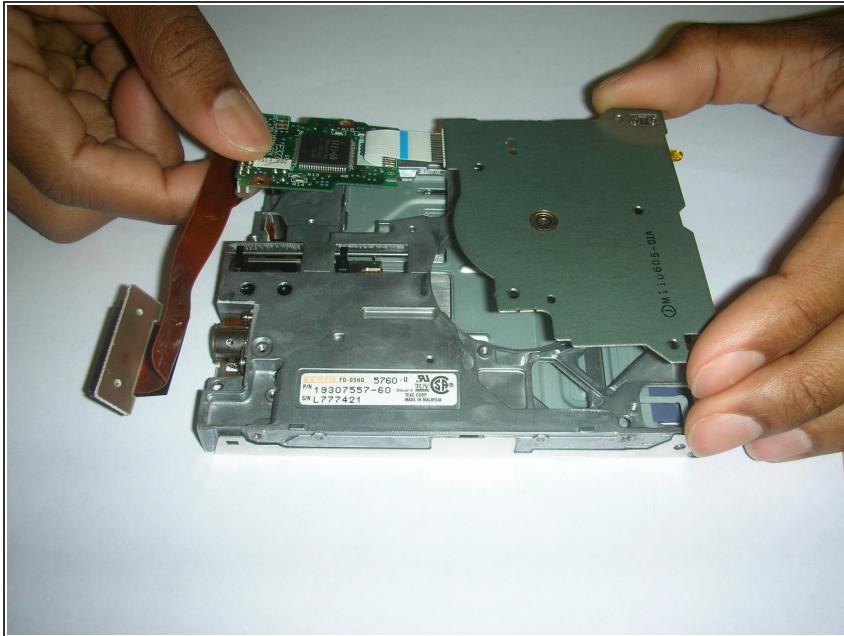
Step 7

- Now that the screws are removed, you can remove the entire processing unit of the floppy drive.

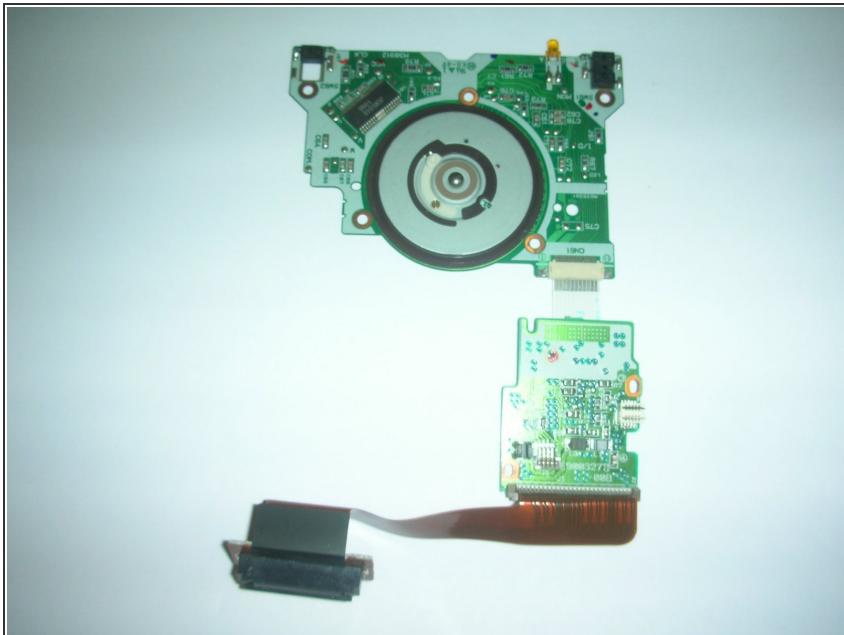
Step 8

- Here is an isolated image of the core hardware of the floppy drive. Here is where the floppy "magic" happens. Check for any connection failures or shortages. You may need to re solder some of the connections.

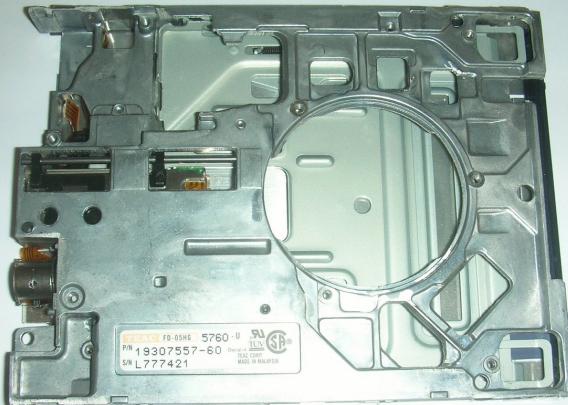
Step 9

- Here is an isolated image of the floppy drive casing unit.
