# Sony XAV-AX100 USB Cable Replacement

Follow this guide to replace the USB cable on a Sony XAV-AX100 radio.

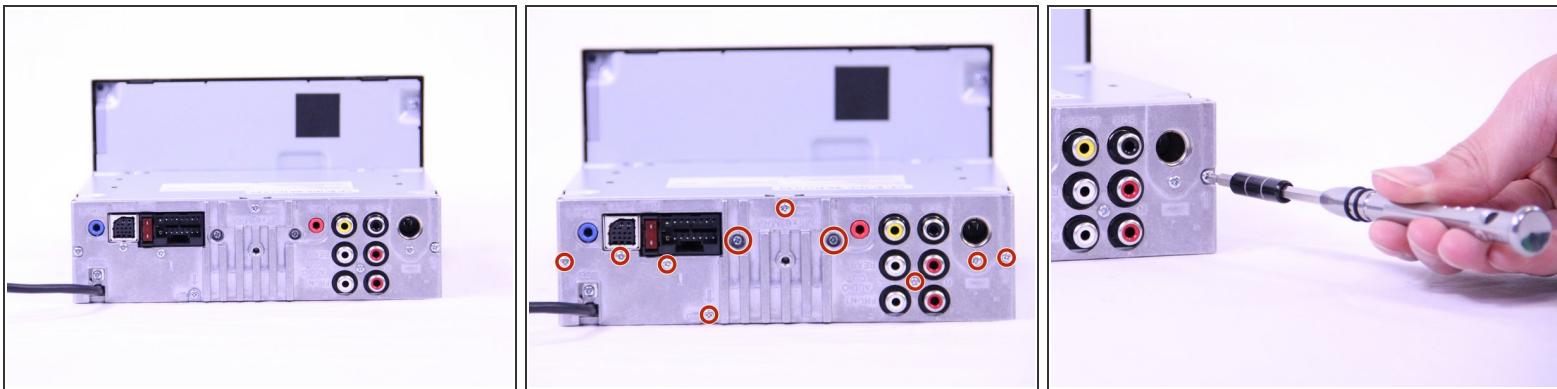
## Step 1 — USB Cable

- Place the device on a flat surface, upside down, so the bottom of the screen would be facing upwards.
- Remove the ten 3.5mm Phillips #0 screws from the back plate.

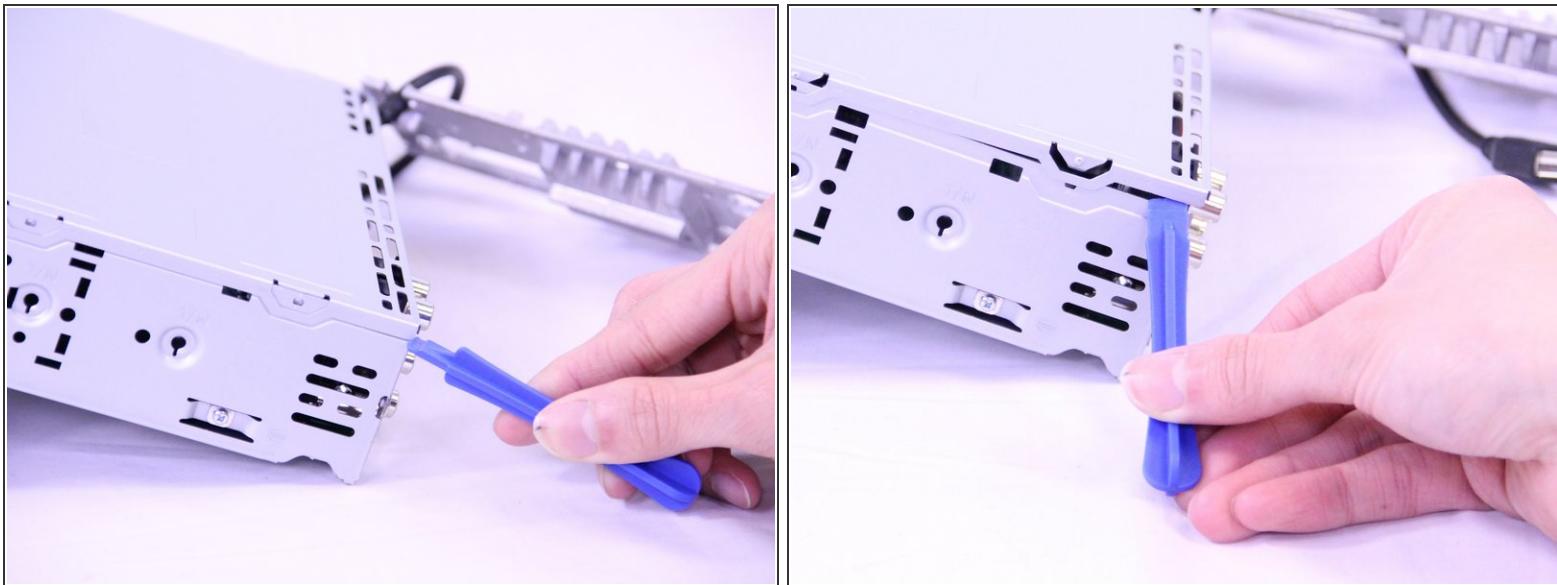
## Step 2

- Use a plastic opening tool to remove the back plate.
- *(i)* Don't remove completely as there will still be cables connected.

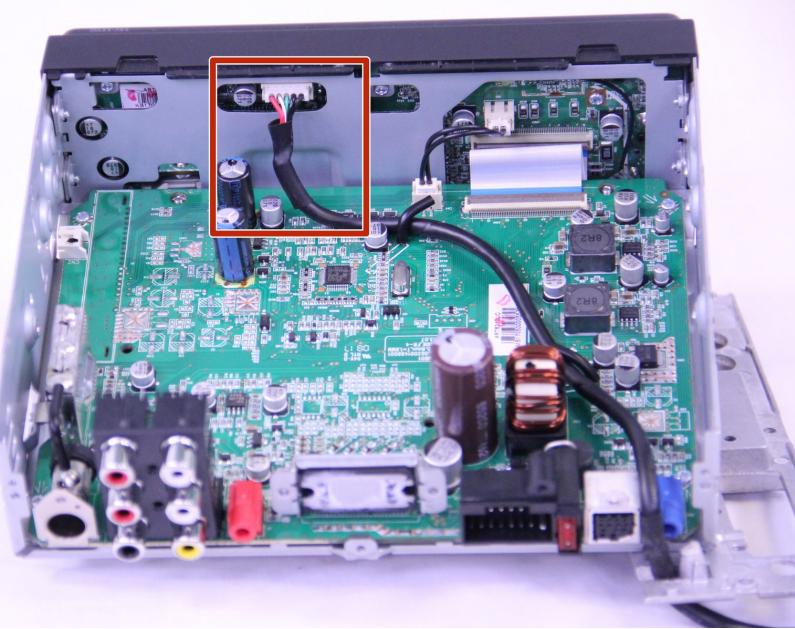
## Step 3

- Disconnect the USB cable from the display board.

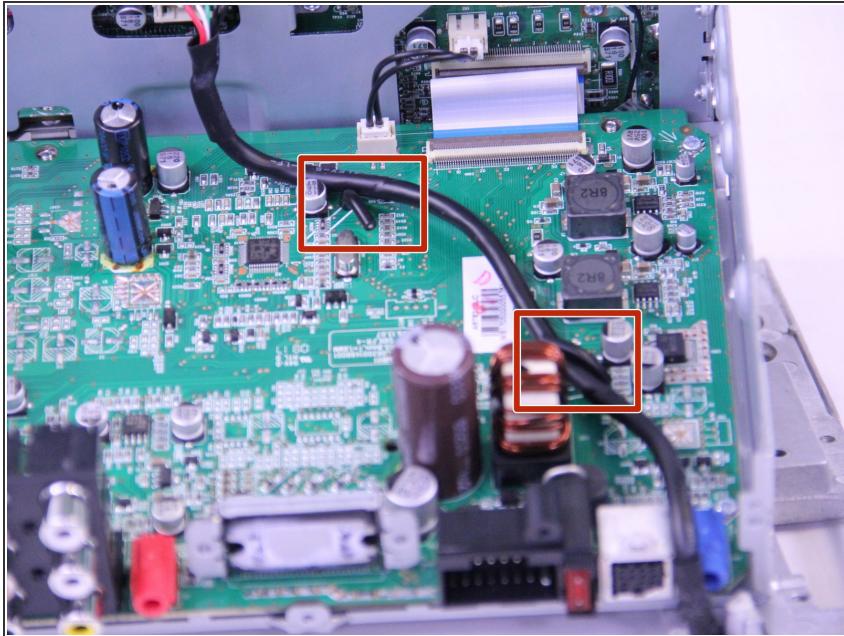
## Step 4

- Adjust the rubber holders that are keeping the USB cable still on the motherboard, so you can remove the cable entirely from the inner compartment.

The rubber holders are extremely sensitive to any applied force. Therefore, be careful while turning them around.

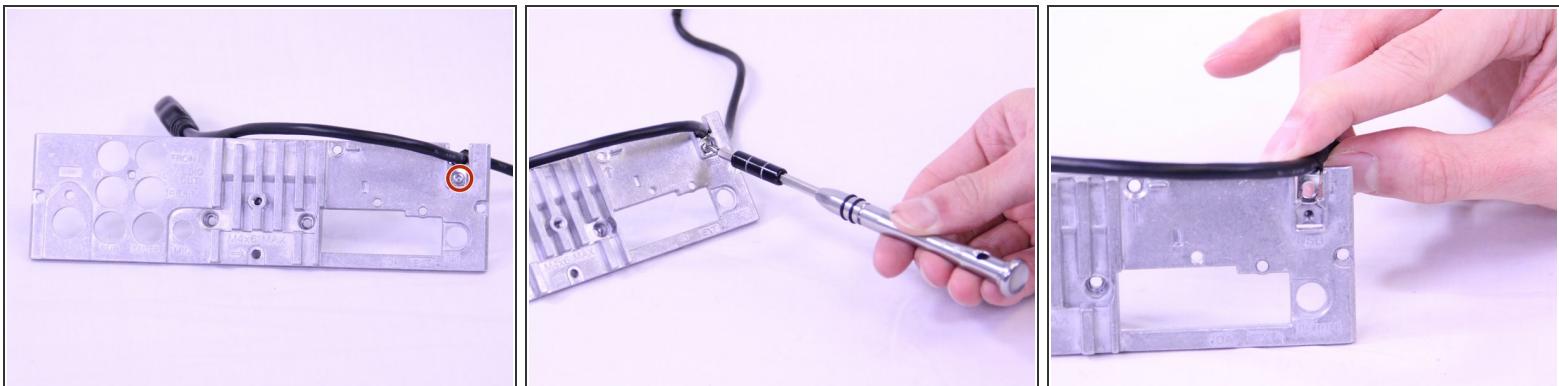
## Step 5

- Remove the 3.5mm Phillip #0 screw that secures the USB cable to the back panel.
- Pull the USB cable off of the back plate.

To reassemble your device, follow these instructions in reverse order.
