# Television Coaxial Connector Replacement

The cable connector was pulled out of the back of the TV, disassembled and repaired.

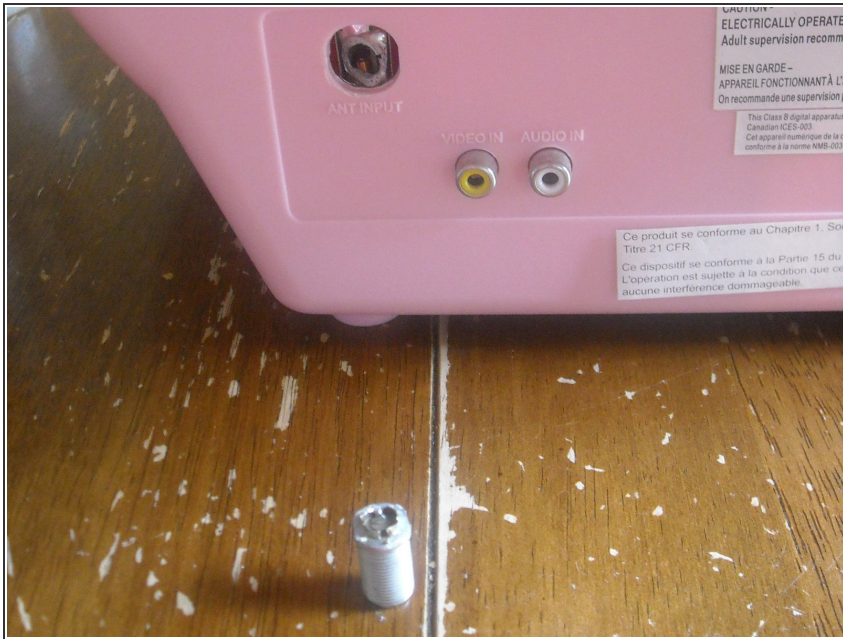
## Step 1 — Coaxial Connector

- Kids pulled the cable connector off the back of the hello kitty TV
