ThinkPad 10 (20C1) Teardown

A brief overview after removing the back cover of my Thinkpad 10, Model: 20C10024MB

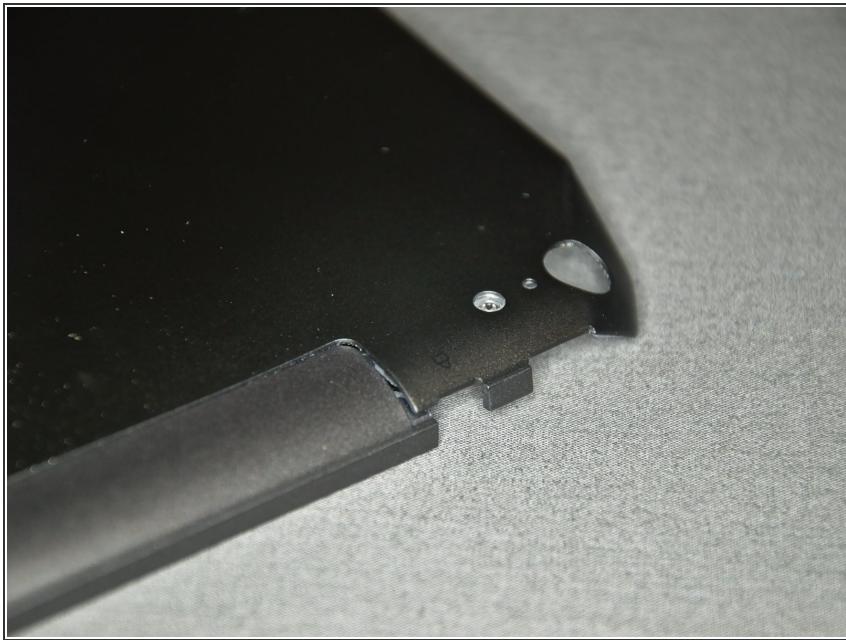
Step 1 — Open the Backcover

- You should follow this video:
<https://support.lenovo.com/de/de/videos/...>
- A plastic Opening Tool is maybe helpful
- I have done it in a different way:
 - You need a bag, that is not providing too much protection, a wet street and a bicycle with working breaks.
 - **⚠** I don't recommend this strategy, because you will most likely also teardown some of your body. (I'm okay, but I won't do it again)

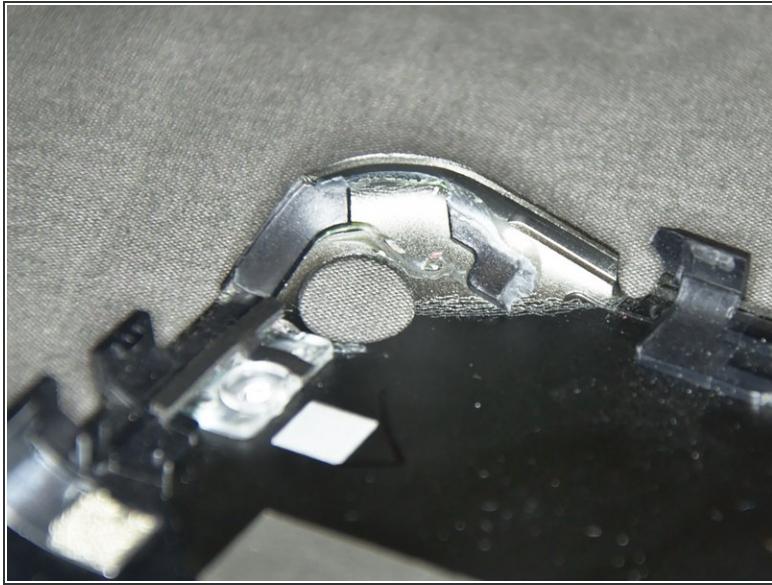
Step 5 — The Alternative Opening Method

- The aluminium back cover has absorbed very much energy during the impact. It's really difficult to bend it back. To my luck, nothing else was damaged

(i) Even without the backcover, the tablet is working fine
