Toshiba Equium M70 Faulty Graphics

This will fix the dreaded graphics driver issues, when windows says the driver has stopped responding. The problem is caused by a very thin heat sink on the GPU, with little to no thermal paste, when the chip heats up the thin heat sink expands & concave

Written By: Terry Sim

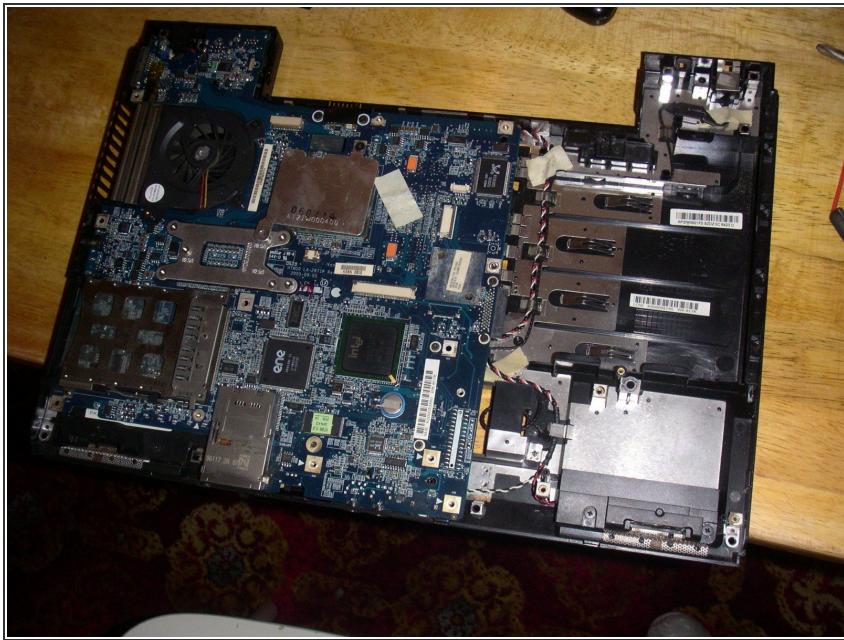
Step 1 — Toshiba Equium M70 Faulty Graphics

- This is a complete top half strip down to fix (takes me less than 30 minutes)

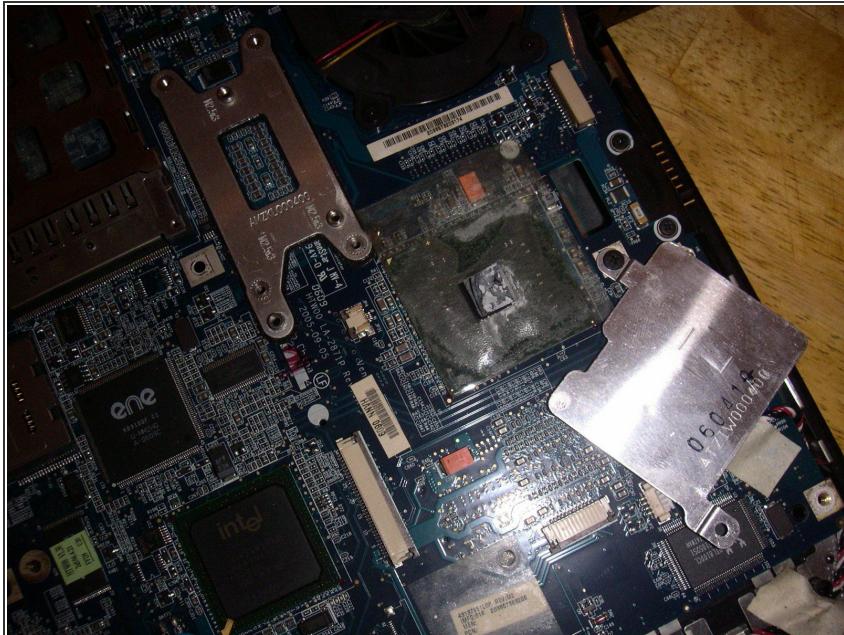
Step 2

- this is the culprit, as you can see the shim can easily overheat & go concave lifting off the chip.

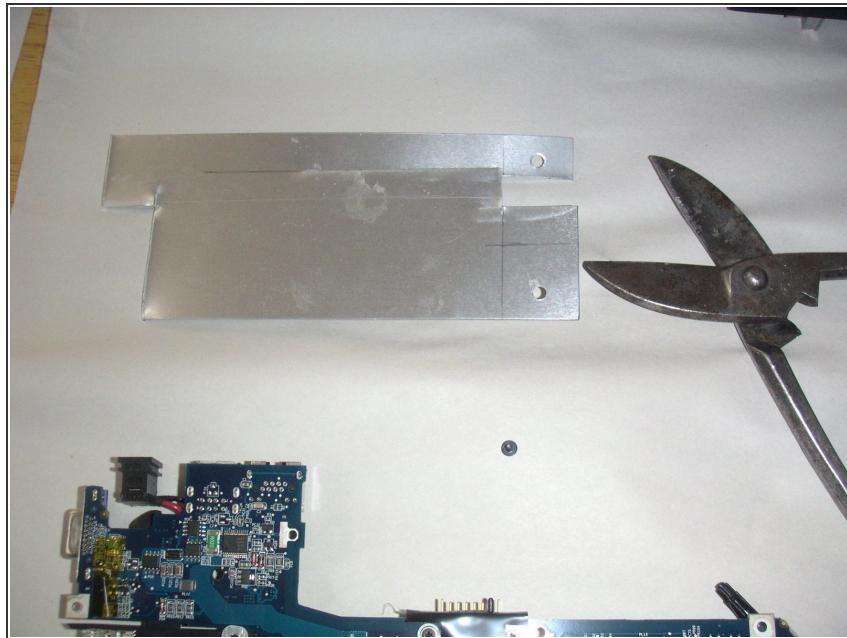
Step 3

- cut a thin piece of alloy to the same size as the existing shim, i used an old alloy door push plate(easy to cut) & is the ideal thickness

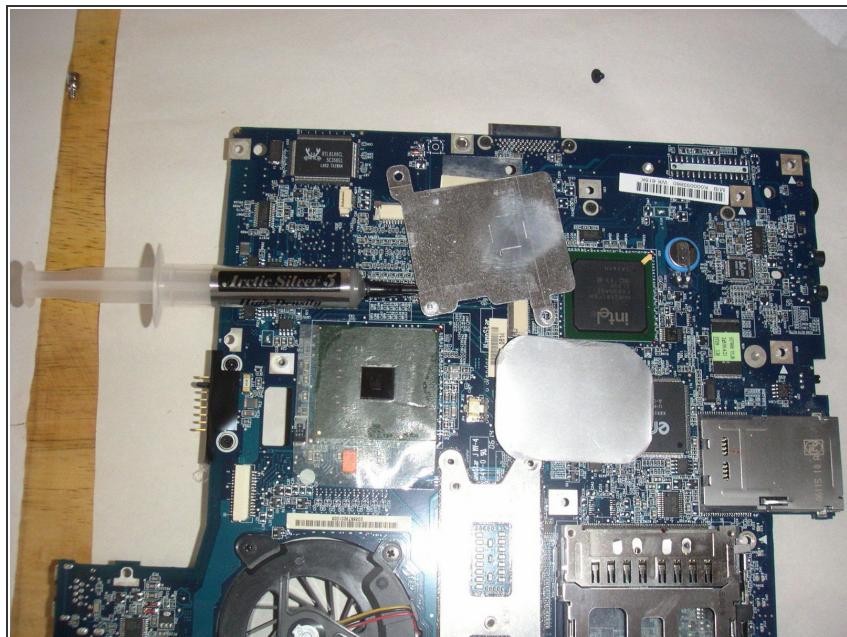
Step 4

- Thoroughly clean the chip with pure alcohol, then apply an even spread of good quality thermal paste(Arctic silver 5) will never let you down

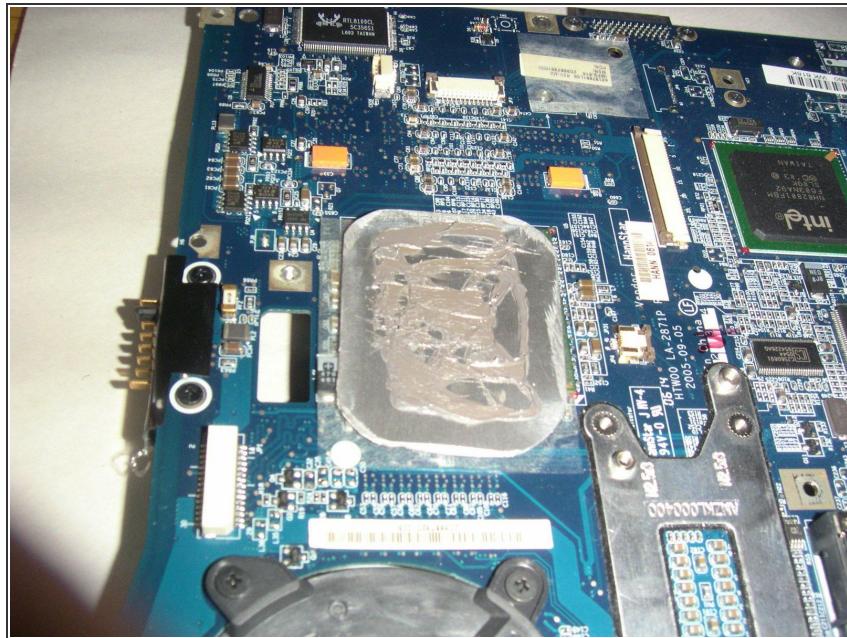
Step 5

- Then apply more thermal paste to the top of the shim

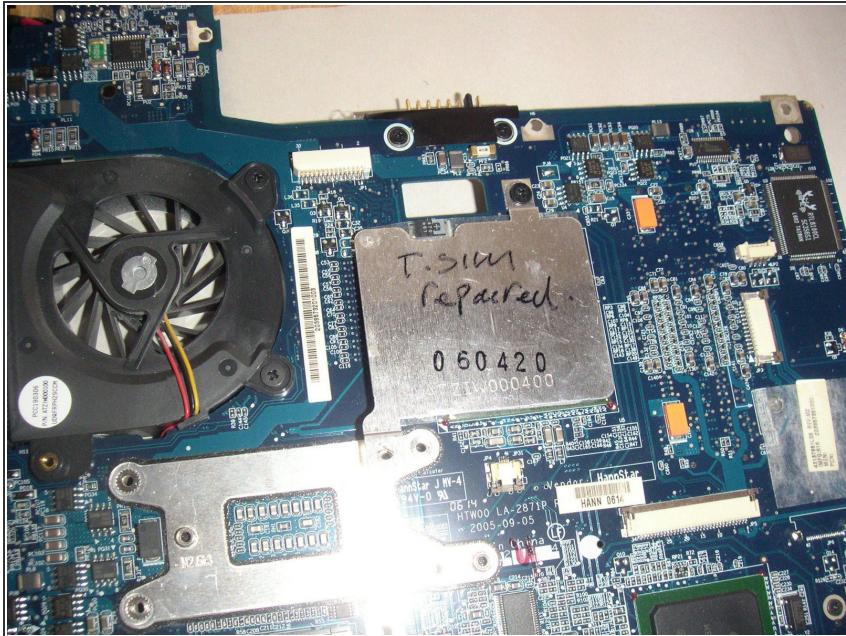
Step 6

- The new alloy shim is under the existing thin shim. I've done more than 20 of these repairs & had 100% success rate I always do the same to the CPU (might as well your already in there),.

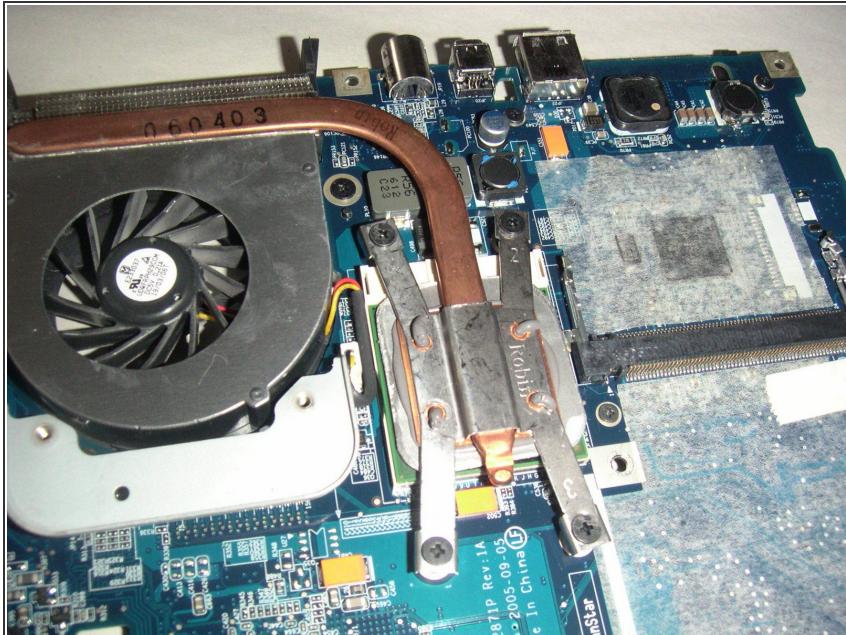
Step 7

- This is the CPU with the new alloy shim fitted.
