Toshiba Satellite A105-S4074 Optical Disk Drive (DVD/CD-ROM) Replacement

Replacing a non-functioning optical disk drive of the Toshiba Satellite A105-S4074. The drive door not open or read any CD's or DVD's.

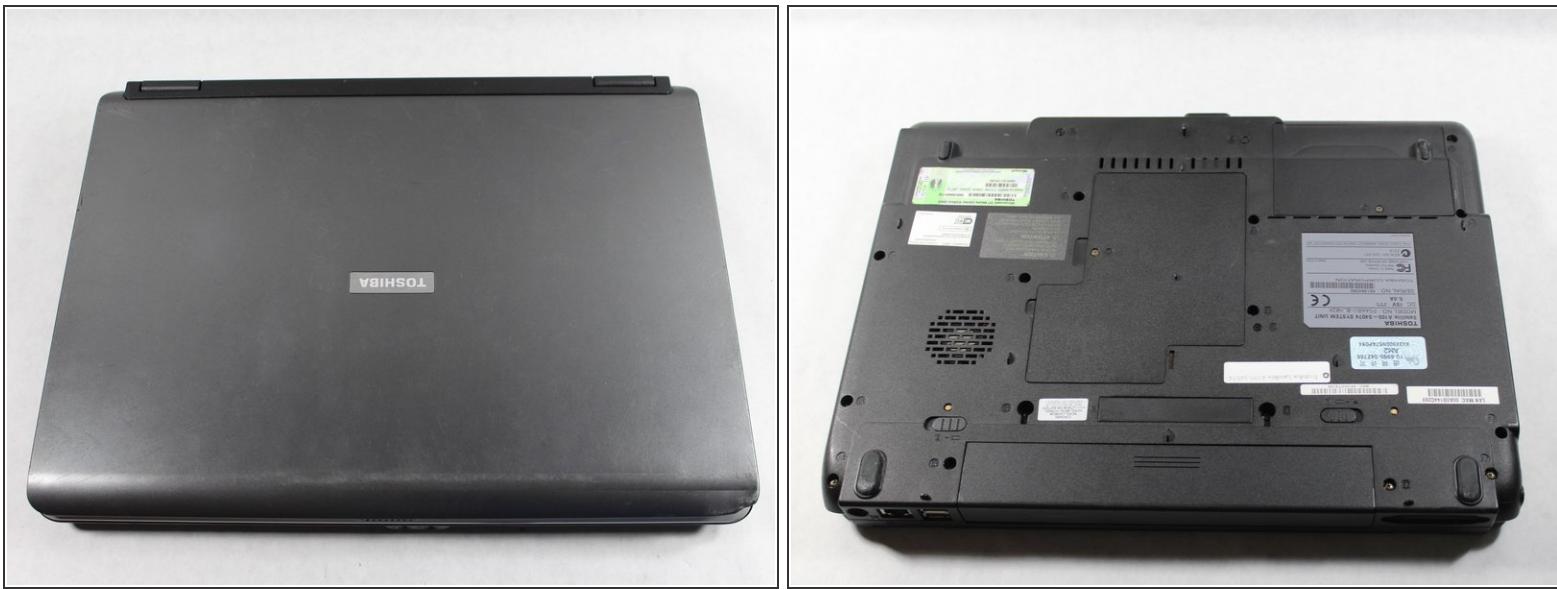
Step 1 — Battery

⚠ To prevent electrical shock, make sure the computer is turned off; and disconnect the power adapter from the computer and electrical outlet prior to beginning any repairs on this device.

- Turn the laptop upside down with the battery facing you.

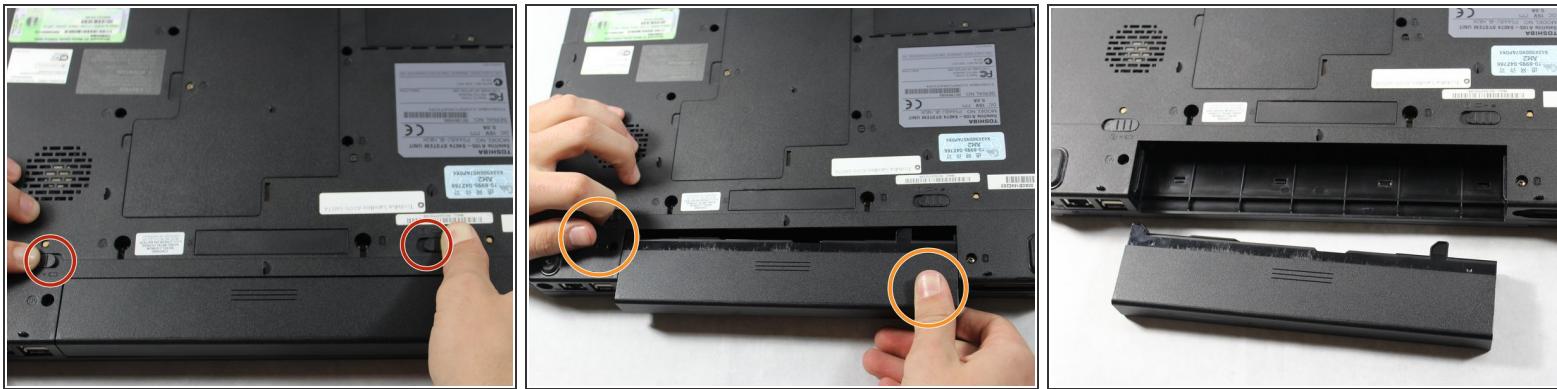
Step 2

- Slide both the left and right battery release tabs outwards away from center of the laptop.
- **i** Right release tab will remain locked in place.
- While still holding the left release tab, slide the battery towards you using your right hand.
- Fully remove the battery from the laptop.

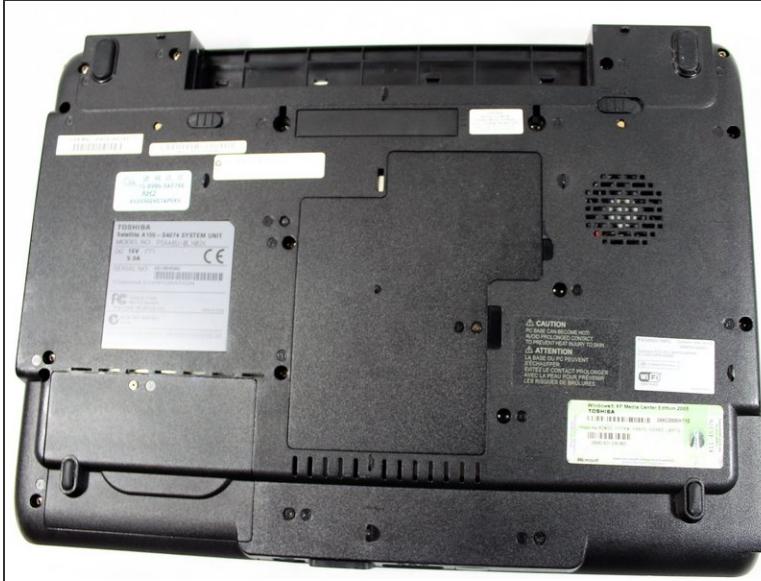
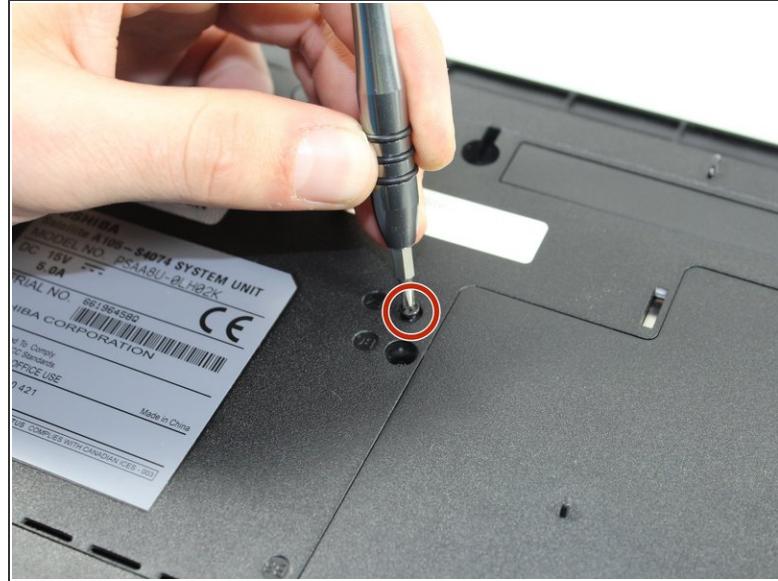
Step 3 — Optical Disk Drive (DVD/CD-ROM)

- Turn the laptop around with the battery slot facing away from you.
- Remove the 5.0 mm screw that is holding the optical disk drive internally in place using the Phillips #1 screwdriver.

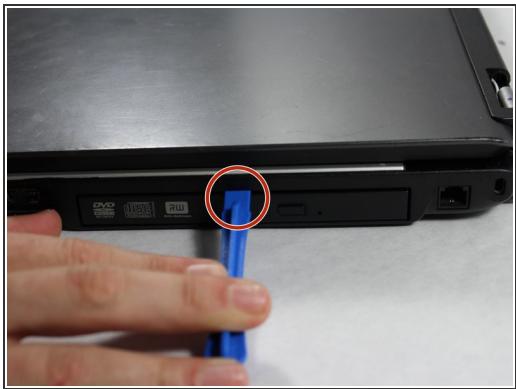
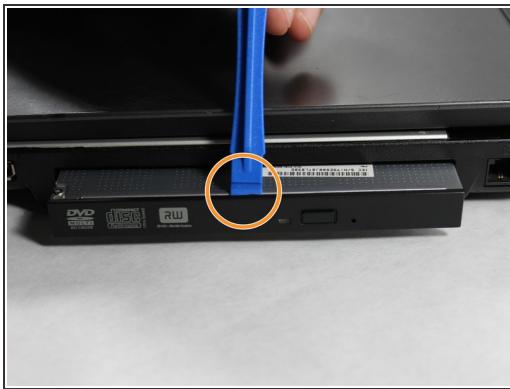
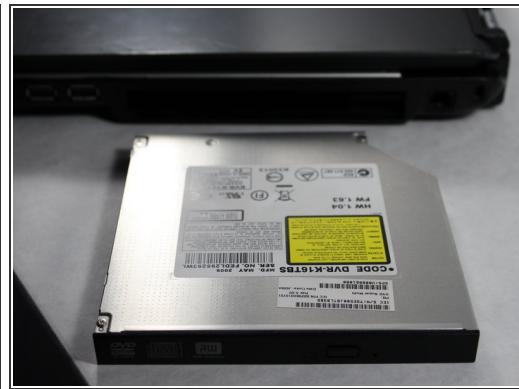
Step 4

- Turn the laptop back over (cover-side up) with the optical disk drive on the right side.
- With the plastic opening tool, pry the drive out from the top.
- Using the opening tool, pull the drive out of the drive bay.

To reassemble your device after replacing the DVD SuperMulti drive, follow these instructions in reverse order.
