Vinotemp VT-12TEDi Motherboard Repair

Remove the motherboard (and connected heat sink) for repair or replacement.

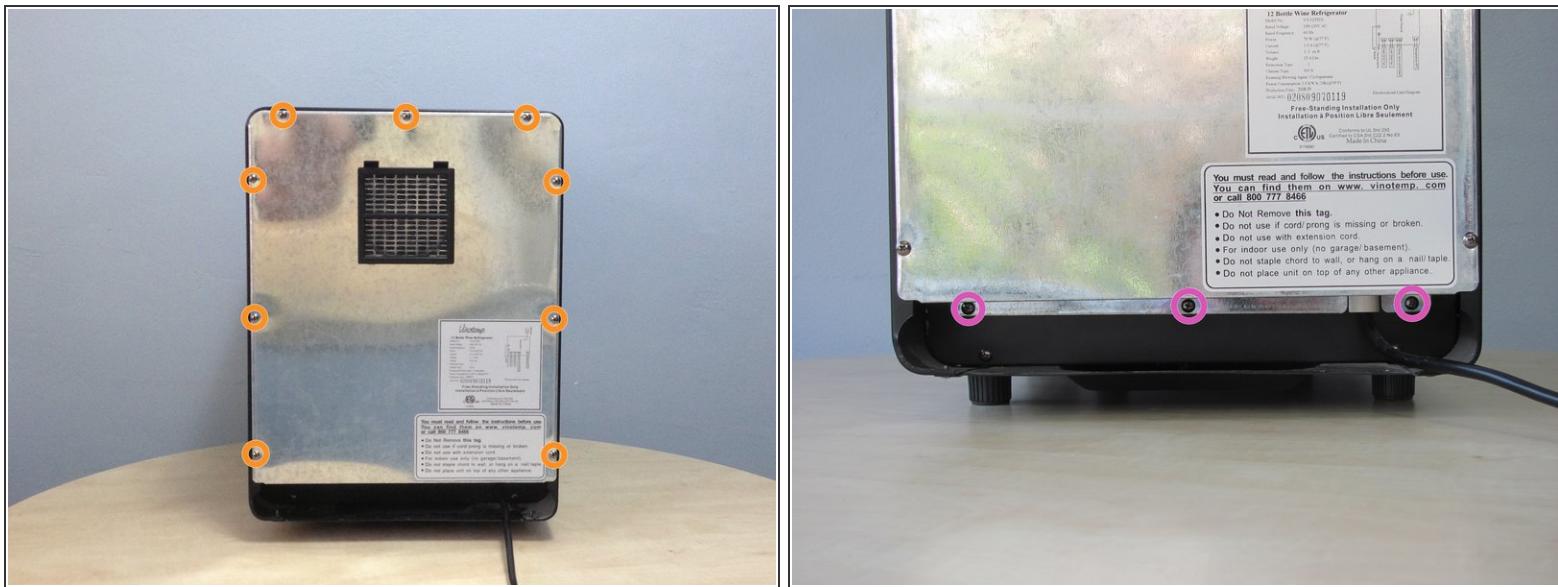
Step 1 — Power Cord

- Remove nine 12mm Phillips screws from the upper back panel.
- Remove three 12mm Phillips screws inset under the back panel.

⚠ As soon as the screws are removed, the panel will fall freely.

(i) When replacing the twelve 12mm Phillips screws, do not tighten the fasteners until all twelve screws have been loosely fitted back onto the cooler. This will ensure the flimsy metal casing will not warp.

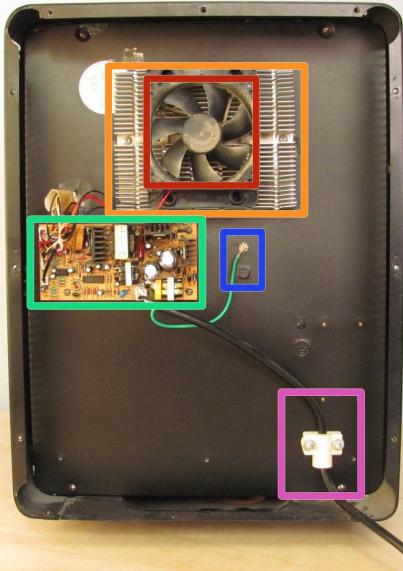
Step 2

- Power Cord Fastener
- Ground
- Motherboard
- Heat Sink Fan
- Heat Sink

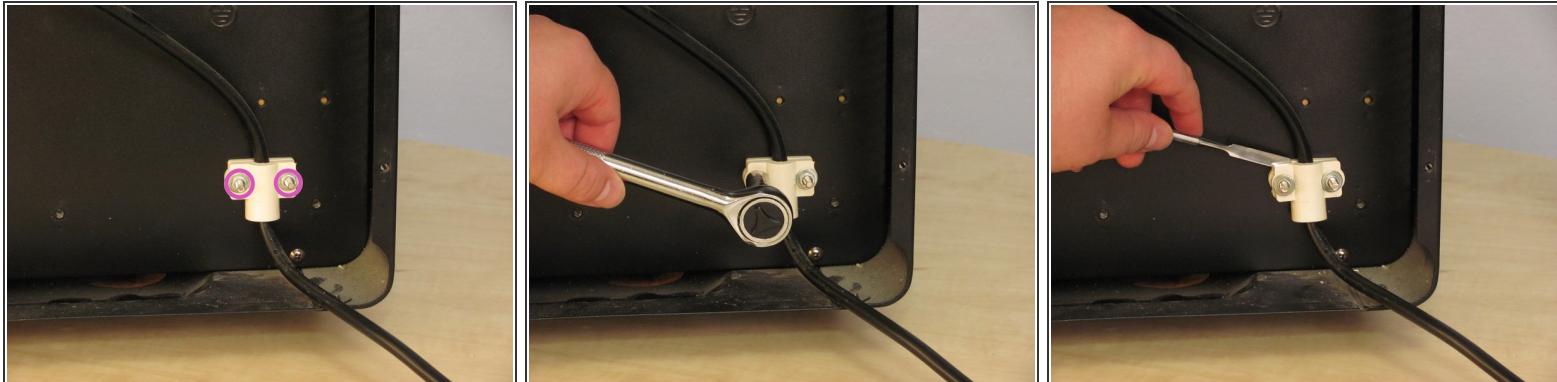
Step 3

- Remove two 7mm Hex Nuts.

i Clearance is minimal and these screws are very tight. You will likely need a socket wrench to avoid stripping.

! If the white plastic components stick, pry them apart with a metal spudger. Don't pull on the power cord to get plastic pieces to separate.

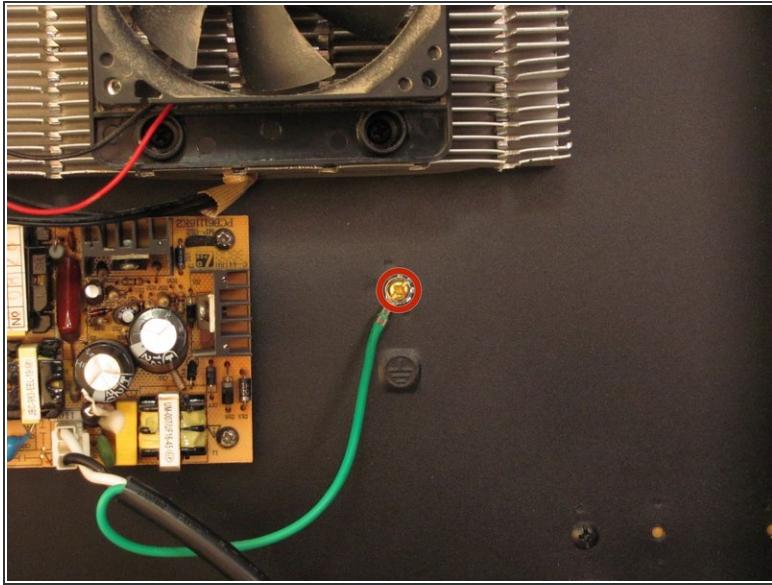
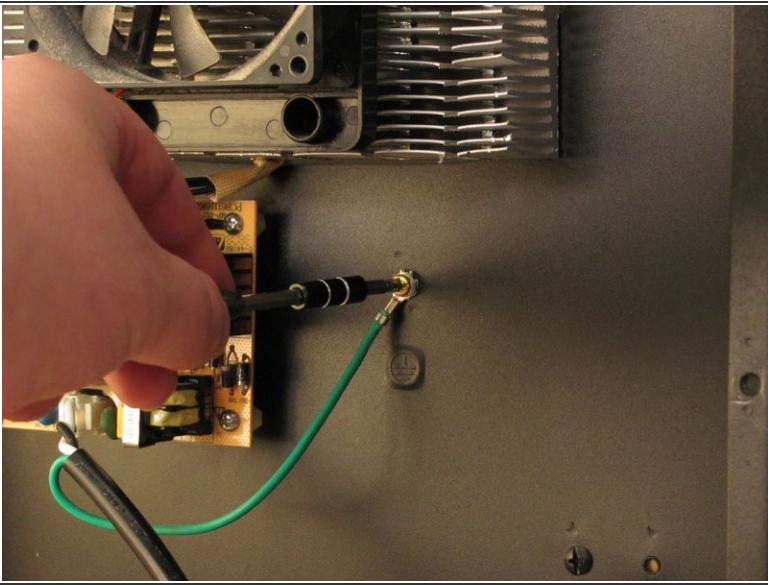
Step 4

- Remove one 12mm Phillips screw securing ground.

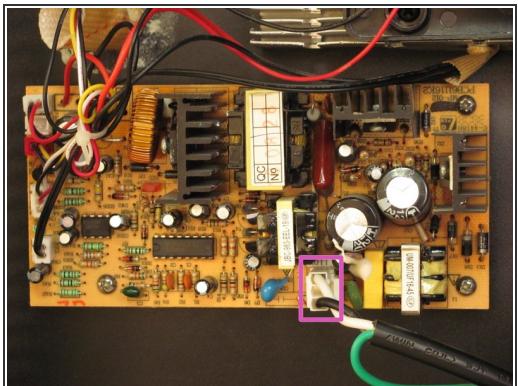
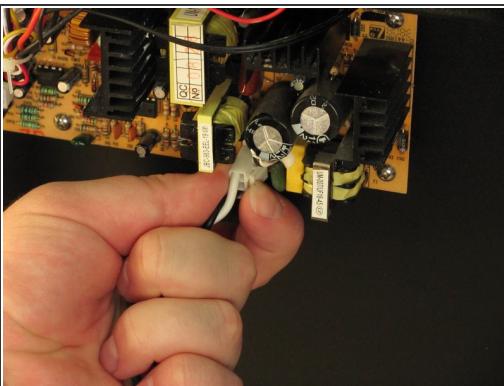
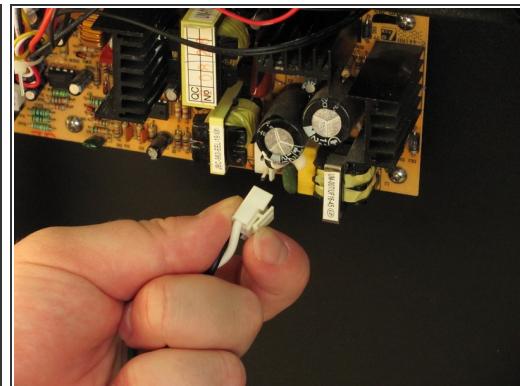
Step 5

- Remove power cable from motherboard.

⚠ Pinch cable connector to release it from the motherboard, then pull.

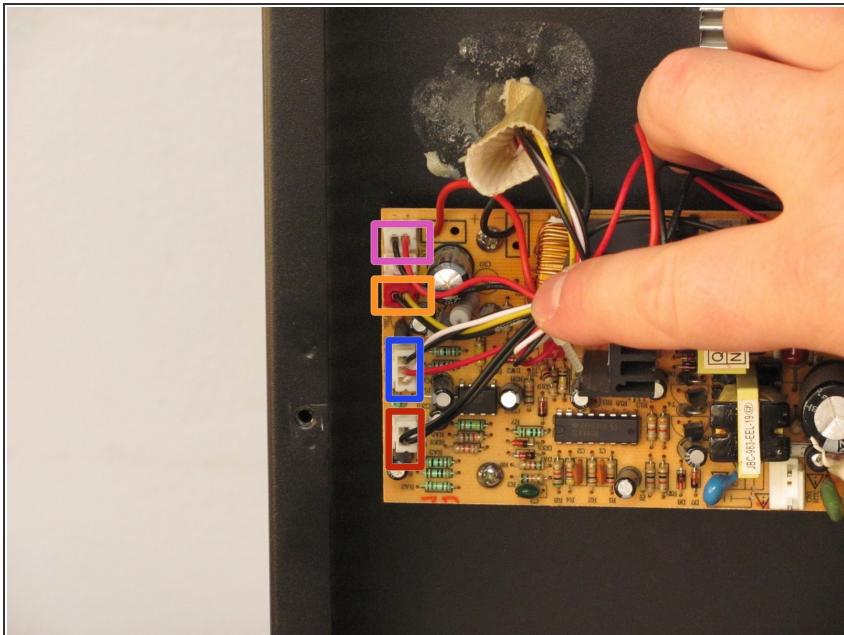
Step 7 — Vinotemp VT-12TEDi Motherboard Repair

- Remove heat sink fan cable connector.
- Remove cold sink fan cable connector.
- Remove temperature control board cable connector.
- Remove temperature NTC cable connector.

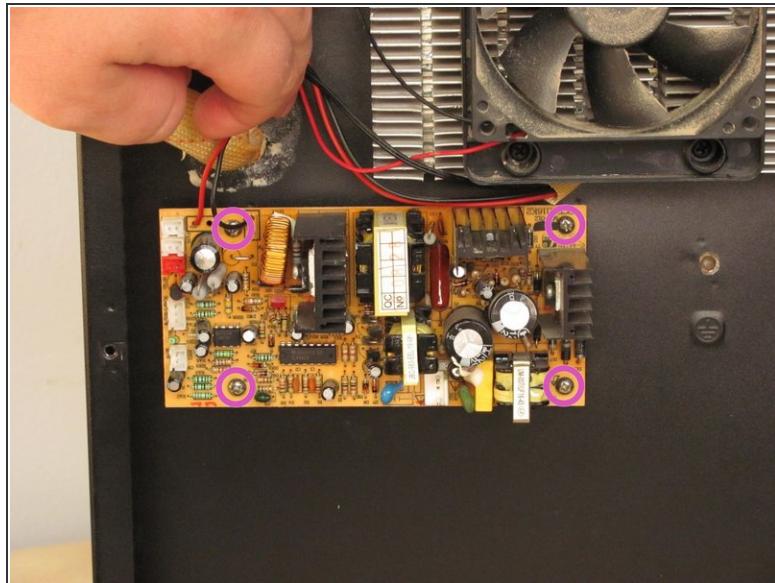
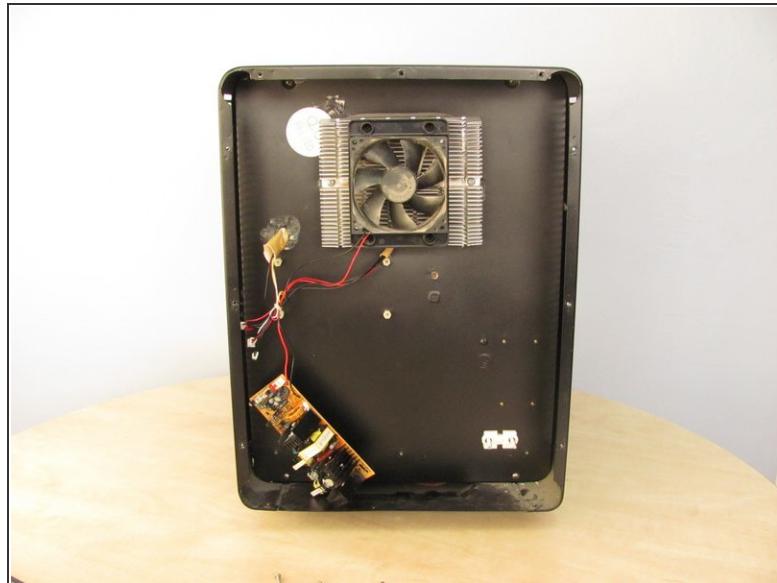
Step 8

- Remove four 12mm Phillips screws.

⚠ Once the four Phillips screws are removed, the motherboard will dangle there until you remove the heat sink. Be careful.

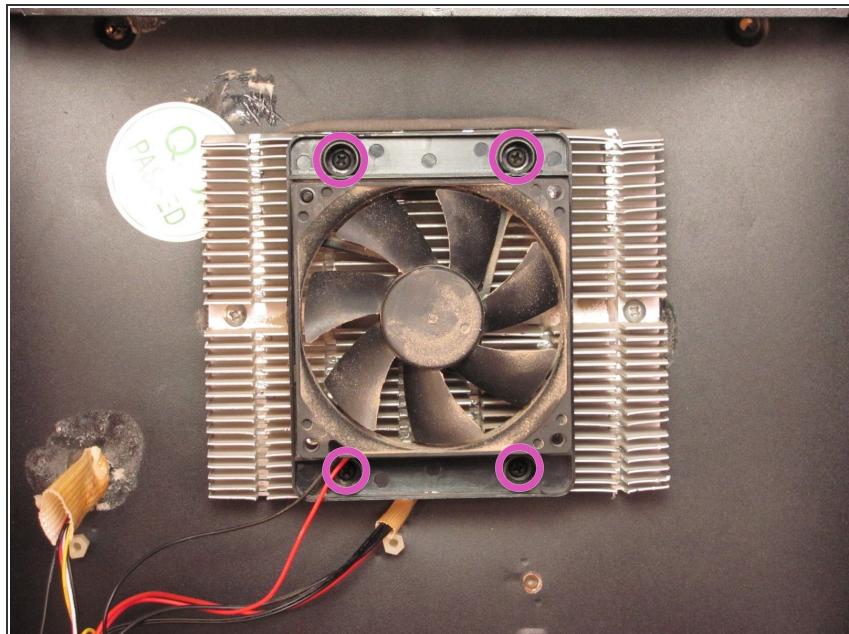
Step 9

- Remove four 15mm Phillips screws.

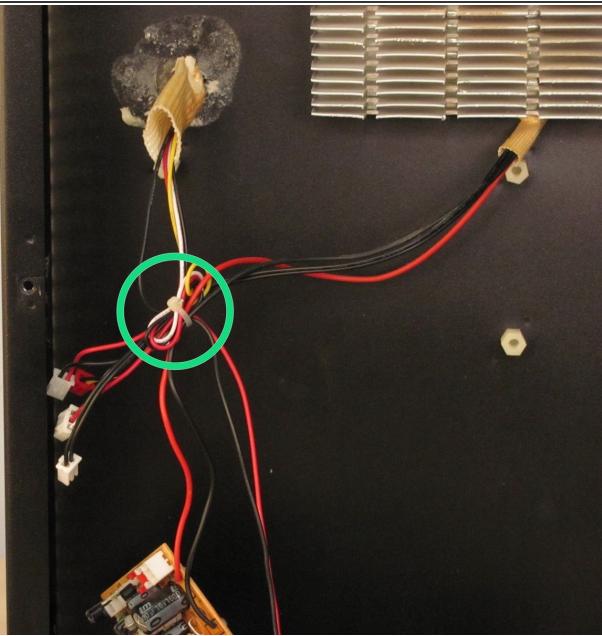
Step 10

- Cut zip tie binding wires together.

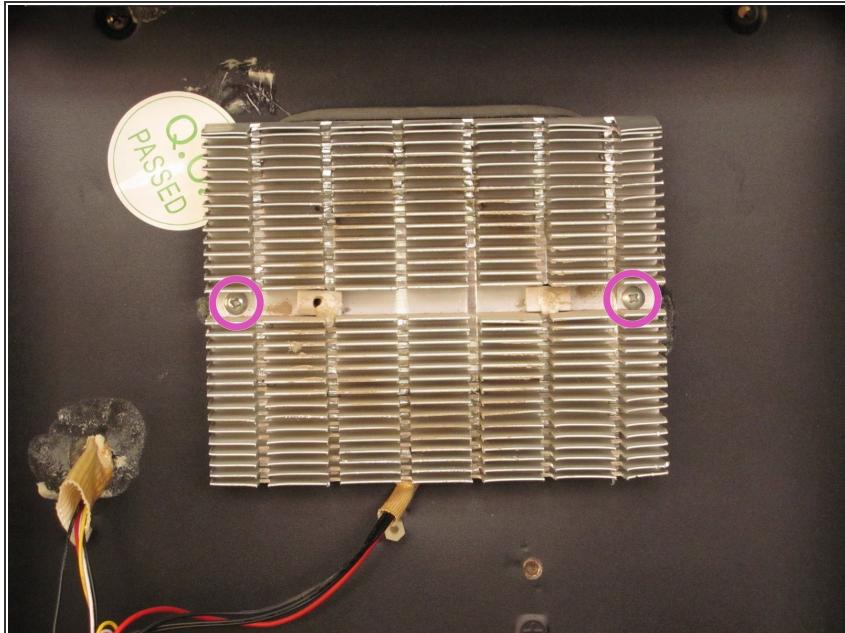
Step 11

- Remove two 32mm Phillips screws.

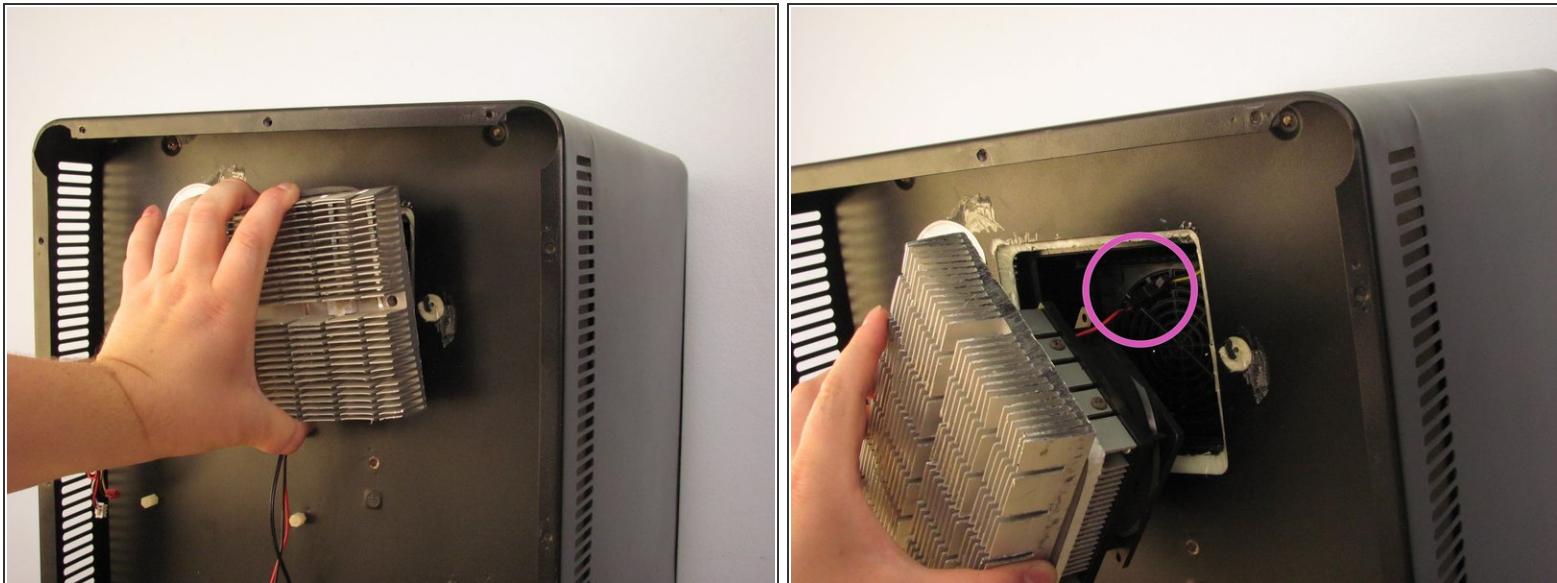
Step 12

- Remove heat sink slowly to avoid breaking cold sink fan cable.
- Disconnect cold sink fan cable.

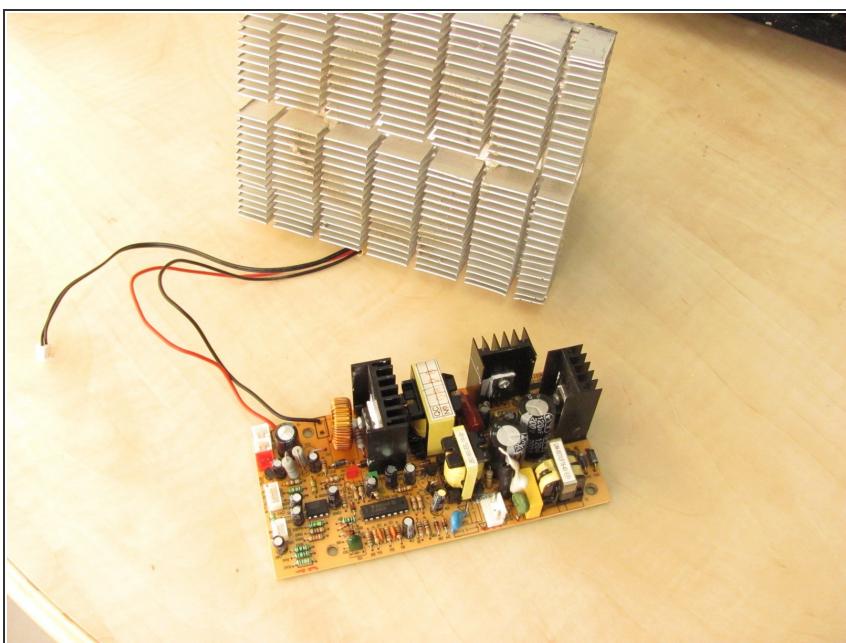
Step 13

- The heat sink and motherboard are removed. Yay!
- The Vinotemp VT-12TEDi has a very high rate of capacitor failure on the motherboard. Before buying a new motherboard:
 - Check for [capacitor failure](#).
 - Learn [how to solder](#) and replace the broken capacitor yourself.

To reassemble your device, follow these instructions in reverse order.
