Vivo X7 Plus Repairability Assessment

Vivo X7 Plus repairability assessment performed on January 10, 2017.

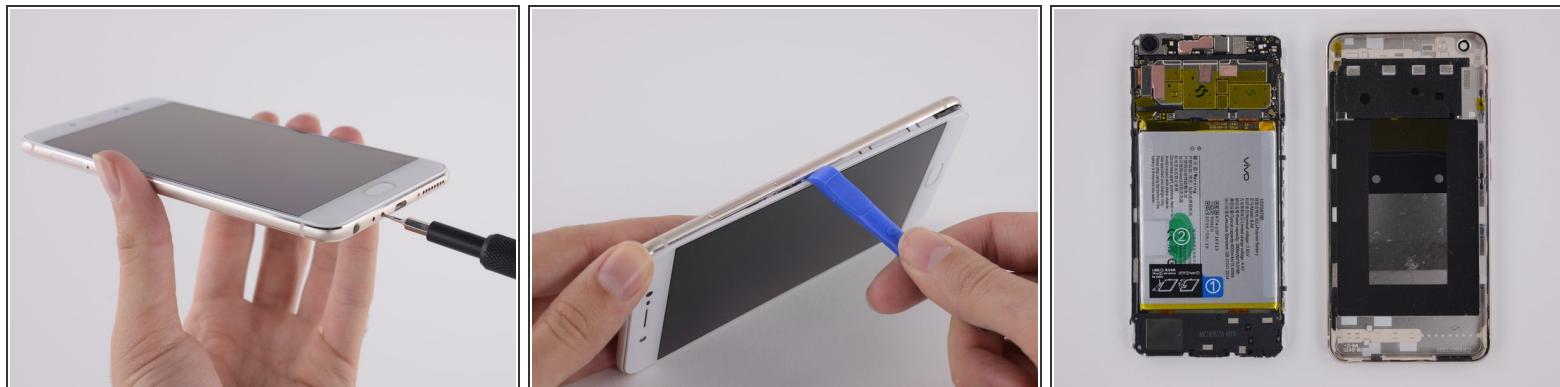
Step 2

- T2 screws on the bottom, but tough clips secure the case, making the screws superfluous.
- Tough prying procedure is made slightly simpler by the larger form factor, more space between clips and more flexibility.
- Interior reference.

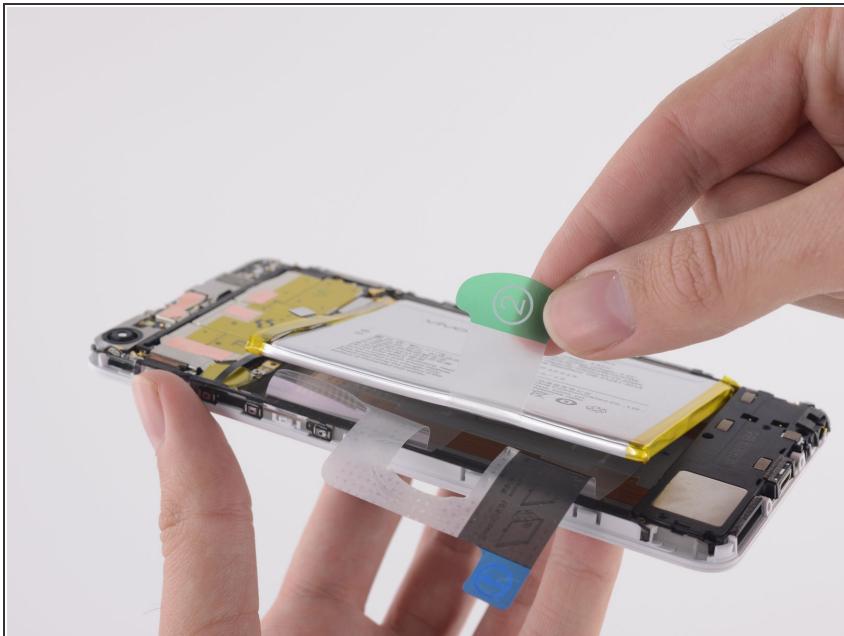
Step 3

- Battery is readily accessible and pull tabs make removal easy.
- Instructions are somewhat ambiguous, but it's hard to mess it up.

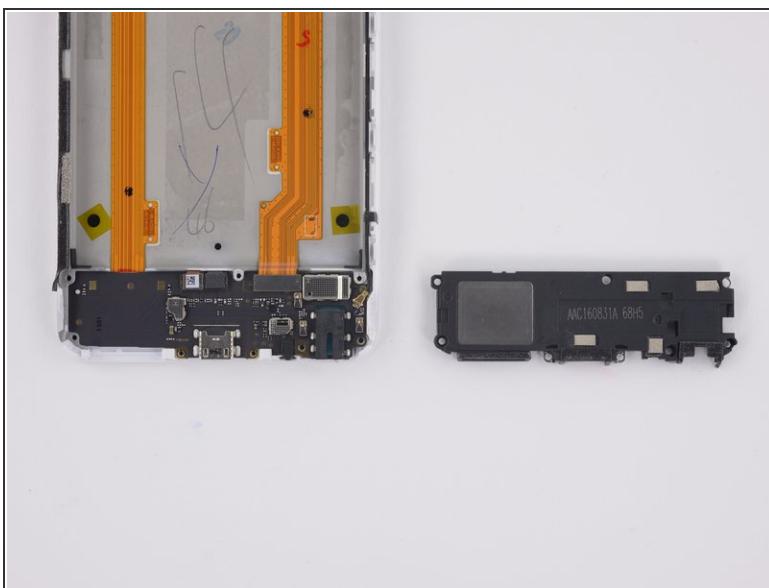
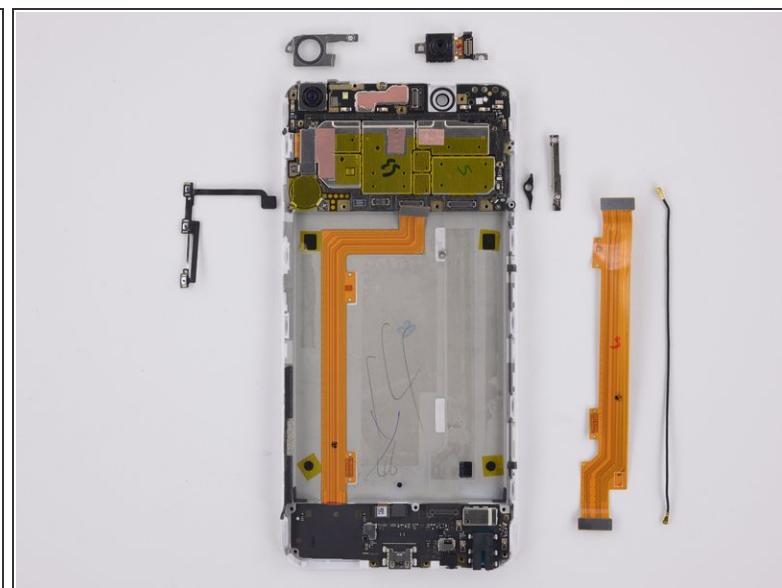
Step 4

- Removal of the speaker/antenna assembly is immediately possible.
- The next layer of components out are: Interconnect cable, antenna interconnect cable, button cable, brackets, SIM eject lever, and front facing camera.

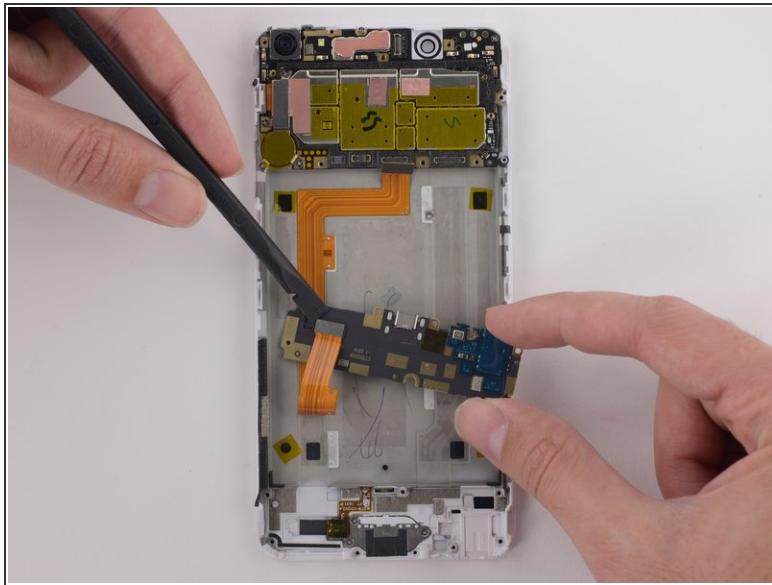
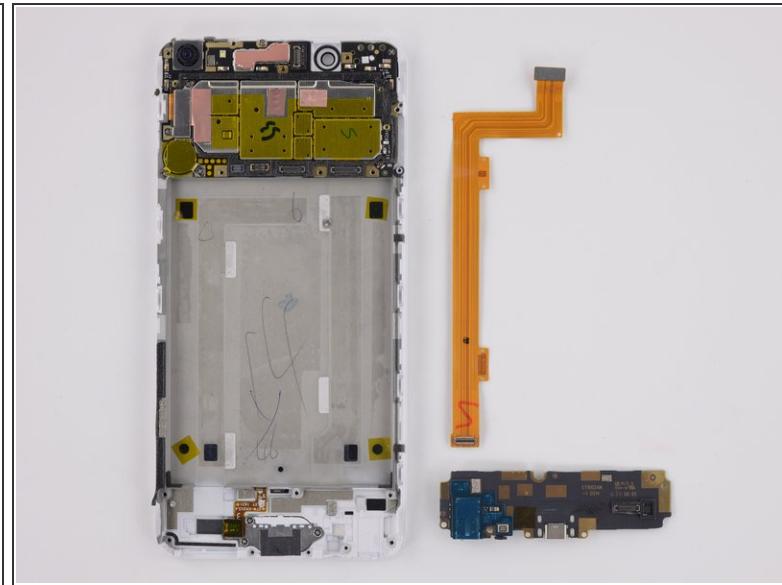
Step 5

- Interconnect cable attached to the rear of the daughterboard is annoying.
- Removal of daughterboard and interconnect cable.
- The daughterboard is relatively bare, but two high-wear mechanical parts make repair more expensive for either headphone jack or charging port replacement.

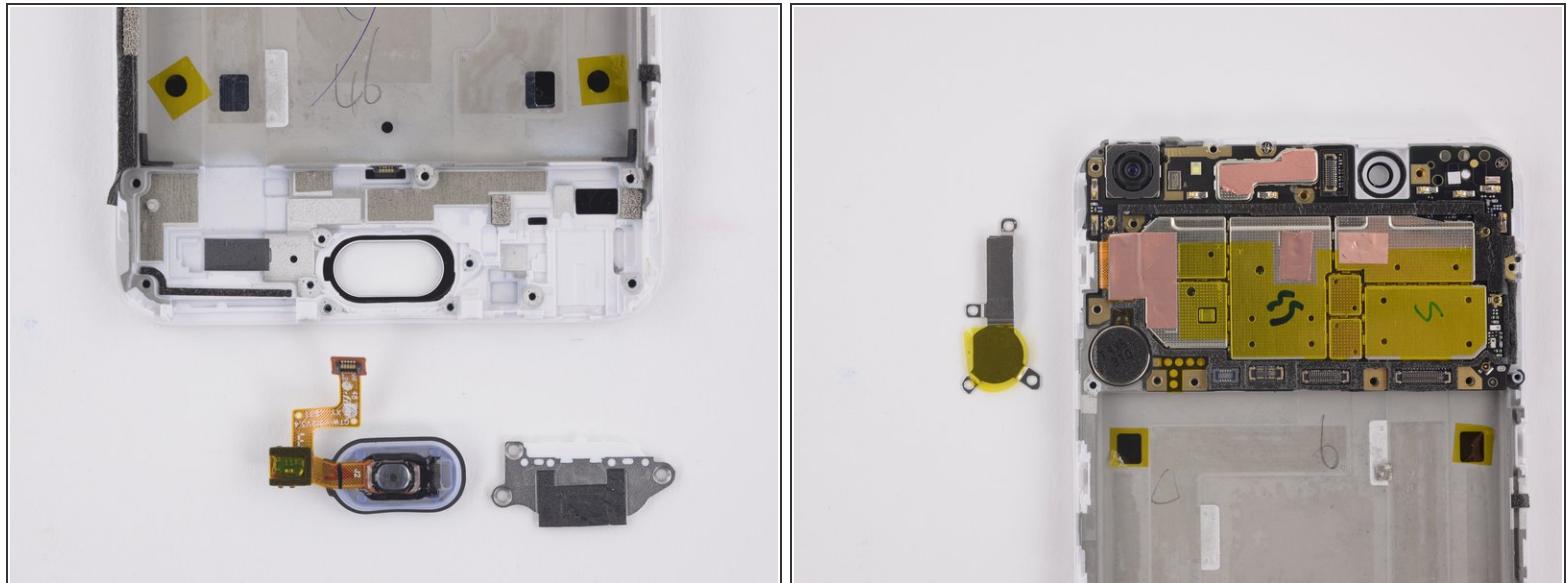
Step 6

- Next removable components are the home button bracket, followed by home button.
- The only upper component immediately removable is the vibrator bracket.
- *(i)* But not the vibrator, which is trapped under the motherboard.

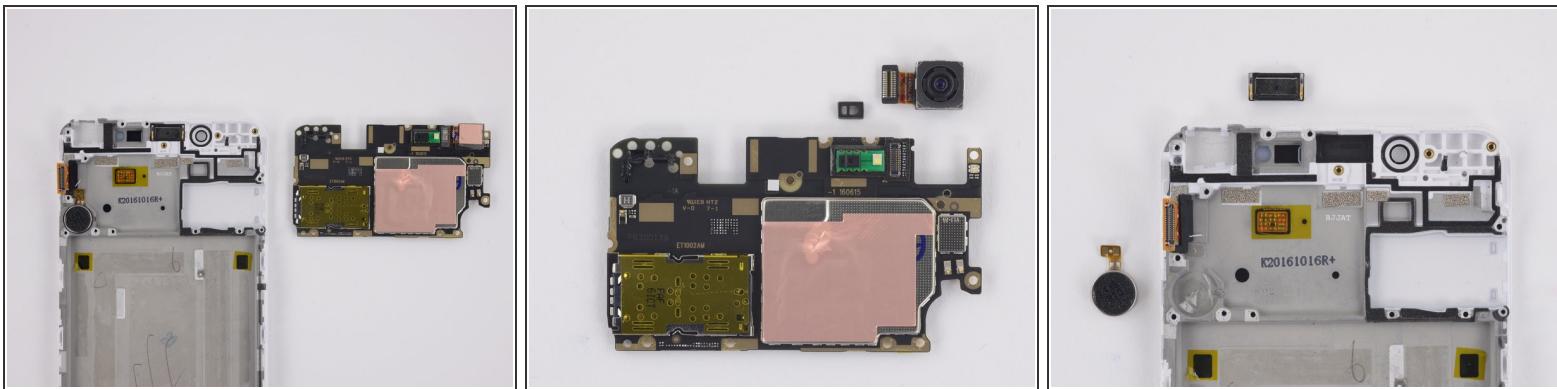
Step 7

- Motherboard is next to come out.
- Once the motherboard is removed, the rear-facing camera can be removed. Also the rubber bumper on the flash/proximity sensor portion of the main board.
- The final components off of the display assembly are the vibrator and speaker.
- Last-out display that is fused and mounted to a frame means a cracked screen is a time-consuming, expensive repair.

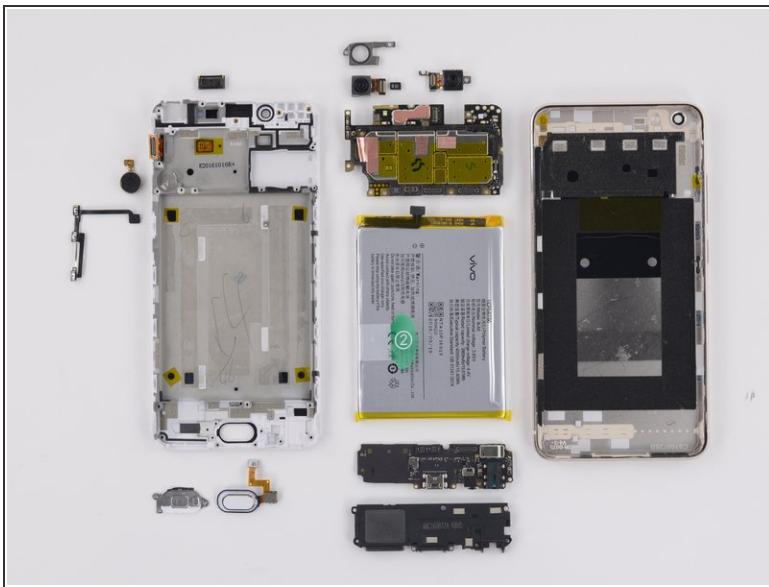
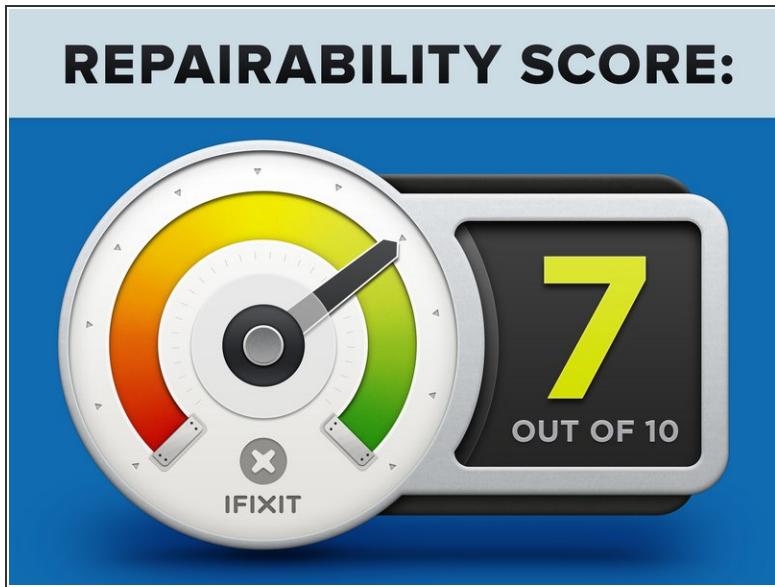
Step 8

- The Vivo X7 Plus earns a **7 out of 10** on our repairability scale (10 is the easiest to repair):
 - Battery is fairly easily accessible and removable.
 - Parts could be more modular, especially mechanical/high wear components.
 - The opening procedure is very tough, but easier than on the smaller model.
 - The single unit display assembly is annoying to reach, and will be a costly part.
 - Manufacturer does not provide user-accessible repair documentation.
