Vivo X7 Repairability Assessment

Vivo X7 repairability assessment performed on January 9, 2017.

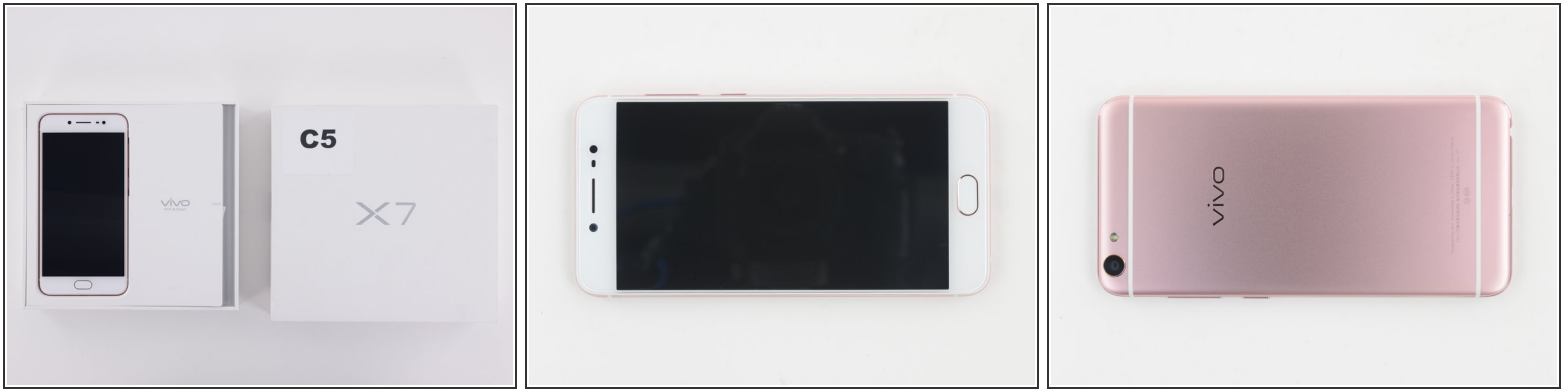
Step 1 — Vivo X7 Repairability Assessment

- Front and back reference shots.

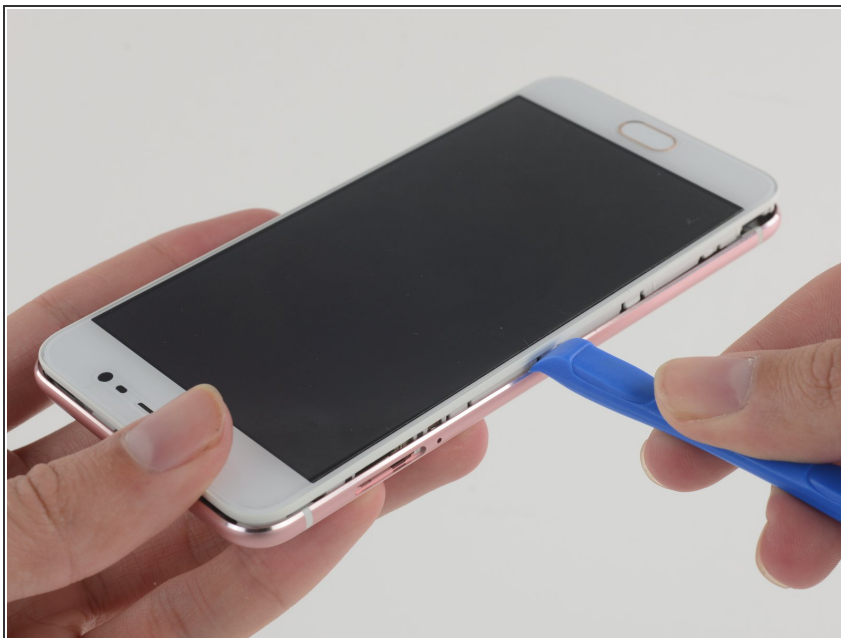
Step 2

- Extremely stiff clips keep the phone closed, even after removing the two T2 Torx screws.
- Use of metal tools may be required, which could damage the device during opening.

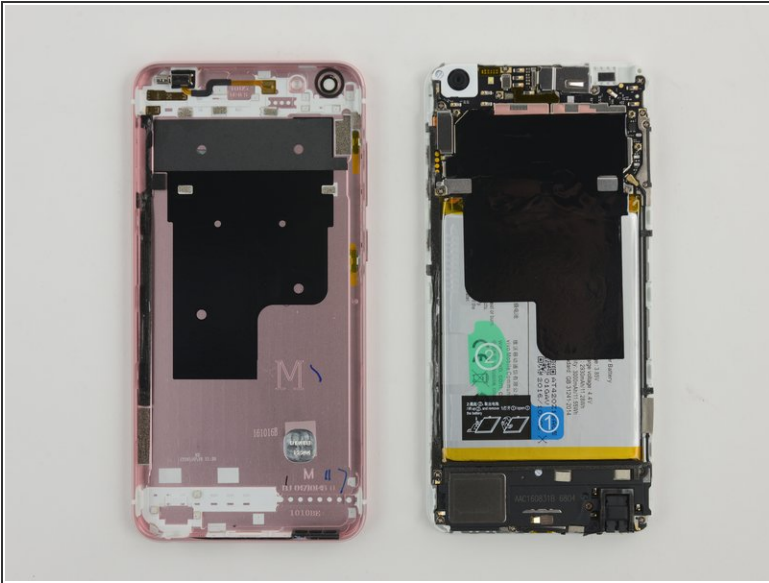
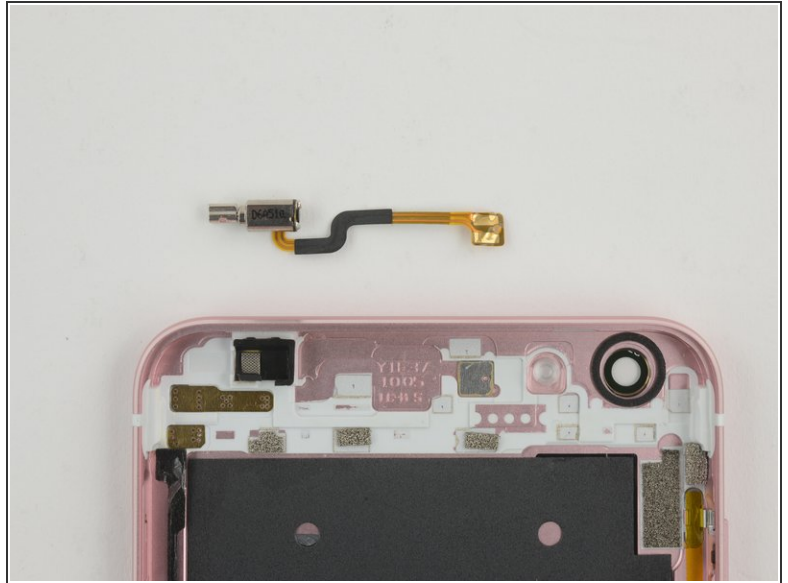
Step 3

- View of the inside.
- The only component in the rear case is a modular vibrator.

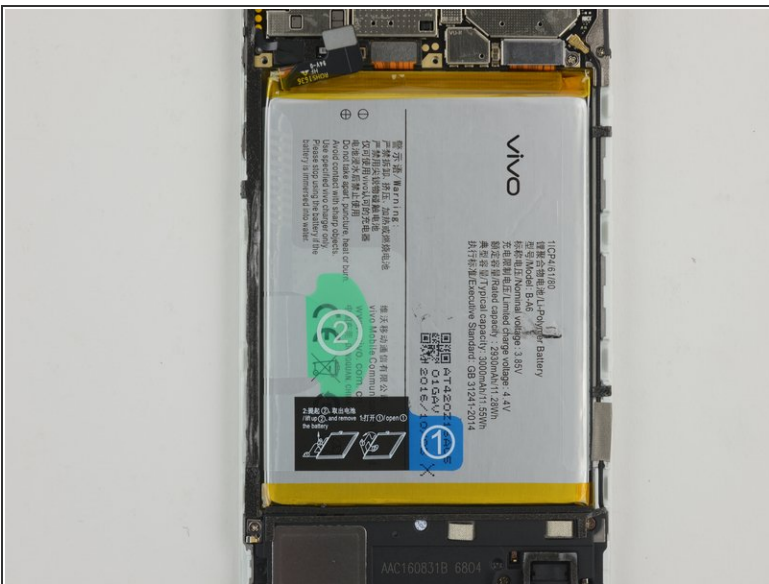
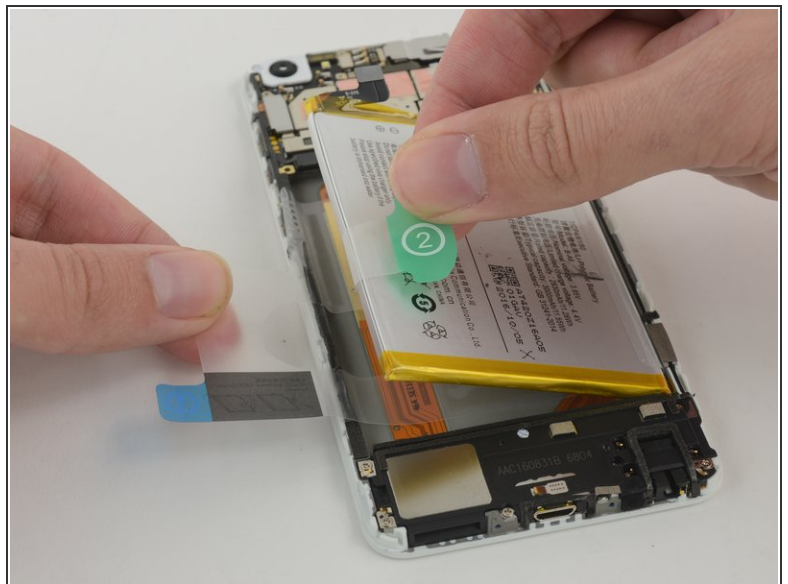
Step 4

- Battery tabs are very handily labeled!
- And very effective!

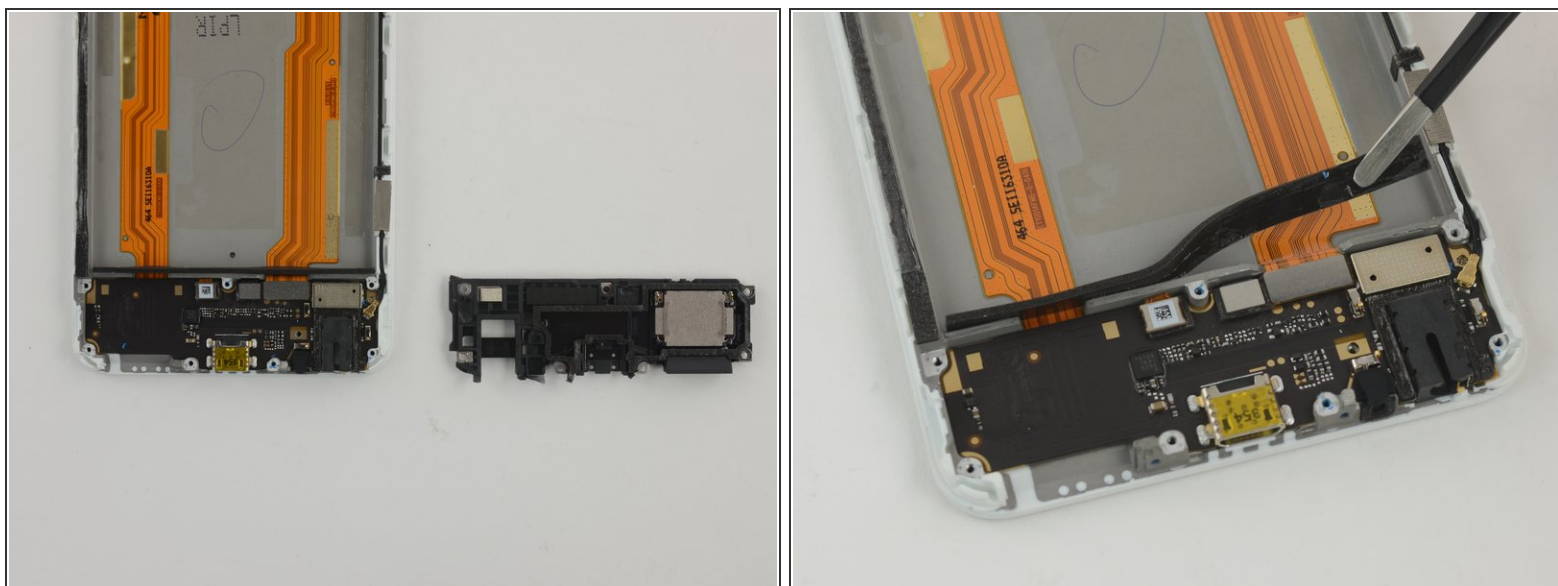
Step 5

- Removing the speaker assembly from the daughterboard is simple enough, screws and light adhesive.
- This foam tape appears to be a moisture barrier. Annoying for reassembly, but might protect against water damage.

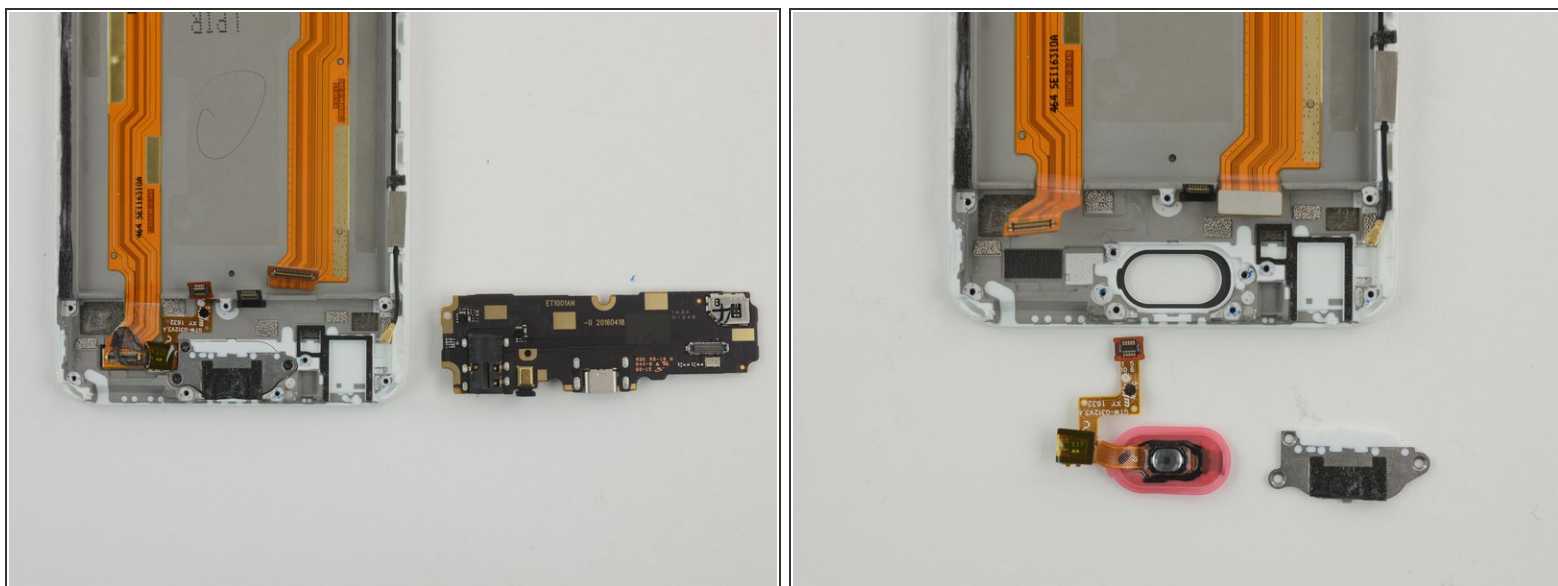
Step 6

- Daughterboard has significant adhesive. Headphone jack and charging port are soldered to the board, making for more expensive replacements of either component.
- Under the daughterboard, home button bracket and home button come out easily.

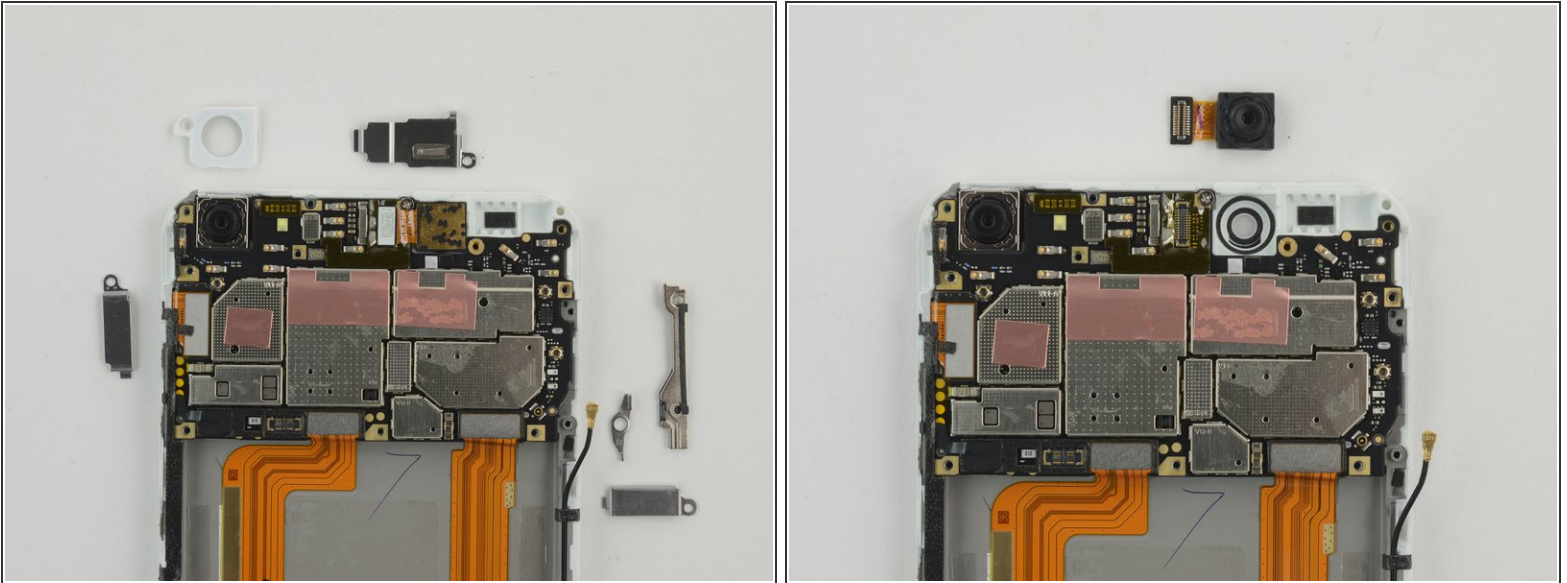
Step 7

- First layer of components off the top end of the phone is a ton of brackets.
- The interconnect cables could be removed at this point as well.
- Only the front facing camera and SIM eject lever are removable before the motherboard.

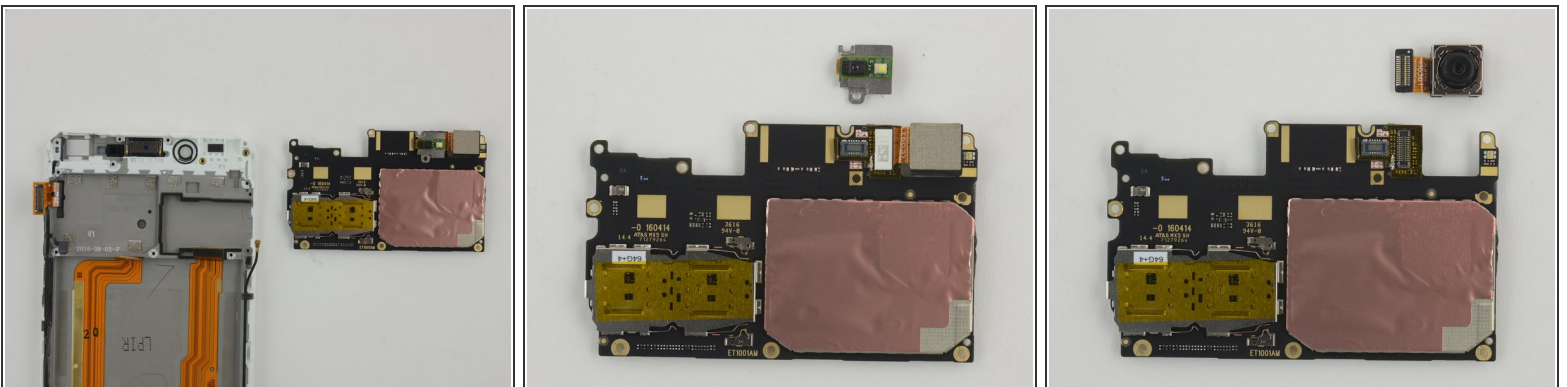
Step 8

- Motherboard removed, only secured by screws.
- Proximity sensor/flash blocks the rear camera connector and must first be removed.
- Rear camera last thing off the main board.

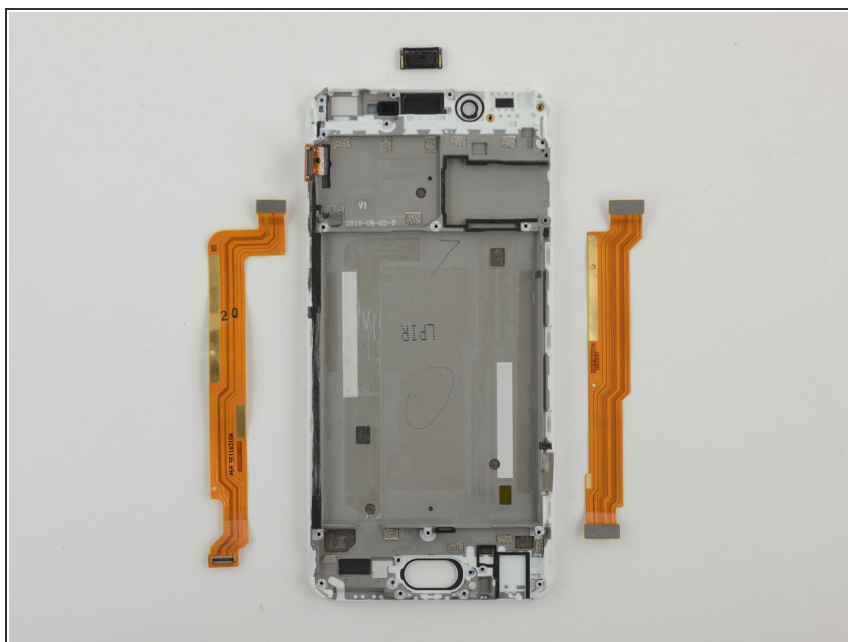
Step 9

- Final components off of the display are the interconnect cables and earpiece speaker.
- The midframe-mounted fused display makes for an expensive part. The fact that it is the last part to be removed makes screen replacements time-intensive.

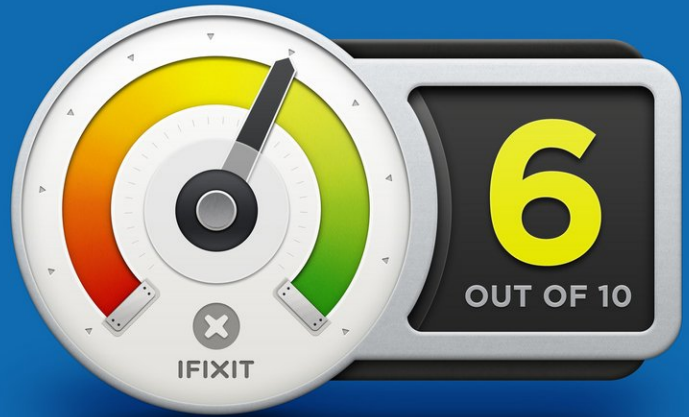
REPAIRABILITY SCORE:

- The Vivo X7 earns a **6 out of 10** on our repairability scale (10 is the easiest to repair):
 - Battery is fairly easily accessible and removable.
 - Parts could be more modular, especially mechanical/high wear components.
 - The opening procedure is extremely tough, clips are very stiff and likely to be broken.
 - The single unit display assembly is annoying to reach, and will be a costly part.
 - Manufacturer does not provide user-accessible repair documentation.
