Water connection seal replacement

Replacement of the water connection seal on a Saeco Vienna Sup018

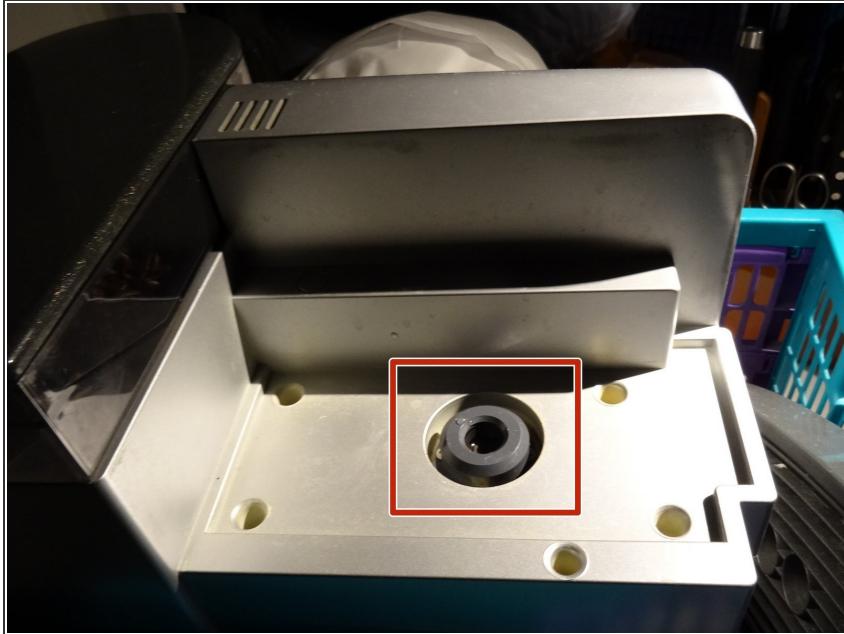
Step 1 — Water connection seal

- Take the water tank off.
- The seal is held in place only by a cover.

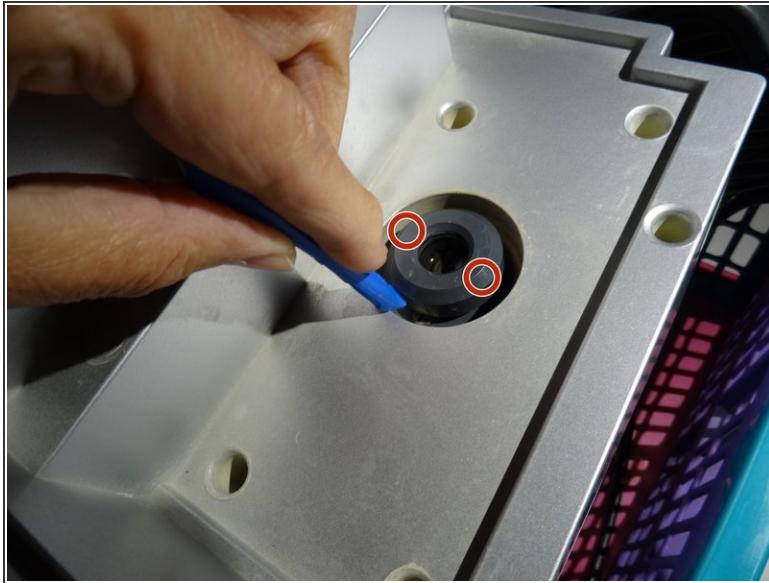
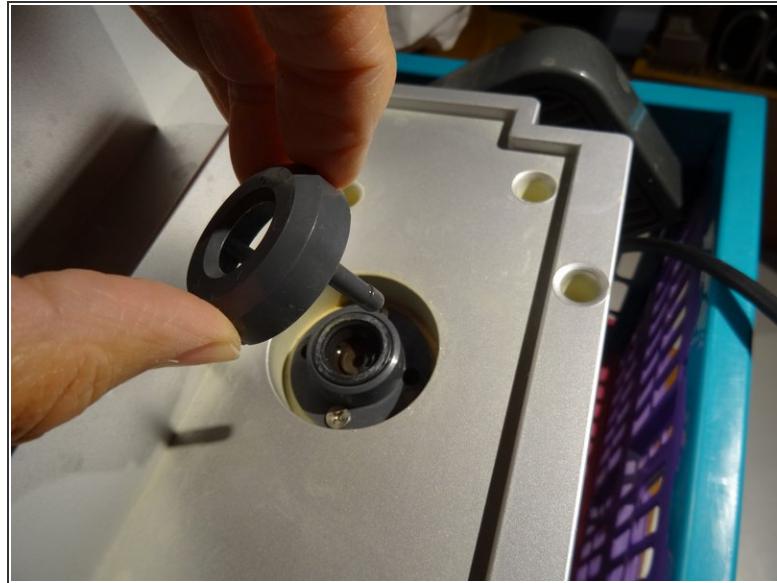
Step 2

- The cover is held in place by two notches below the marked points.
- Using a plastic opening tool, gently pry the seal cover alternately near the notches until it releases.
- Remove the cover

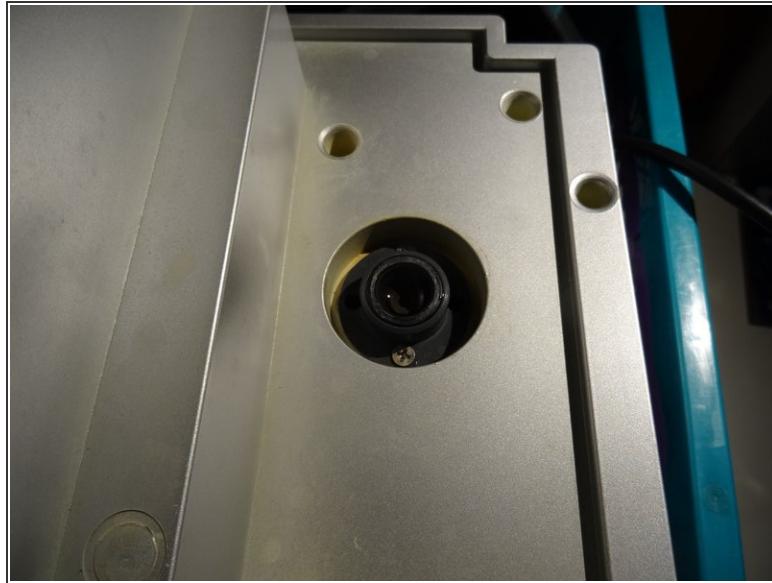
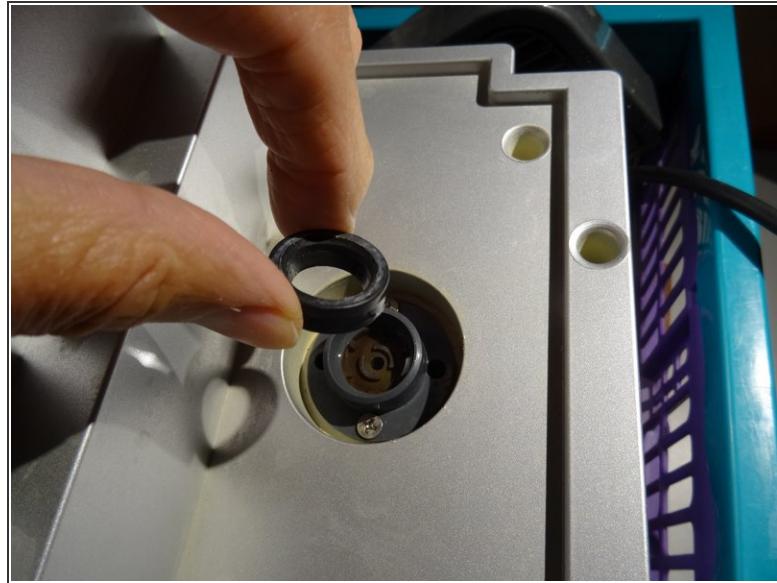
Step 3

- With the cover removed, simply remove and replace the gasket.
- *(i)* The straight side of the seal points upwards, the side with the lip points downwards.
- Replace the seal cover by pressing it firmly until it clicks into place
