Withings Activité Pop Smartwatch Teardown

This guide is for the complete teardown of Withings Activité Pop Smartwatch , showing the individual components and parts during the process.

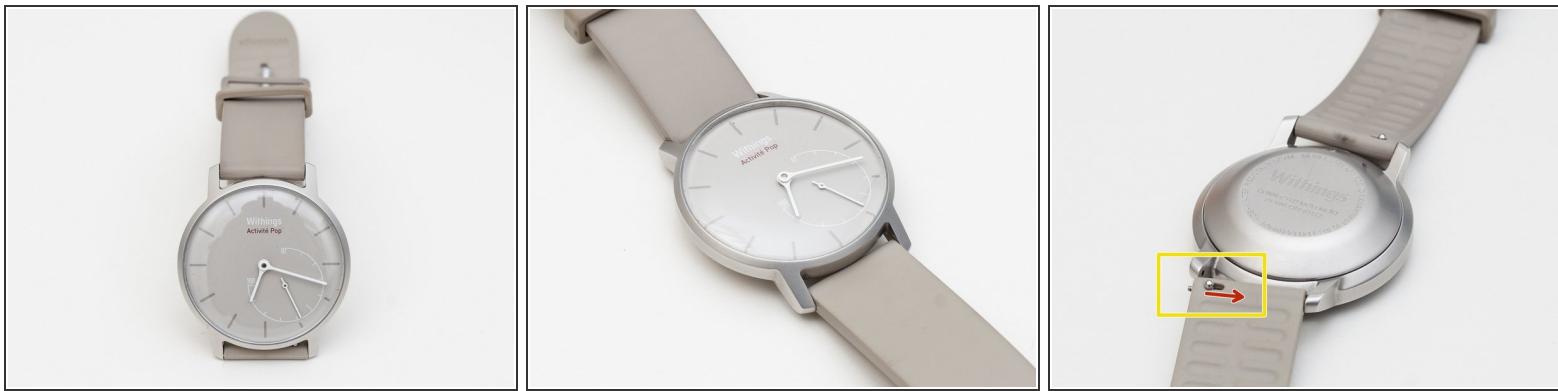
Step 1 — Introduction, remove the rubber band

- This is Withings Activité Pop Smartwatch. A beautifully designed no frills smartwatch that shows your daily activity score with an analogue gauge. Remove the rubber band by pulling tiny levers at the back along arrow direction.

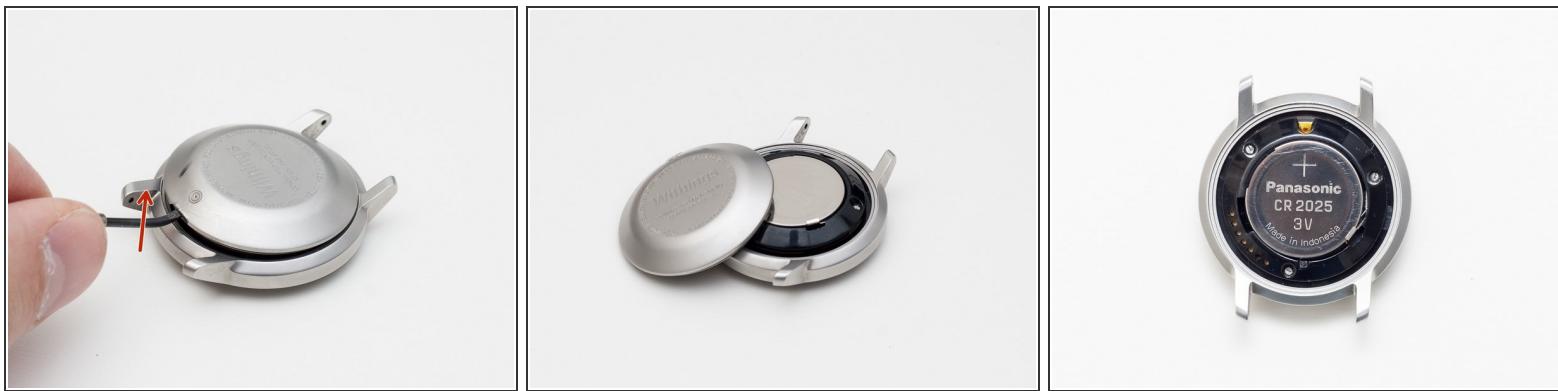
Step 2 — Remove case back and access the battery

- The case back can be opened by prying with the opening tool or a flat screwdriver. You will see the CR2025 lithium battery shining with all its glory.

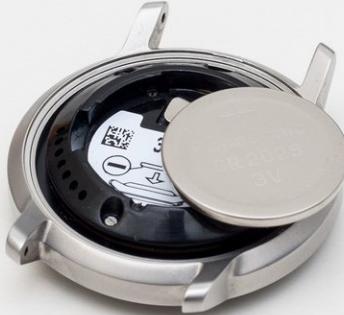
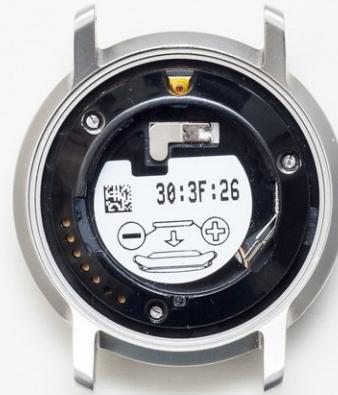
Step 3 — Remove the lithium battery

- Pry the CR2025 lithium battery off and ponder the meaning of three hexadecimal numbers on the information sticker.

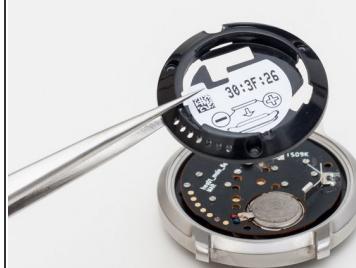
Step 4 — Remove the inner plastic cover

- Using a thin flat blade screwdriver remove three self tapping screws holding the inner plastic cover. The vibration motor (round metal part in second photo) has a sticky tape on it. You may need to apply force to separate the motor from the inner plastic cover. See the main PCB.

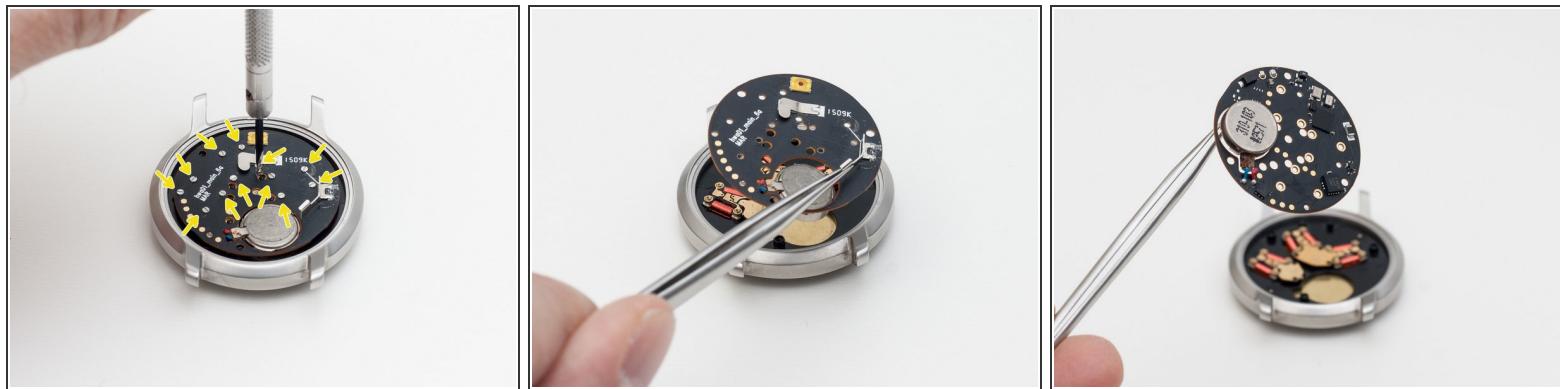
Step 5 — Access and remove the main PCB

- Using a thin flat blade screwdriver remove 12 (!) fine threaded screws to release the main PCB from the stepper motors of three dial hands.

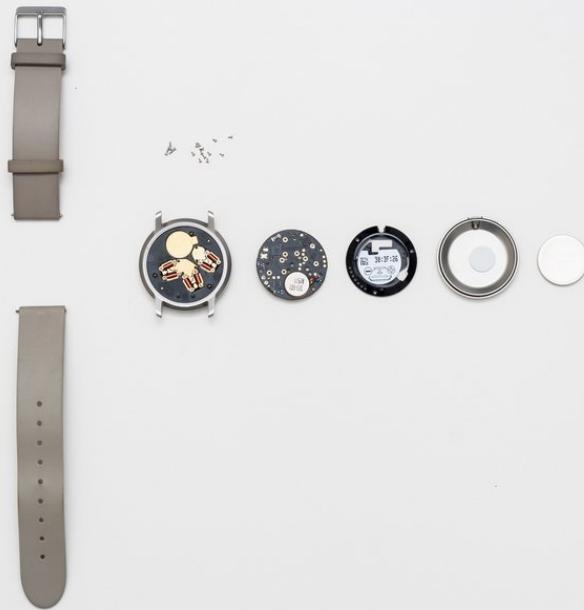
Step 8 — Teardown complete...

- This Withings Activité Pop Smartwatch had water ingress and it failed due to corrosion. A common fault with this watch is loose inner screws, leading to poor PCB contact with motors. When you change battery make sure you apply silicone grease on the rubber gasket of the case back. The dial and hands are not accessible since the glass is pressed.
