Xbox One S All Digital Edition Wifi Card Replacement

This guide covers the replacement of the WiFi Card on the Xbox One S All Digital Edition (Model 1681). The WiFi Card acts as a transmitter and receiver between the Xbox and the network it is hooked up to. Symptoms of a broken WiFi Card could be the Xbox's inability to find or connect to any near-by networks. Disconnect all cables prior to disassembly.

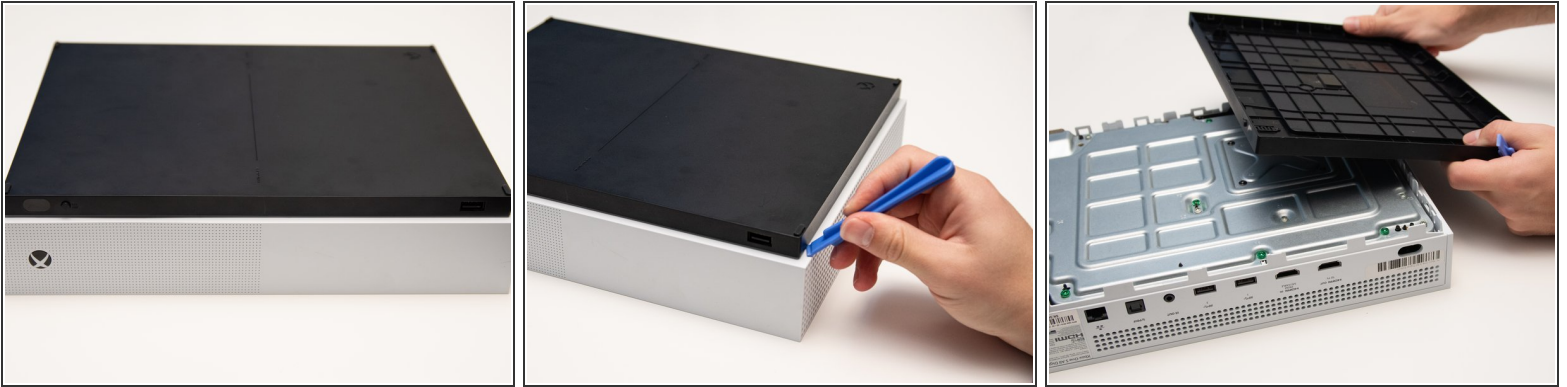
Step 1 — Plastic Enclosure

- Position the iFixit Opening Tool's riveted edge in between the top and bottom cover of the plastic enclosure.
- Apply downward pressure on the iFixit Opening Tool until the security clip unlocks.
- Repeat on different points of the plastic enclosure until the bottom cover is removed.

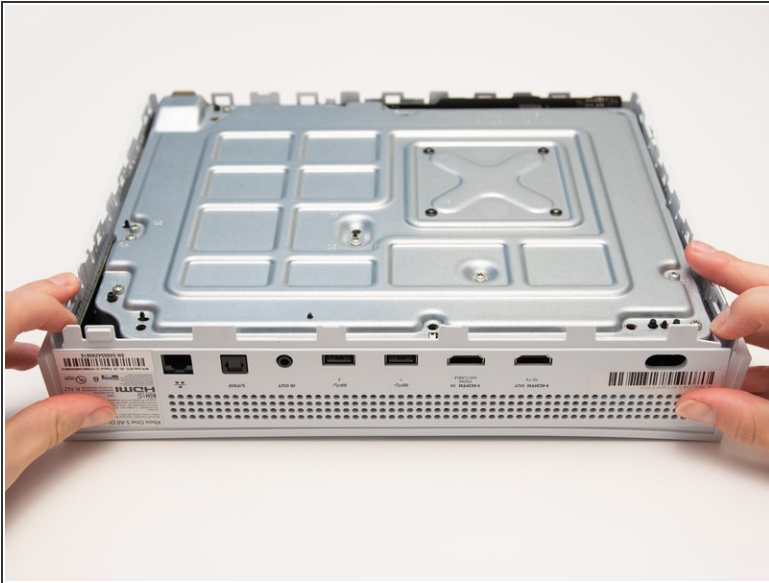
Step 3

- Apply pressure to peel off the sides of the casing.
- Separate the metal chassis from the top cover, lifting the back of the chassis up and away from the top cover.
- ⓘ The plastic back panel is meant to stay attached to the metal chassis.

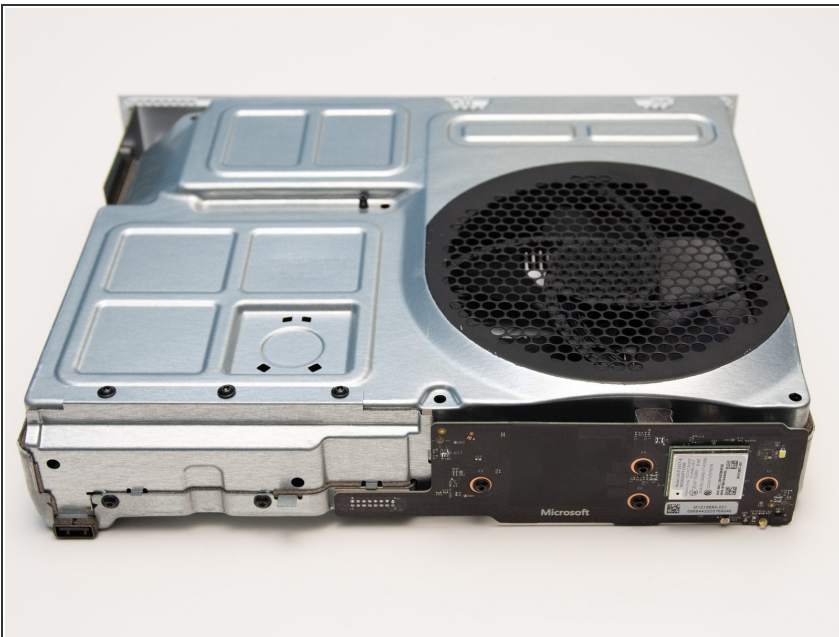
Step 4

- Flip the metal enclosure so that the fan cover is on top.

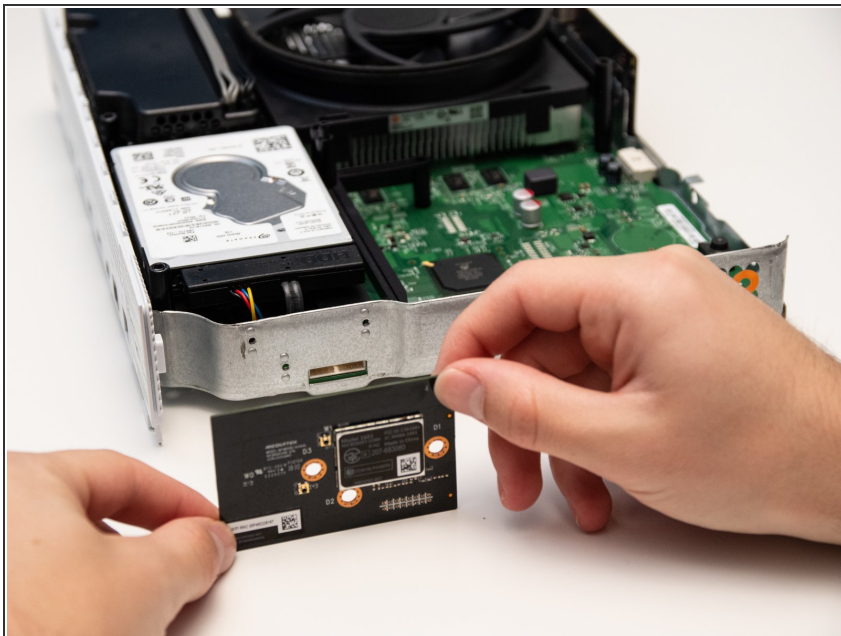
Step 6

- Carefully remove the WiFi Card from the metal chassis.
