iPhone 11 Pro Back Glass Replacement

iPhone 11 Pro Back Glass Replacement/Repair

Written By: Phryne

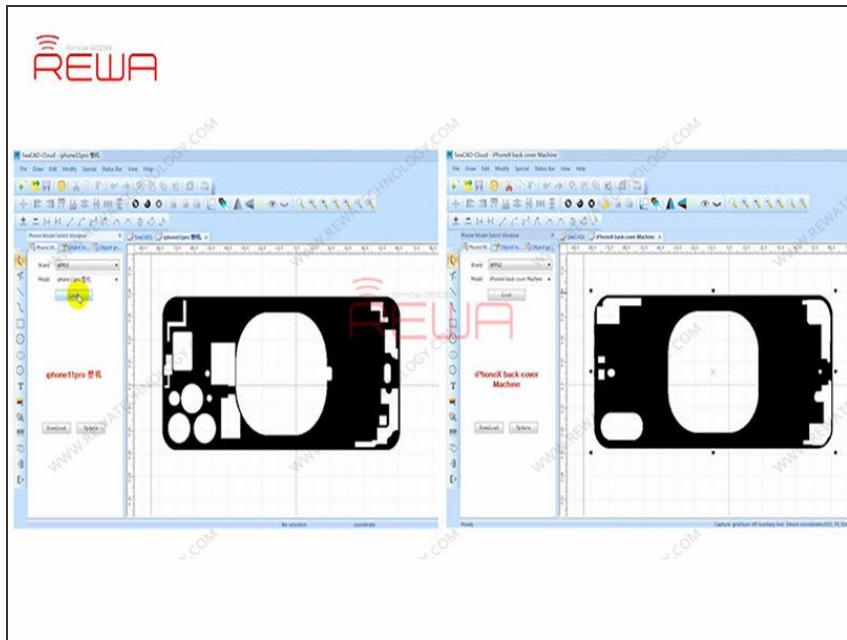
Step 1 — Choose The Right Laser Drawing

- Place the iPhone 11 Pro back glass under the probe for focusing. Then place the iPhone 11 Pro back glass on the operating panel.

- Choose 'iPhone 11 Pro' from the model list and click 'Load' to load the drawing.

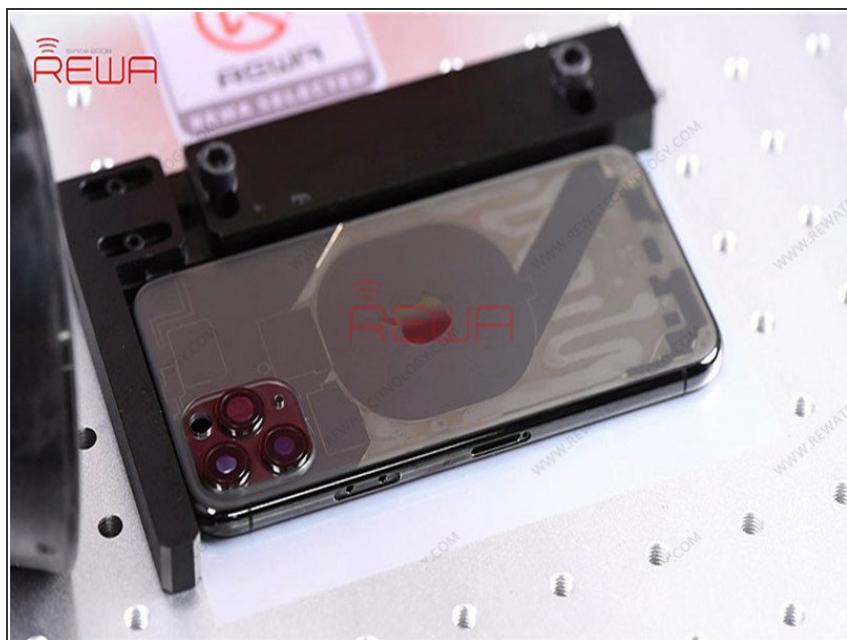
Step 2 — Scan The Back Glass With Laser

- Adjust the laser light scanning area on the back glass.
- Once finished, get the parameter set and click 'Mark' to scan the back glass with the laser light.

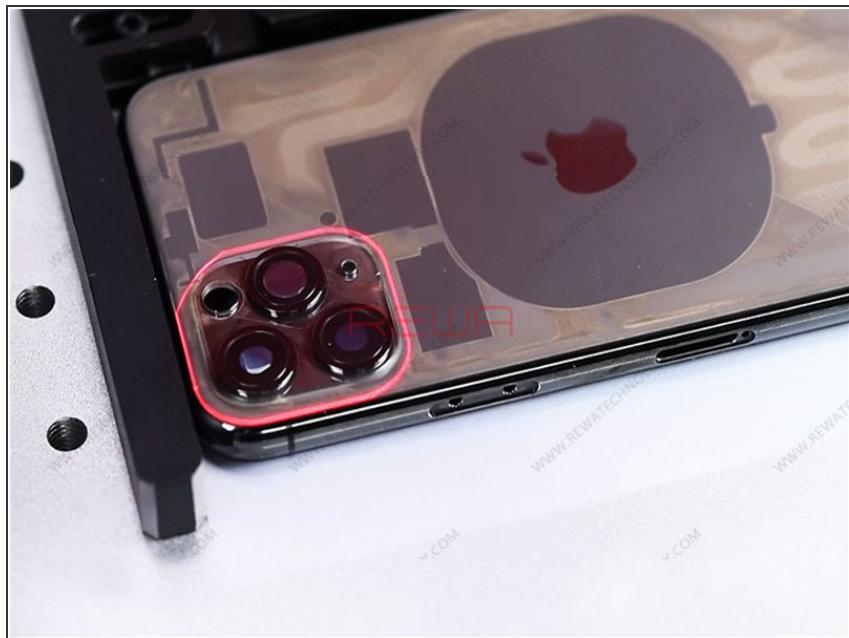
Step 3 — Scan The Glass Around The Triple-lens Camera With Laser

- The laser light scanning didn't work well with the triple-lens camera area here.
- After several attempts and experiments, [REWA LAB](#) successfully completed a specialized drawing for the triple-lens camera area.
- Scan the triple-lens camera area again with the laser with the help of the drawing.

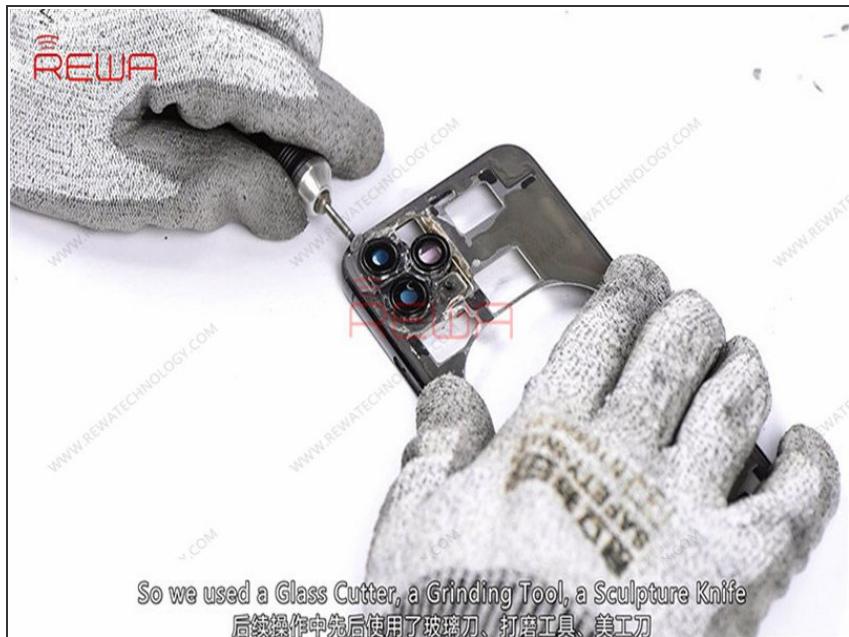
Step 4 — Separate The Back Glass From The Mid-frame

- The scanned back glass can be separated easily. However, the glass around the triple-lens camera needs further operation.
- Our commonly used tools failed to remove the glass here, so we used a glass cutter, a grinding tool, a Sculpture Knife and a Cutting Nipper to remove the glass around the triple-lens camera.
- Once completed, remove residual black adhesive with the Laser Machine.

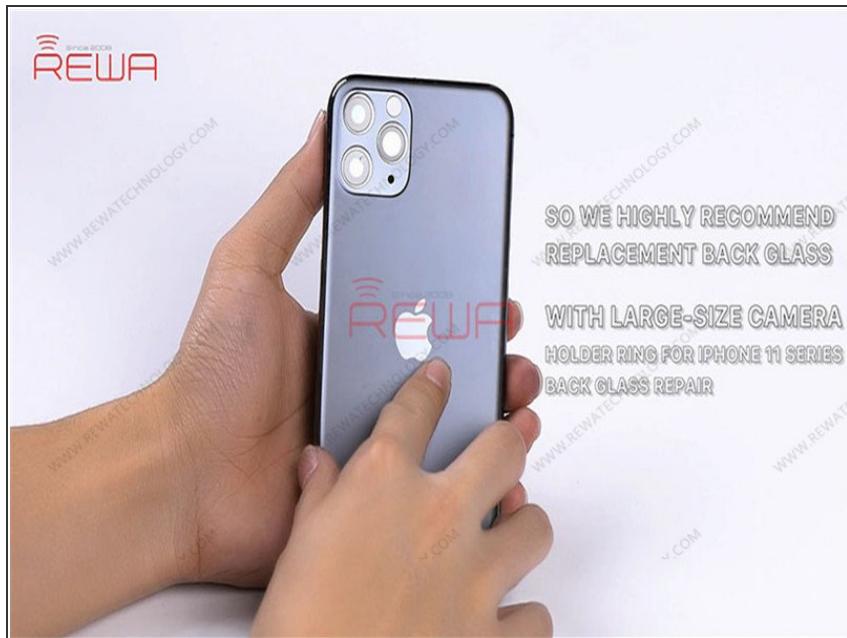
Step 5 — Big Hole Back Glass

- The camera holder ring of iPhone 11 series is harder and comes with thick inside walls, adding to the difficulty of polishing. Meanwhile, the camera lens can also be easily damaged during polishing.
- So we highly recommend replacement back glass with a big camera hole for iPhone 11 series back glass repair.
