iPhone XS Max Flickering Screen - A False Alarm?

iPhone Xs Max Flickering Screen Caused By Mistake

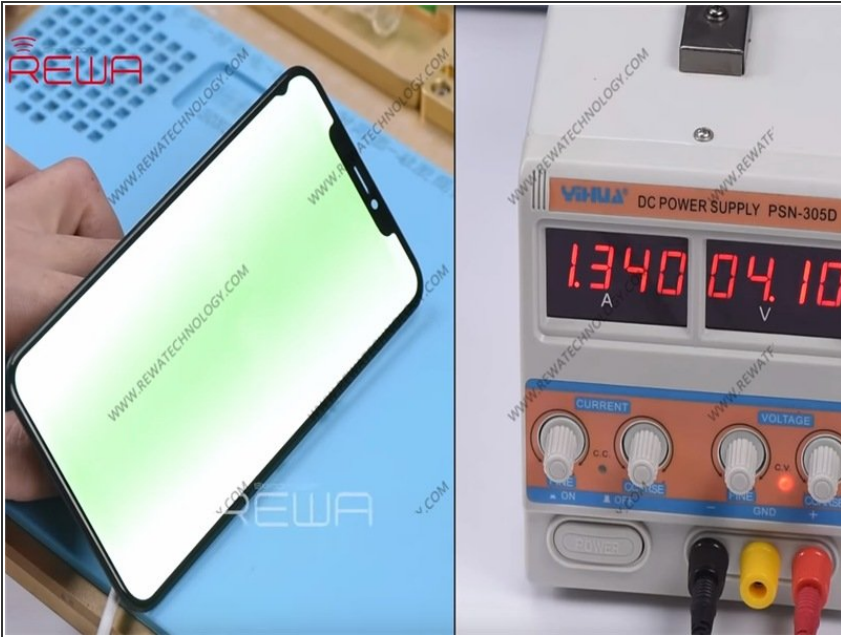
Step 1 — Test

- Connect an iPhone XS Max display assembly with the motherboard and connect the battery connector with the DC Power Supply.
- Get the motherboard powered on with tweezers. We can see that the screen comes with abnormal display and the boot current is larger than normal value. However, the phone can access the activation screen.
- Judging by this, the display problem is probably related to the display circuit, the GPU circuit or the third space PCB.

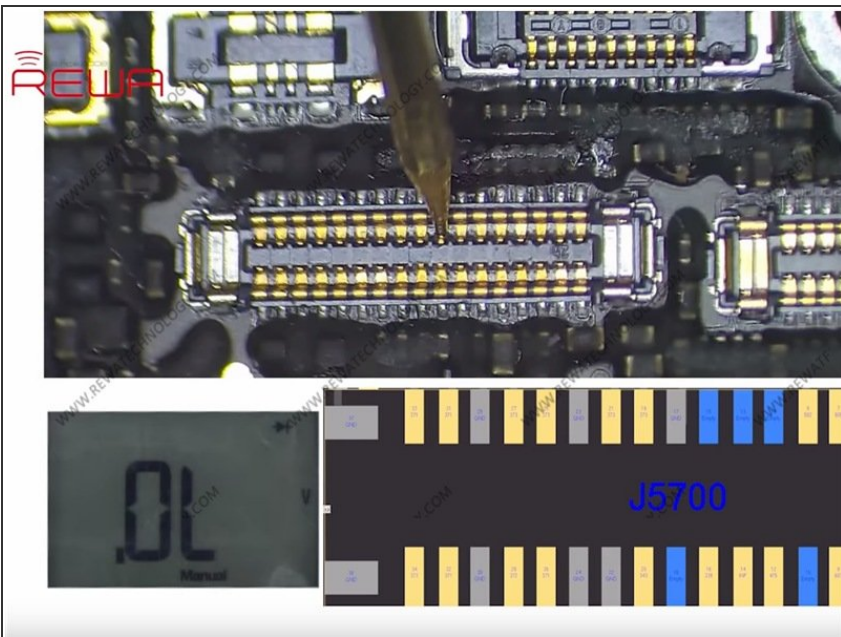
Step 2 — Troubleshoot

- Let's check the display circuit first. Run diode mode measurement of the display connector J5700. The measured value is normal. So the display problem has nothing to do with the display circuit.
- Next, we need to check the GPU circuit.

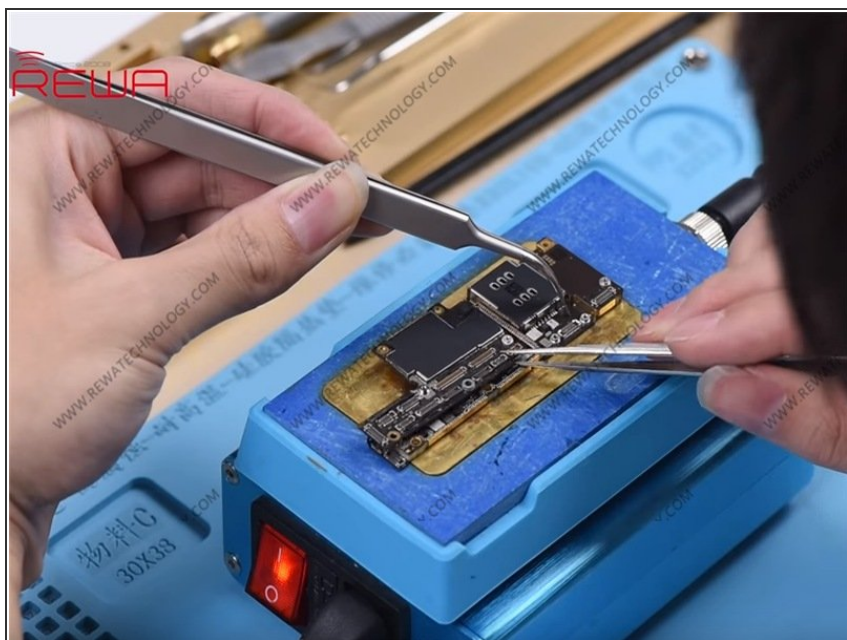
Step 3 — Motherboard Separating

- We need to separate the motherboard before the test. Place the motherboard on the specialized Heating Platform. 3 minutes later, pick up the upper layer with tweezers and then the lower layer.

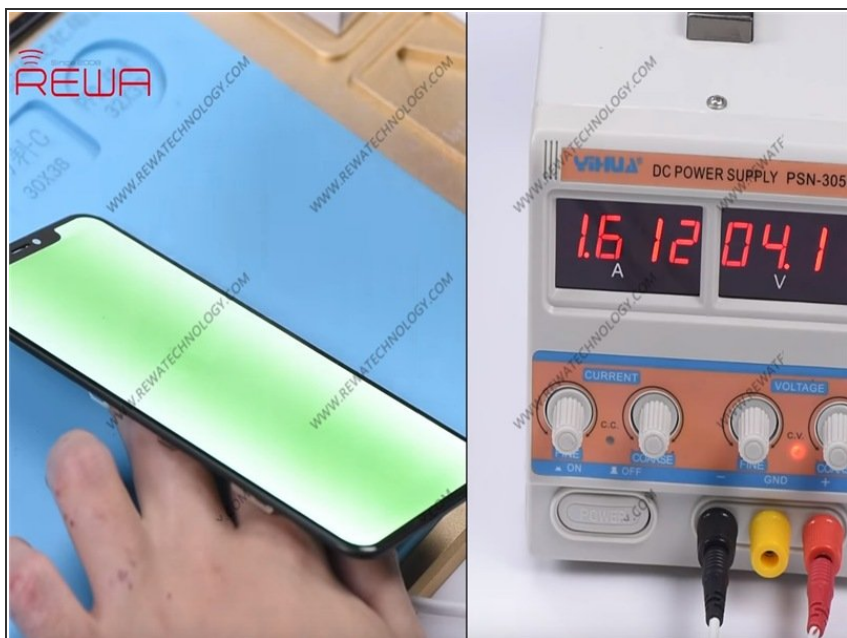
Step 4 — Troubleshoot

- Connect the iPhone XS Max display assembly with the upper layer and connect the battery connector with

the DC Power Supply. Get the upper layer powered on with tweezers. The problem remains the same.

- Which indicates that the display problem has nothing to do with the third space PCB.

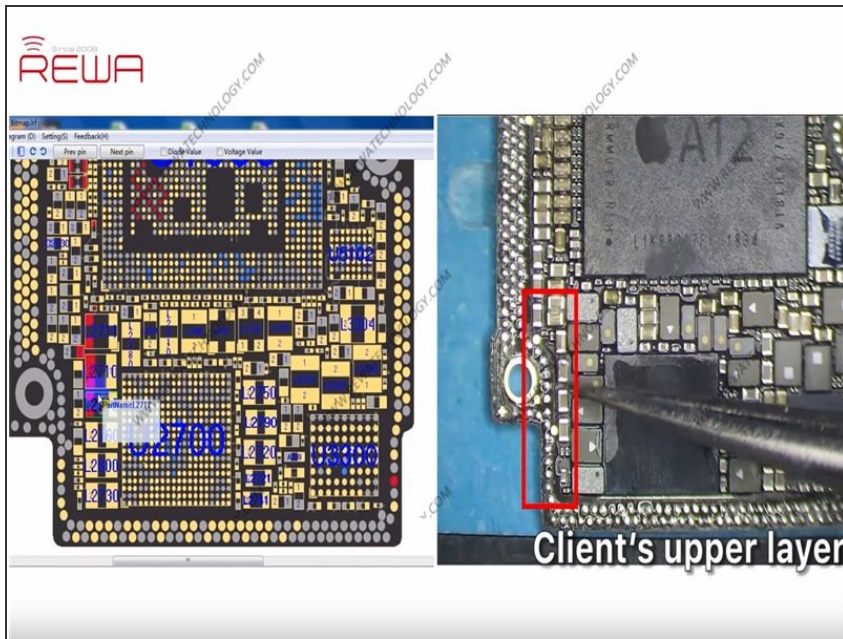
Step 5 — Check GPU Circuit

- We need to continue with the GPU circuit.
- Attach the upper layer to the PCB Holder. Open REFOX and find the GPU circuit of iPhone XS Max.
- Compare the upper layer we are dealing with and the one on the bitmap, we find that the one we are dealing with is an iPhone XS upper layer not an iPhone XS Max upper layer as described.

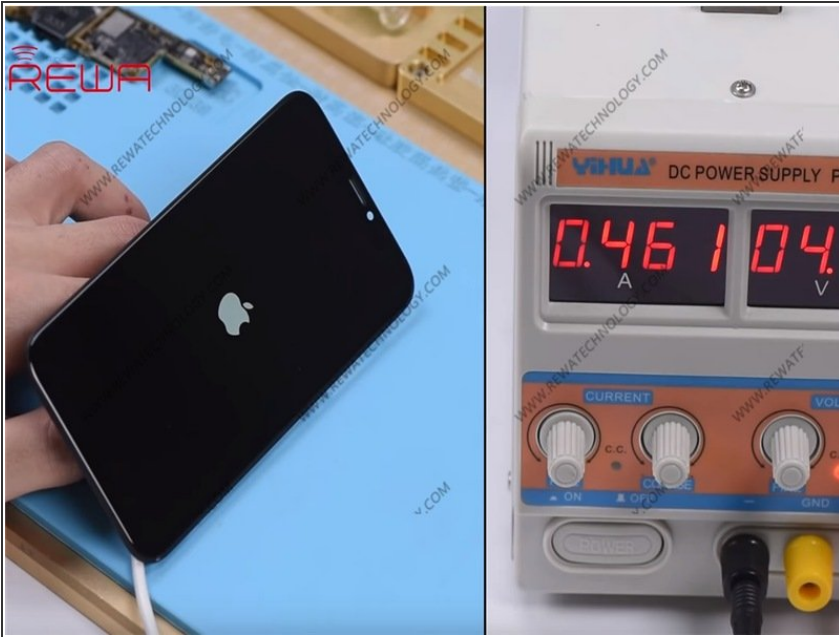
Step 6 — Test

- Try to connect an iPhone XS display assembly with the upper layer and connect the battery connector with the DC Power Supply.
- Get the upper layer powered on with tweezers. The phone turns on normally with normal display. The phone can access the activation screen and the boot current is also normal this time.
- We can confirm now that our client soldered an iPhone XS upper layer onto an iPhone XS Max lower layer and resulted in the abnormal screen display.
