TP183518 AND TP183519 SETS OF PARTS, TP182793 HEAT SINK PLATE
AND TP180000 CODE BAR BASKET

APPARATUS AFFECTED: 33A, 33A-1, 33A-2, 33A-3, 33A-4, 33B, 33C-1, 33C-2, 33C-3, 33C-4, 33C-5, 33D, 33D-1, 33D-2, 33D-3, 33D-4, 33E, 33F, 33F-1, 33F-2, 33F-3, and 33F-4 Teletypewriter-Sets.

OBJECT: To improve the operation of the teletypewriter-set by replacing and/or modifying old style parts.

SECTION 574-100-800.15

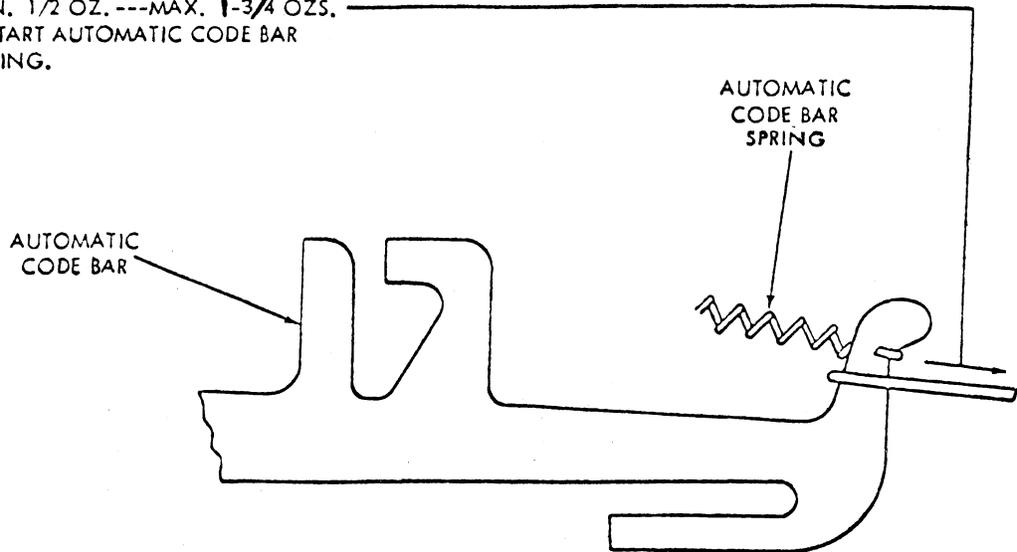
PRINT SUPPRESSION AND NO.3* (4) CODE BAR SPRING
 REQUIREMENT

WITH PRINTER IN STOP CONDITION AND NO.3* (4)
 CODE BARS FOLLOWER ON CARRIAGE LIFTED.
