BCG800XL Grinder Jamming due to Worn Impeller

This guide will walk through replacing the impeller to fix the most common cause of jamming with the Breville BCG800XL and BCG800 Smart Grinder.

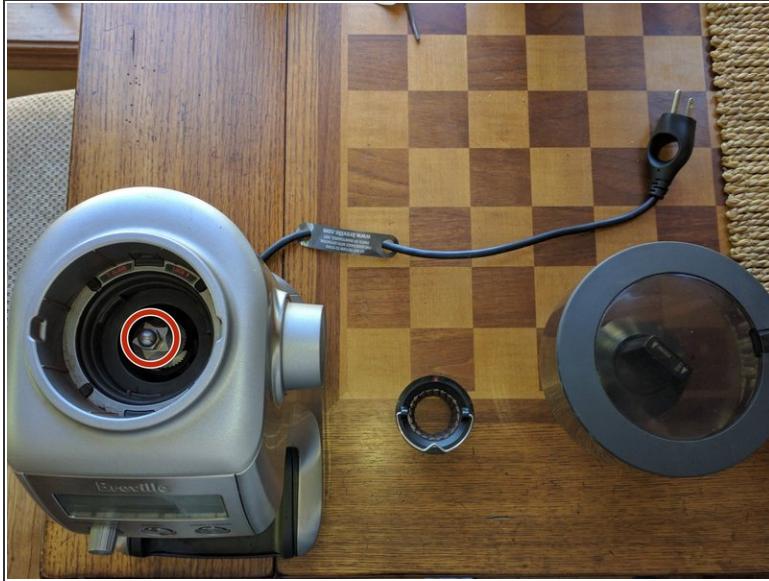
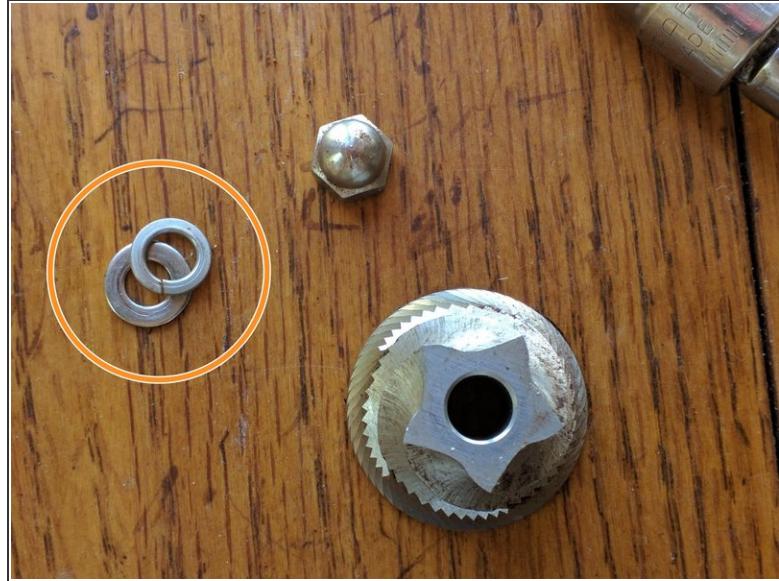
Step 4 — Remove hopper, upper burrs, and lower burrs

- Remove the hopper and upper burrs.
- Use a 10mm socket to remove the nut for the lower burrs.
 - ⓘ The nut for the lower burrs is reverse threaded. Rotate **clockwise** to loosen.
- Turn the grind-adjustment knob to the finest setting.
- Remember what order in which the washers were removed for proper reassembly.

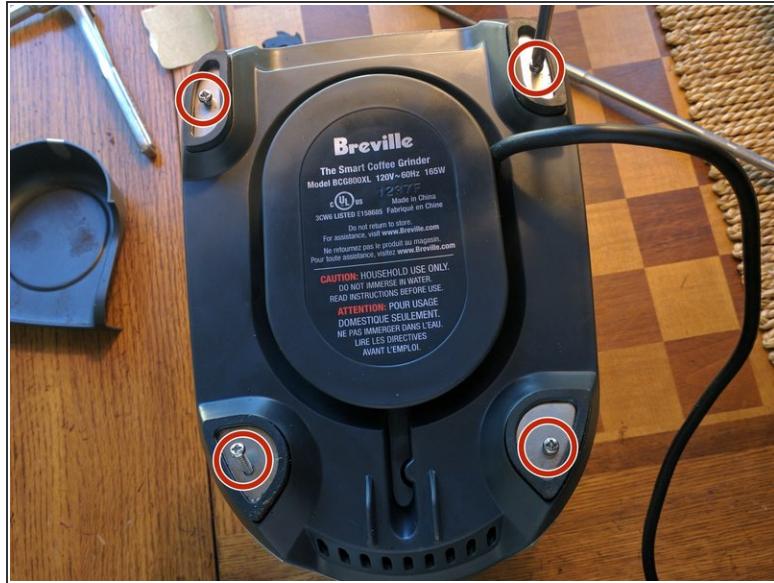
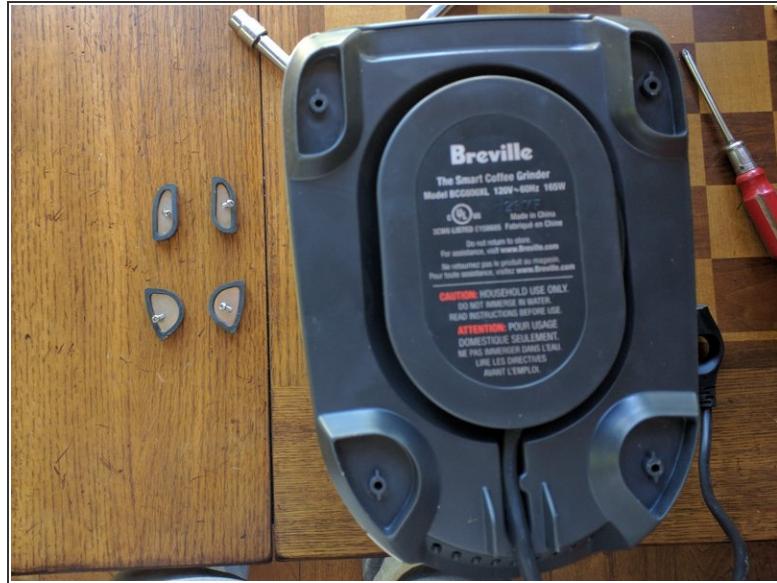
Step 5 — Remove the base

- Unwrap the power cord and remove the 4 screws from the base.
- Remove the four rubber pads
- Slide the power cord through the hole in the base while lifting the base away from the grinder.

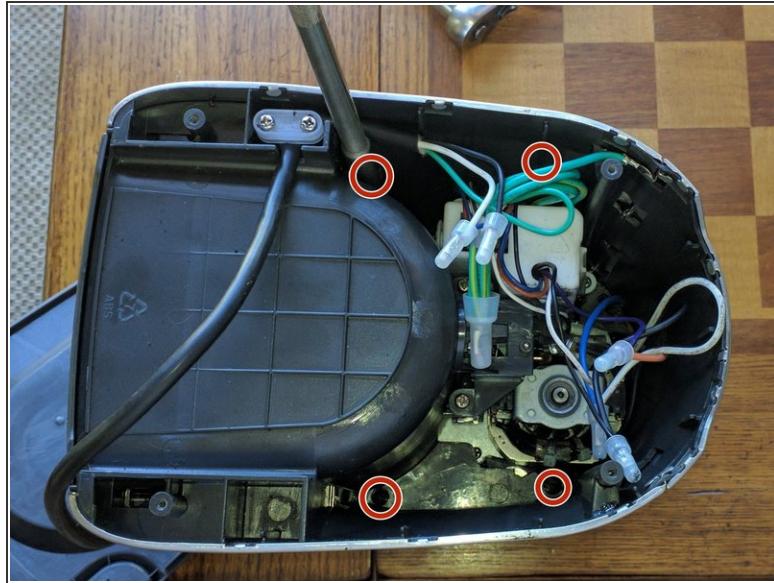
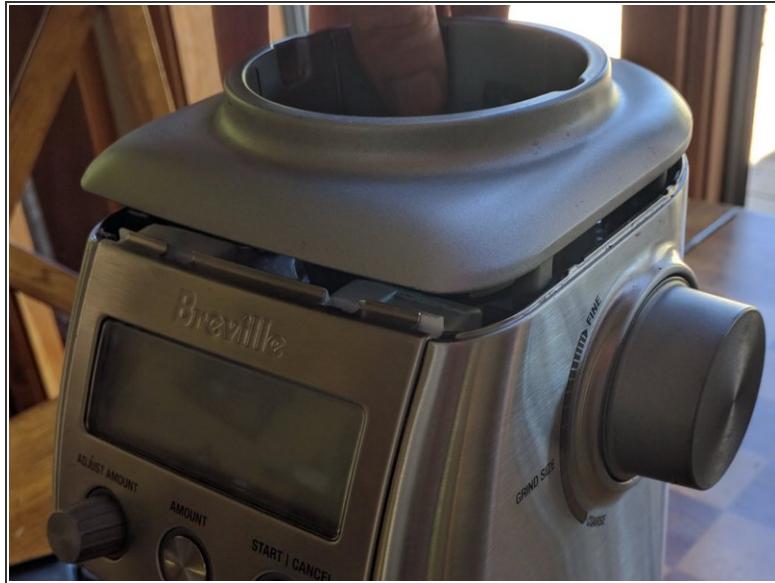
Step 6 — Remove 4 screws holding the top on

- Use the long Phillips #2 driver to remove the 4 screws holding the top in place.
- Flip the grinder over and slowly lift away the top.

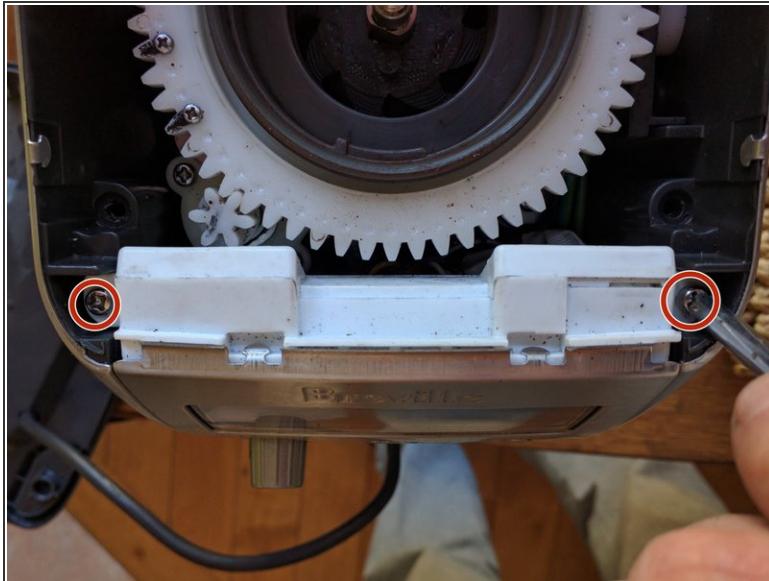
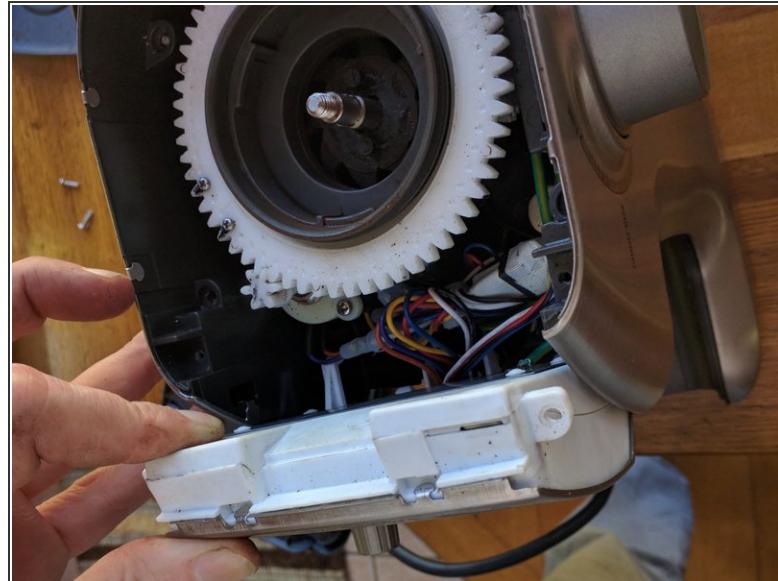
Step 7 — Remove the front display

- Remove the two screws from the top of the display.
- Lift the display up and out of the frame.

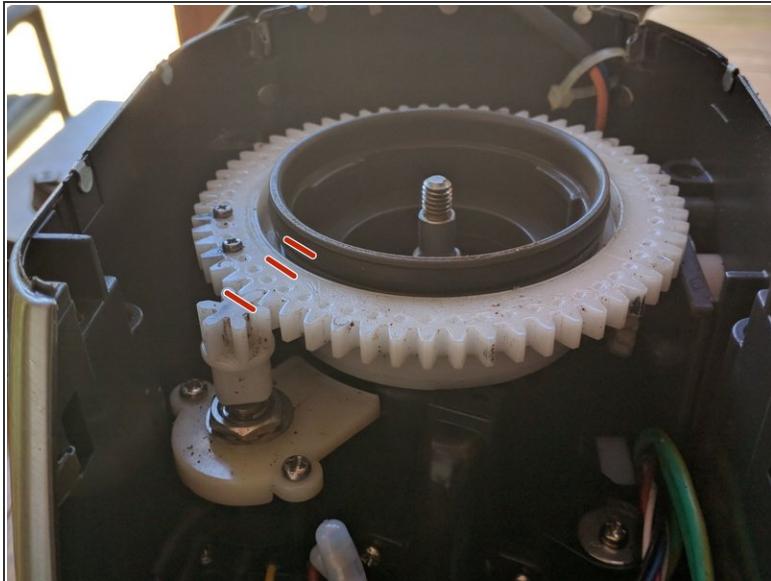
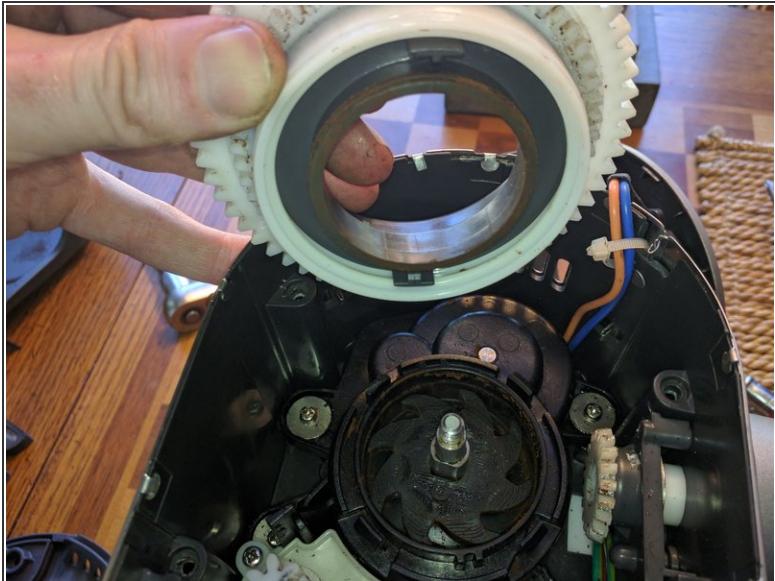
Step 8 — Gear / Burr holder Assembly Removal

- Be sure the grind knob is turned to the finest setting.
- ⚠ It's critical that the alignment be preserved when removing the gear assembly. The small gear in the picture is an encoder. Its purpose is to track the position of the grind adjustment level so it can be displayed on the digital readout. If it gets out of alignment the display will end up reading wrong.
- Use a permanent marker to make alignment marks on the three parts of the gear assembly. The marks should line up during reassembly.
- There are 4 plastic tabs radially holding the big white gear assembly in place. I used both hands, placing my finger tips under each side of the big gear and pulled straight up to remove it.
- If pulling straight up isn't working, try curling your fingers under just one side of the white gear, and prying upwards until that side pops free a little. Then do the other side.

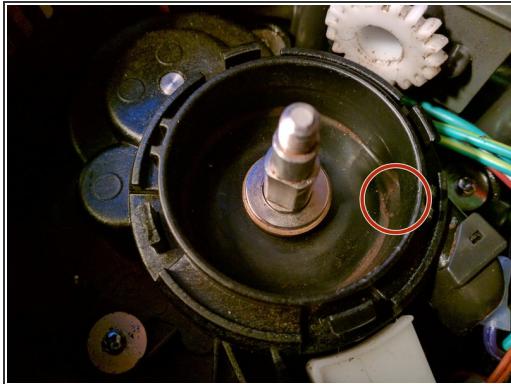
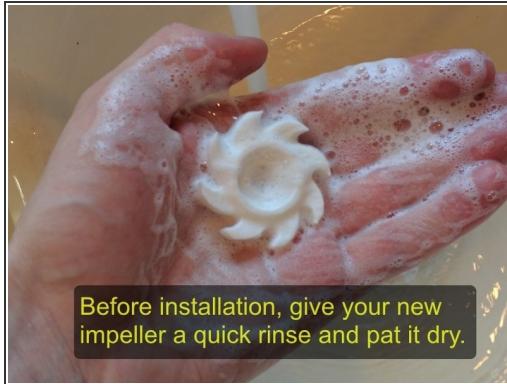
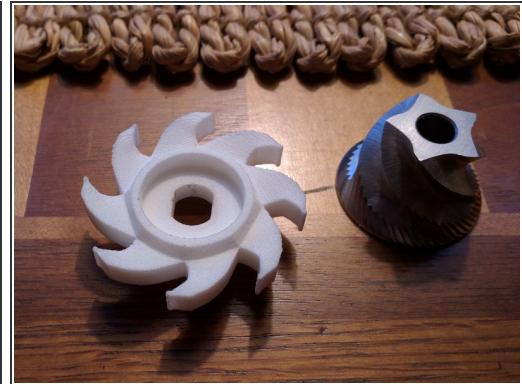
Step 10 — Clean the exit chute and rinse the new impeller

- While it's accessible, use compressed air or toothpick to clean out the exit chute so it's free of any compacted coffee.
- Give your new replacement impeller a quick rinse with soap and water. Then pat it down with a towel. This prevents static charge during first grinding.

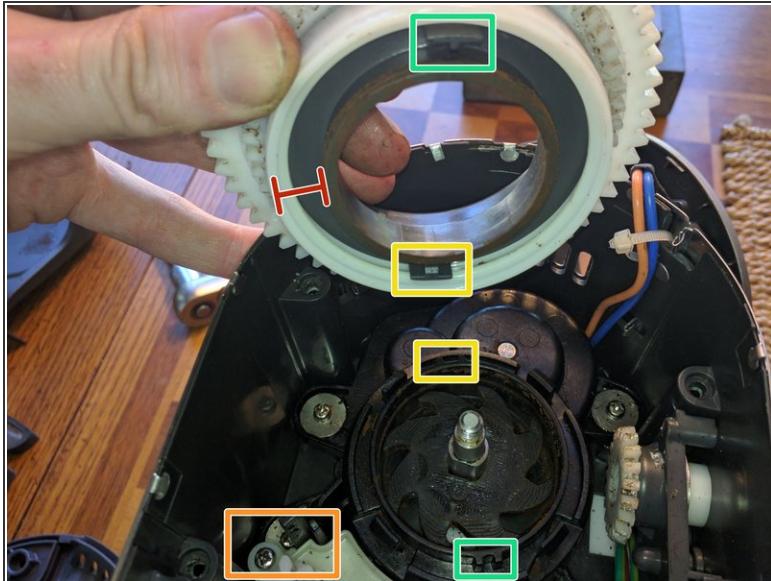
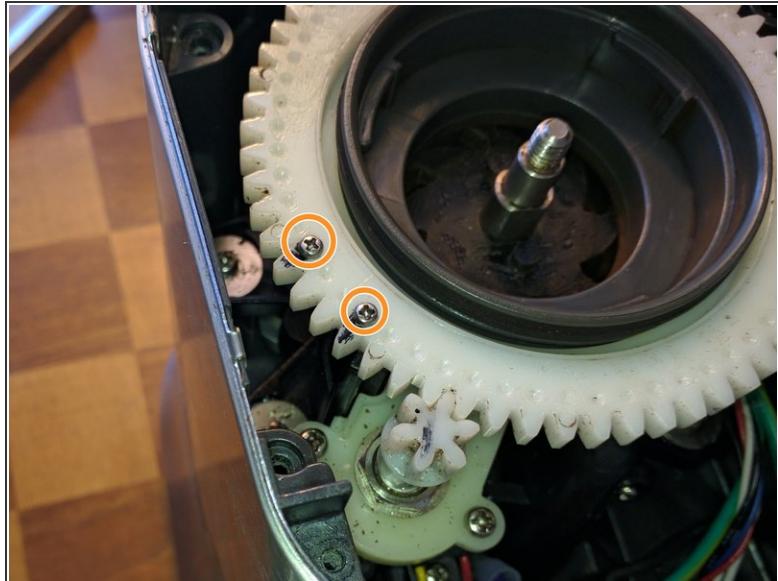
Step 13 — Reinstall the Gear / Burr holder assembly

- With the following pieces aligned carefully set the gear assembly into place:
 - Avoid rotating these pieces to maintain alignment.
 - As you set the assembly into place, make sure the two stop-screws are on the left side of the black plastic stop.
 - Align the large peg with the wide slot.
 - Align and the small peg with the small slot.
- Press down on the gear assembly to snap it into place.
- Once in place, rotate the coarseness knob through the full range to make sure it's all working.

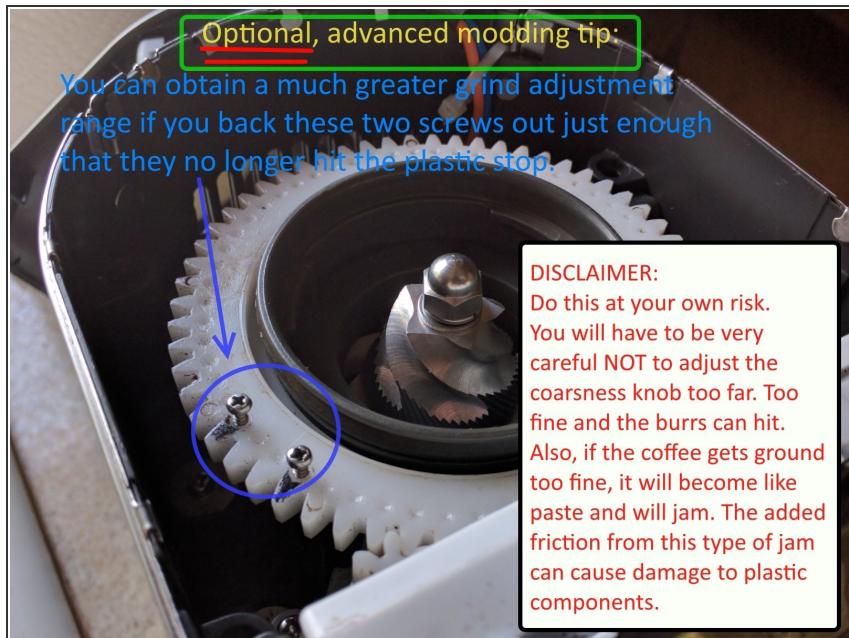
Step 14 — Optional Modification for Better Grind Adjustment Range

- Advanced Modding Tip: If you want greater grind-control range, you can back out the two screws in the big gear in the photo. You will then be able to adjust the grind much beyond the normal range. Caveats: Go too fine and the grounds become like paste and it will certainly jam. Also, you must not adjust too fine or the burrs will hit!
- Note: The encoder driven by the little gear also has a hard stop built into it. You will still run into this stop if you keep turning the adjustment knob.
- DISCLAIMER: This step is completely optional. It is up to you and ultimately your responsibility if you choose to do it. Understand the risks of jamming and burrs hitting. Also be aware of the possibility that others may use your grinder and need to be informed of the modification. You do this unnecessary and optional step at your own risk.

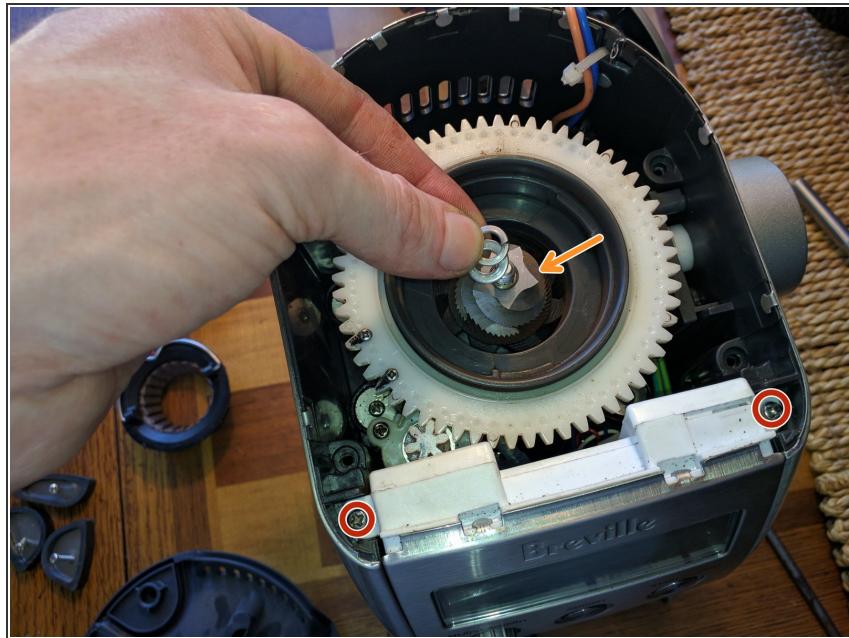
Step 15 — Reinstall the Display and the Conical Lower Burr

- Place the display back into the frame and screw in the two screws that hold it in place.
- Put the conical burr in place making sure it sets on the drive pegs of the new impeller properly.
- Place the washers on while maintaining their original order. ie: Flat washer on the bottom, split washer on top.
- Tighten the **reverse threaded** 10mm nut.
 - *(i)* Tighten the nut as hard as you can. The impeller, being plastic, has a small amount of springiness to it and must be squashed hard so that the height of the lower burr does not vary. If you find that the burrs are too close after you're all done, then this is the reason. Tighten until the motor begins to move, and then give it an extra wack.
- Check the grind knob to be sure it has full range of motion.

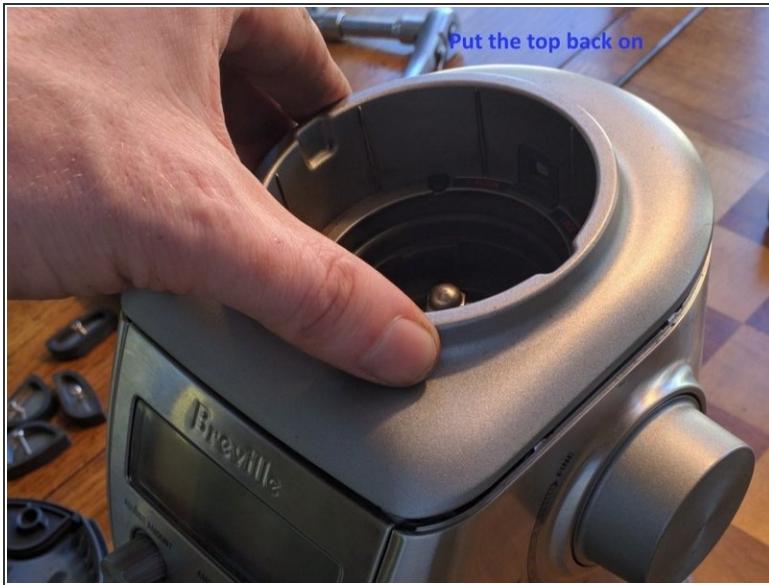
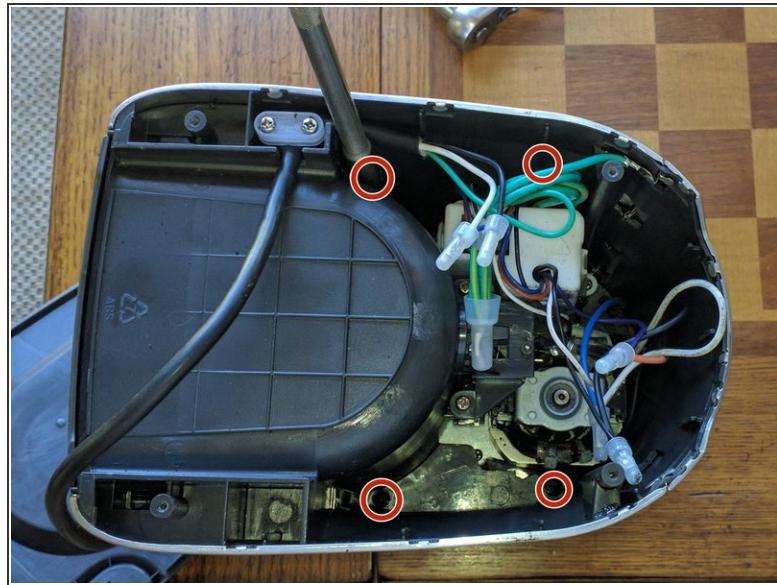
Step 16 — Put the top back on and screw it back in

- Put the plastic top back on.
- Flip the grinder over and use the long Phillips #2 screwdriver to reinstall the 4 screws that hold the top in place.

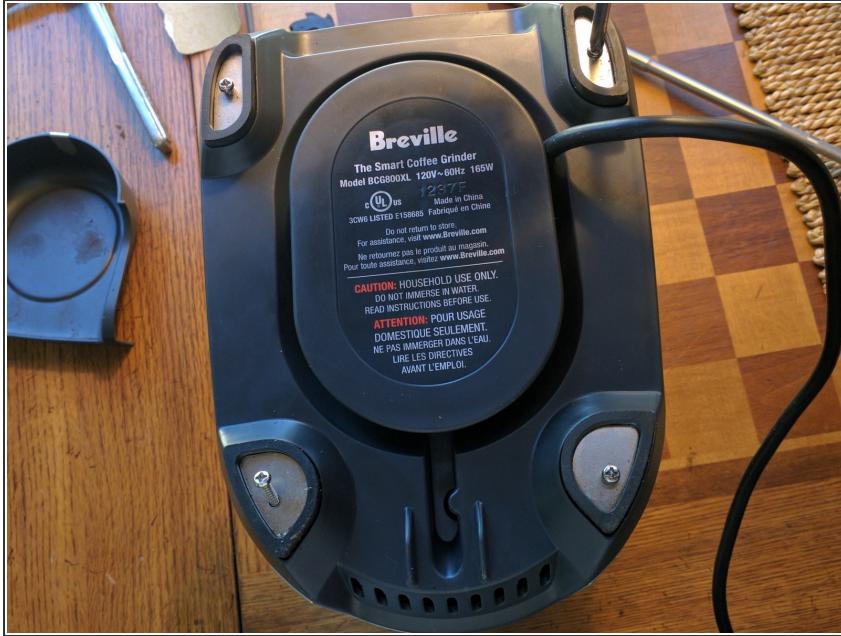
Step 17 — Reinstall the bottom

- Put the four rubber feet back in place.
- Screw back in the four base screws.
- Re-wrap the cord.

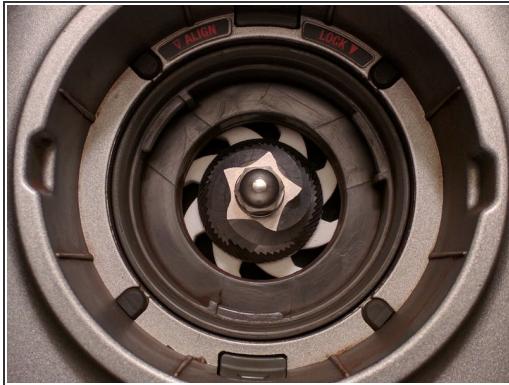
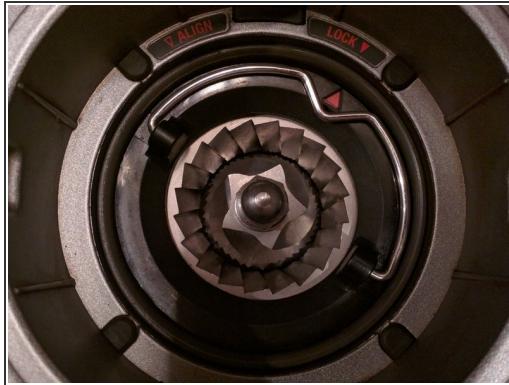
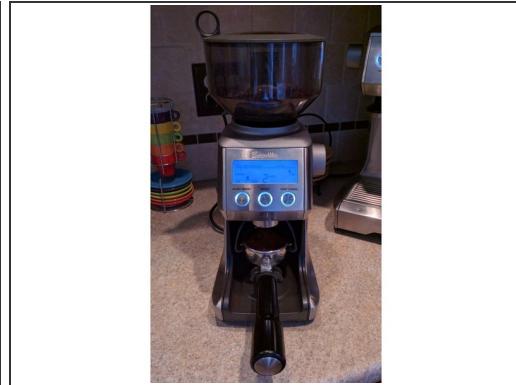
Step 18 — Reinstall upper burrs and hopper

- Put the upper burr back on and reinstall the hopper (without coffee beans yet).
- Run the (empty) grinder briefly to make sure it all sounds OK. Try both coarse and fine grind settings.
