Lenovo ThinkCentre A70z Backlight Cable Replacement

The ThinkCentre A70z Monitor lamp turns off so can't see display without a light to verify LCD screen is working.

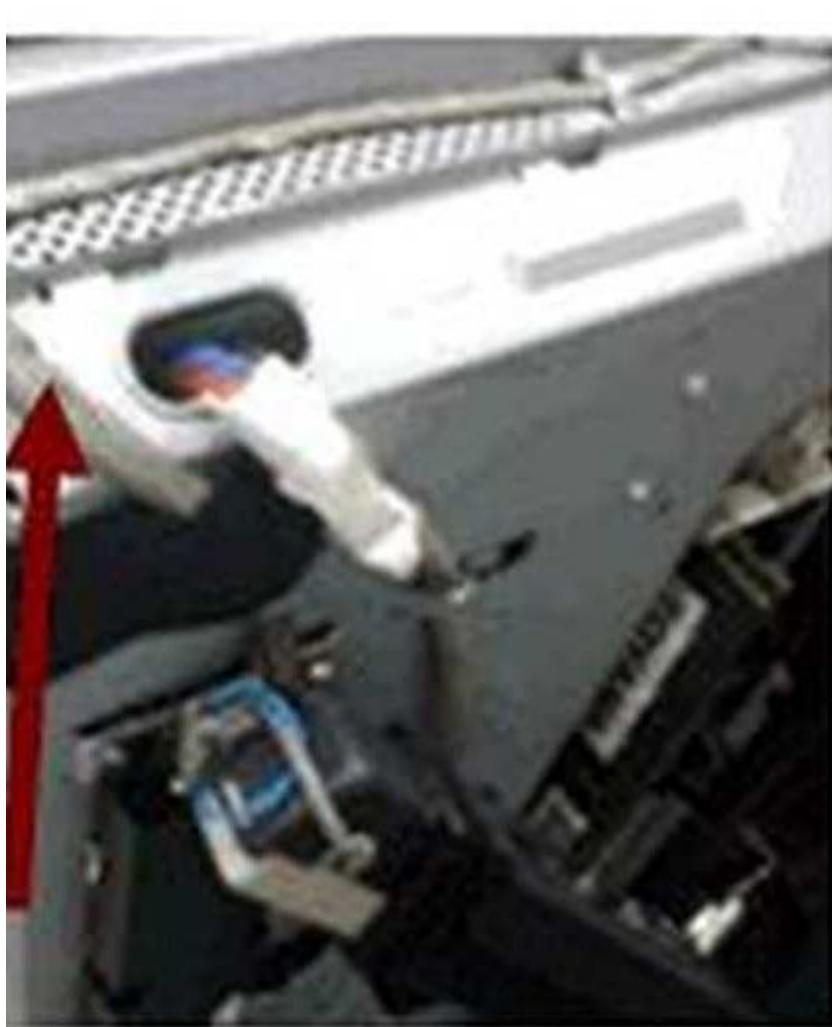
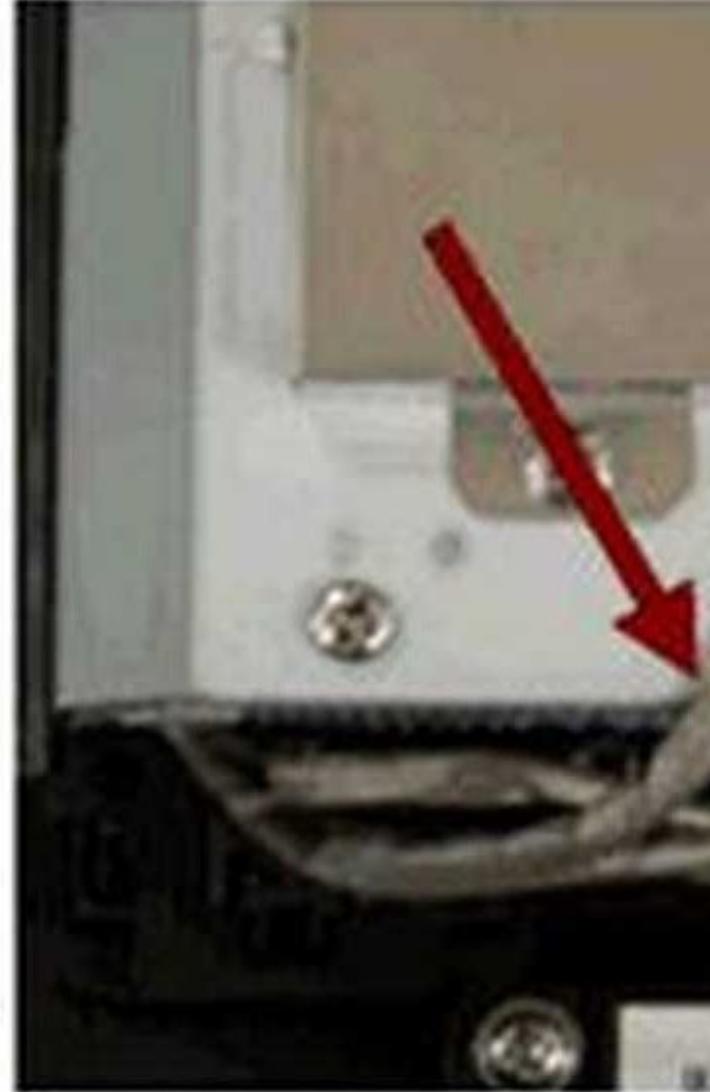
The issue is caused by the conductive tape wrapped around the backlight cable as seen below.

The issue has a low failure rate with the woven type of conductive tape. However, has a high failure rate with an aluminum foil type of conductive tape.

LG panel mentioned, "do not attach a conducting tape to lamp connecting wire directly. If the lamp connecting wire attach to a conducting tape. LCD module will have a risk for low luminance.

I removed the conductive tape wrapped around the backlight as noted and now the computer is working great again other than a login issue that will be corrected with a Windows 10 reset or I'm thinking a fresh install of a Linux OS for a multiboot system.

- Remove conductive tape wrapped around the backlight cable as below seen below.
- The issue has a low failure rate with the woven type of conductive tape. However, has a high failure rate with an aluminum foil type of conductive tape.

- Order special tape that has sponge as noted: 03T9708 34.3BE7.001
FRU_EMI_GASKET_MB_SHEILDING_TOYAMA
- Replace previous conductive tape with new tape 03T9708 after Removing original tapes.
