Philips Wake-Up HF3520 Power supply repair

Flashing or flickering light when using radio can be caused by a malfunctioning switchmode power supply IC.

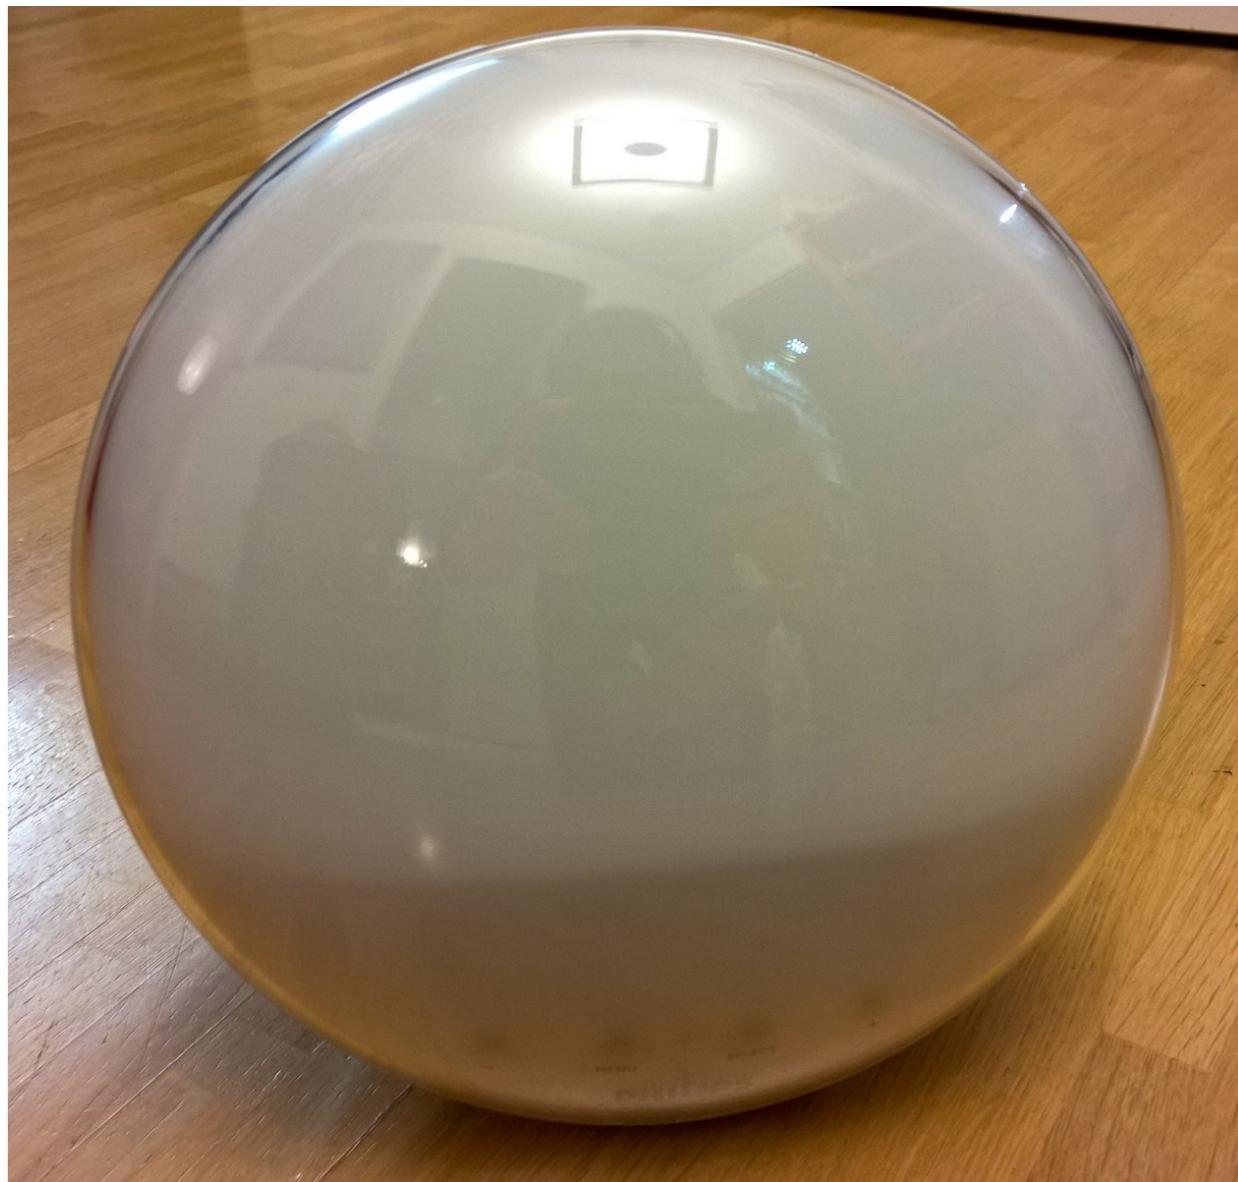
The IC (chip) inside the lamp seems to die slowly resulting in flickering/flashing lamp operation when using the radio. Also the buttons may become unresponsive.

The problem occurs specifically when the device is cold and/or humid. Heating up the IC makes it work again.

- On the main PCB with the power-jack, replace the MTX2410 switchmode regulator IC (SO-8 Package).
- There is a pin-compatible device from Quorvo (ACT4060ASH-T) which has a different internal voltage reference but otherwise works fine. Only a resistor must be changed for this to work.
- Feedback Voltage for MXT2410 is 1.222V, for ACT4060 is 1.293V, so voltage divider on Pin5 must be changed accordingly.
 - One can best adjust R4+R3 (series). Remove R4, measure R3 and R4, and increase. It should measure about 10.67kOhm (R3 plus R4), and it can be slightly increased to 11.51kOhm. So basically add 1kOhm to R3+R4.
