iPhone X Bottom Speaker Not Working Repair

Written By: Phryne

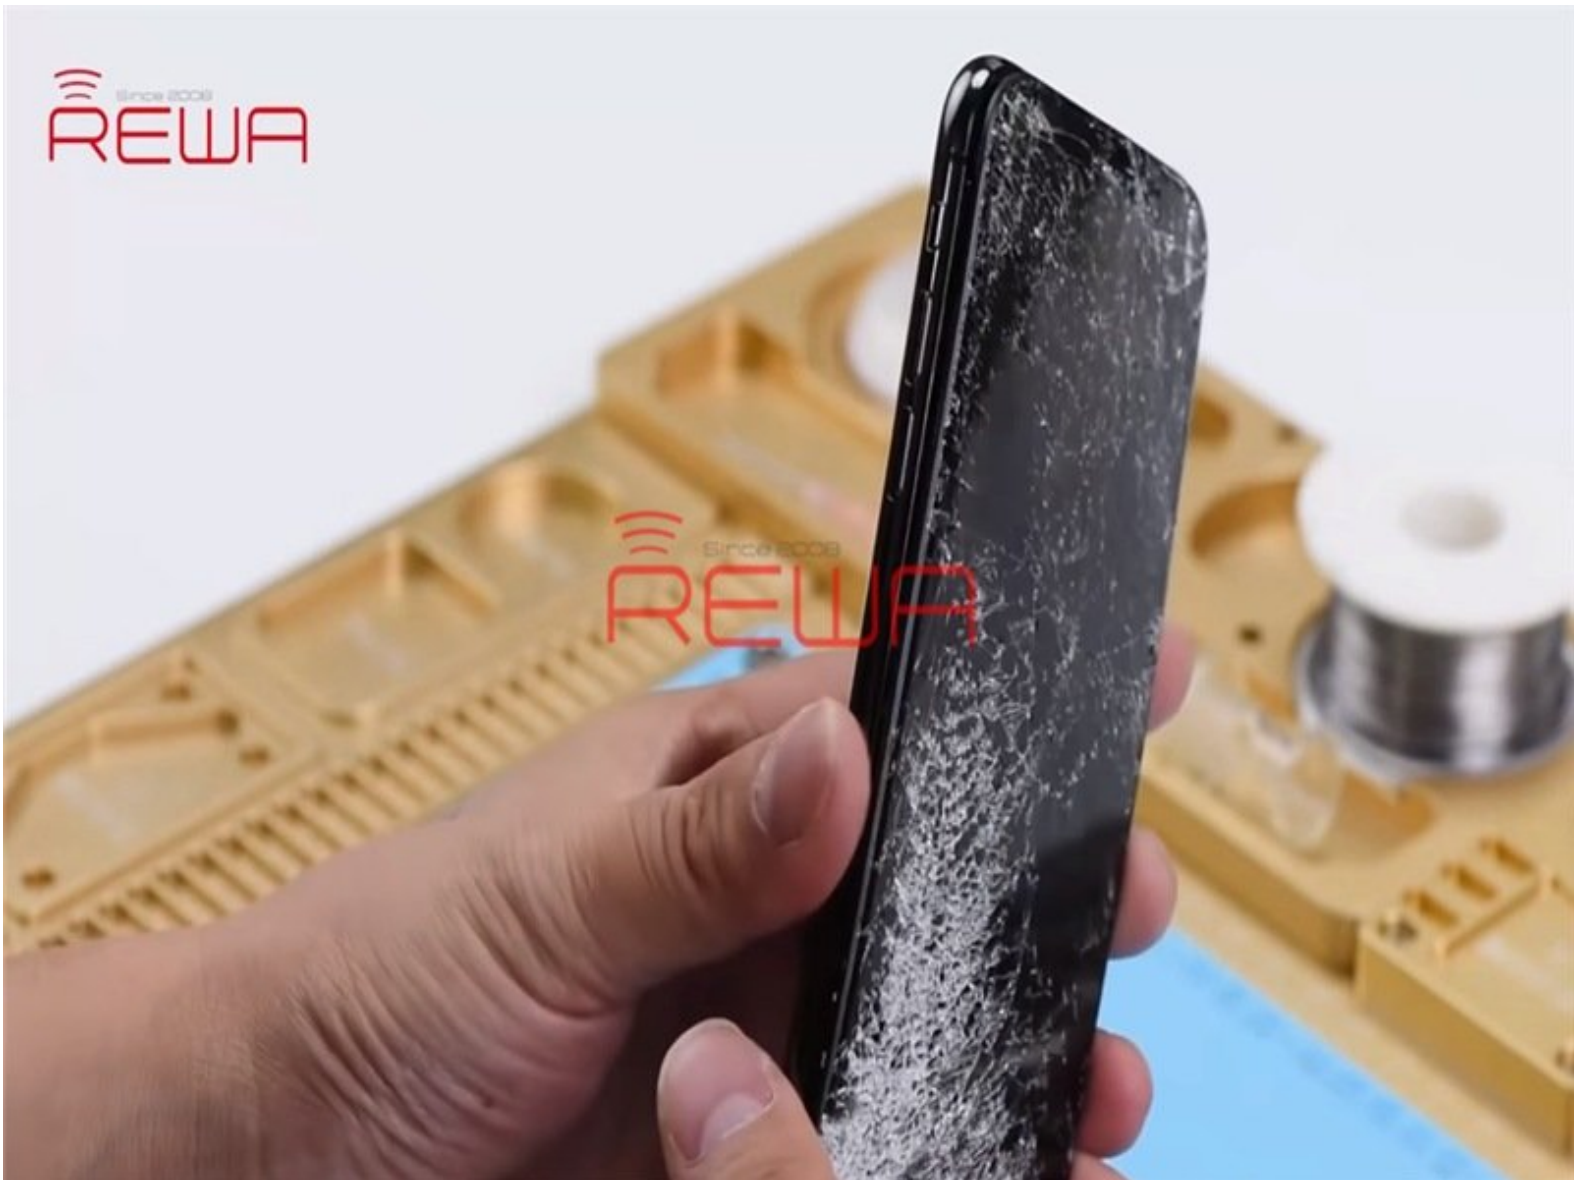
Pseudo soldering of components may result in different iPhone issues. And causes for pseudo soldering can be different. For example, defective soldering techniques, improper operations in the repairing process or bad habits of users, etc..
