# Brocade Fabric OS v5.0.4

## Release Notes v1.0

April 5, 2006

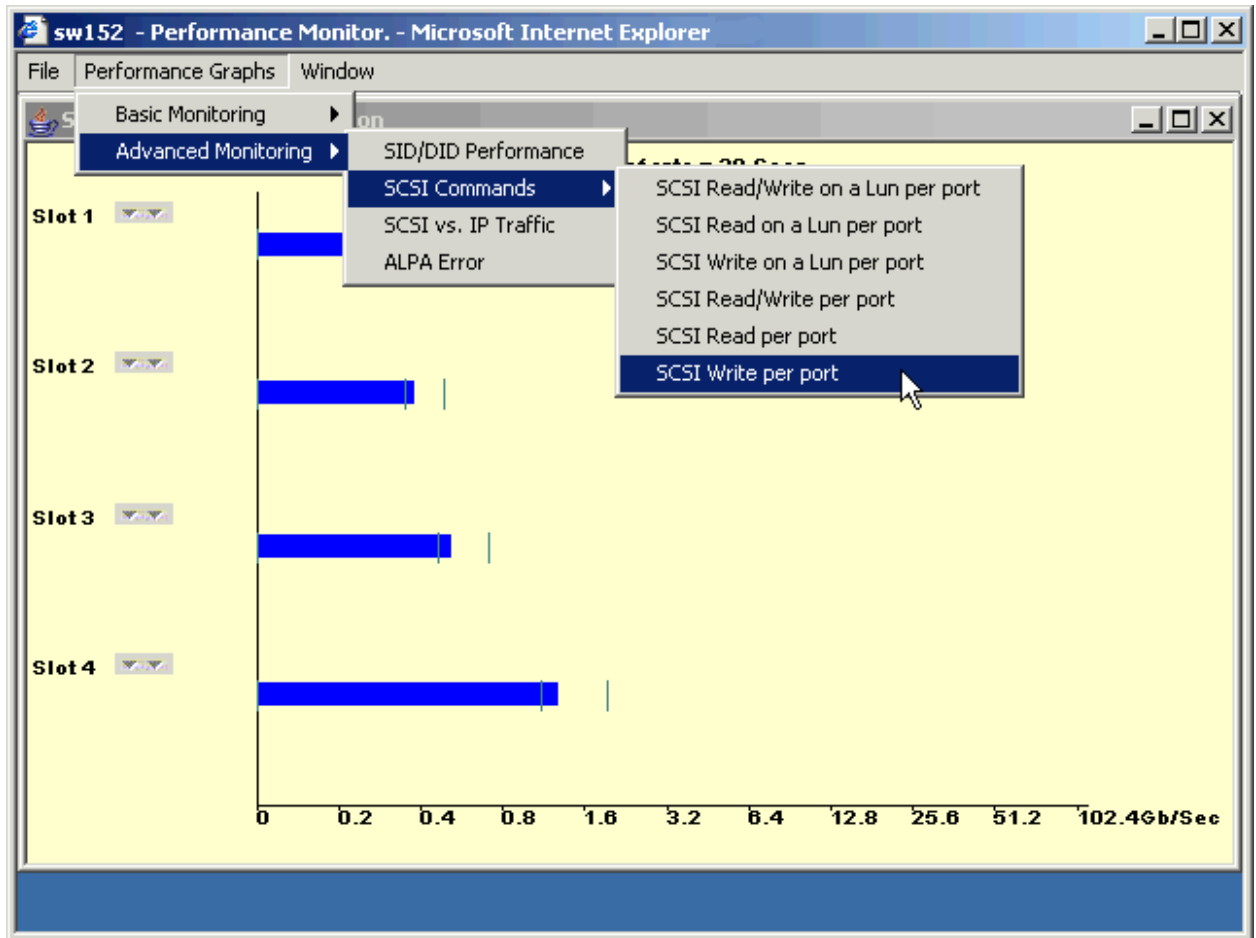
**Figure 14-1** Accessing Performance Graphs

Port throughput utilization is represented by a horizontal bar for each selected port, which gets longer or shorter depending on the percent utilization for that port at the last poll time. Thin short vertical intersecting bars give a historical perspective by representing the highest and lowest values reached for each selected port since the graph was opened. A third bar between them represents the average of all values polled. (See Figure 14-1.)

On page 14-3, replace Figure 14-1 with this one:
