Brocade Fabric OS v5.0.5b

Release Notes v1.0

November 03, 2006

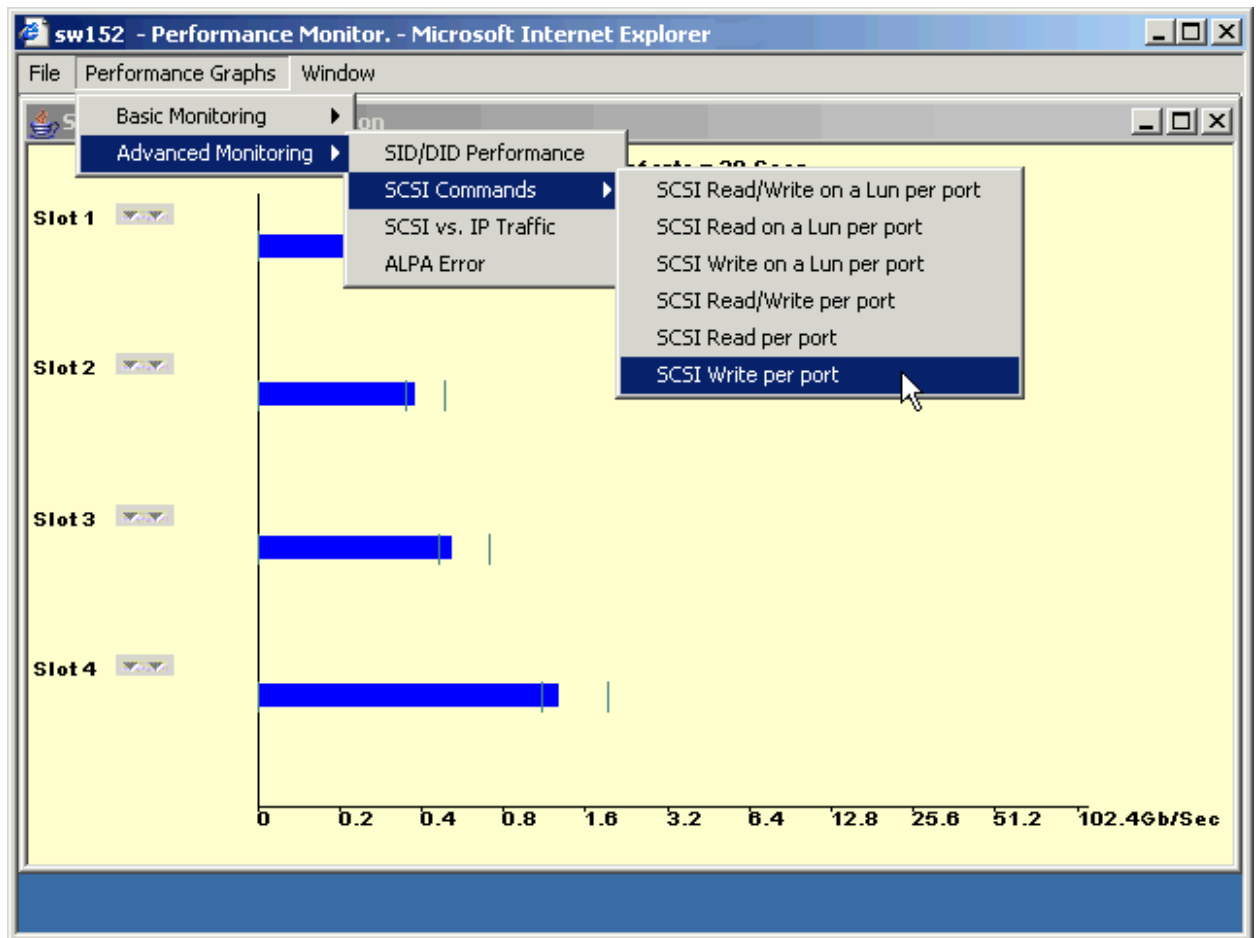
Figure 14-1 Accessing Performance Graphs

Port throughput utilization is represented by a horizontal bar for each selected port, which gets longer or shorter depending on the percent utilization for that port at the last poll time. Thin short vertical intersecting bars give a historical perspective by representing the highest and lowest values reached for each selected port since the graph was opened. A third bar between them represents the average of all values polled. (See Figure 14-1.)

On page 14-3, replace Figure 14-1 with this one:
