# Brocade Fabric OS v5.0.5c

## Release Notes v1.0

January 19, 2007

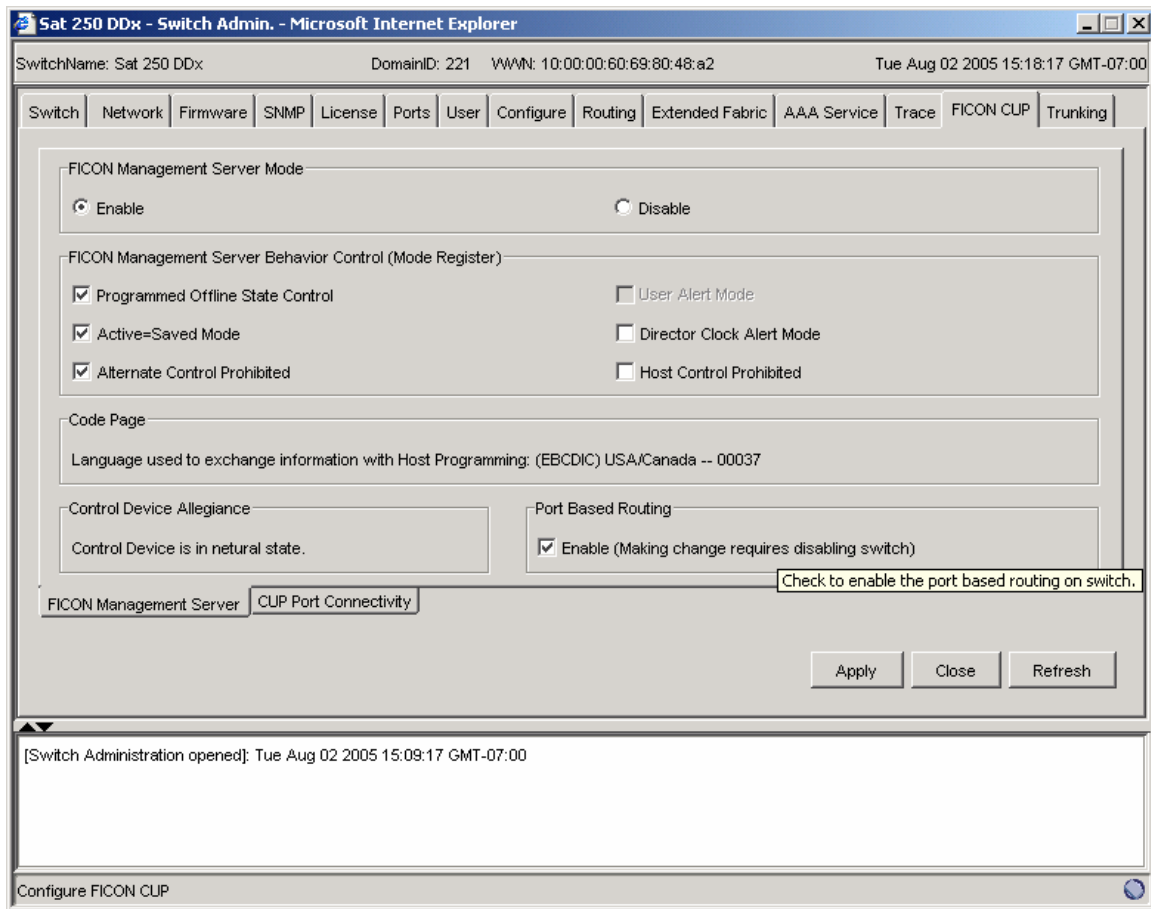
**Figure 12-1** FICON CUP Management, Port Based Routing.

The FICON CUP tab displays, with the FICON Management Server subtab in front, as shown in Figure 12-1.

4. Click the **Enable** radio button to enable the port-based routing policy.

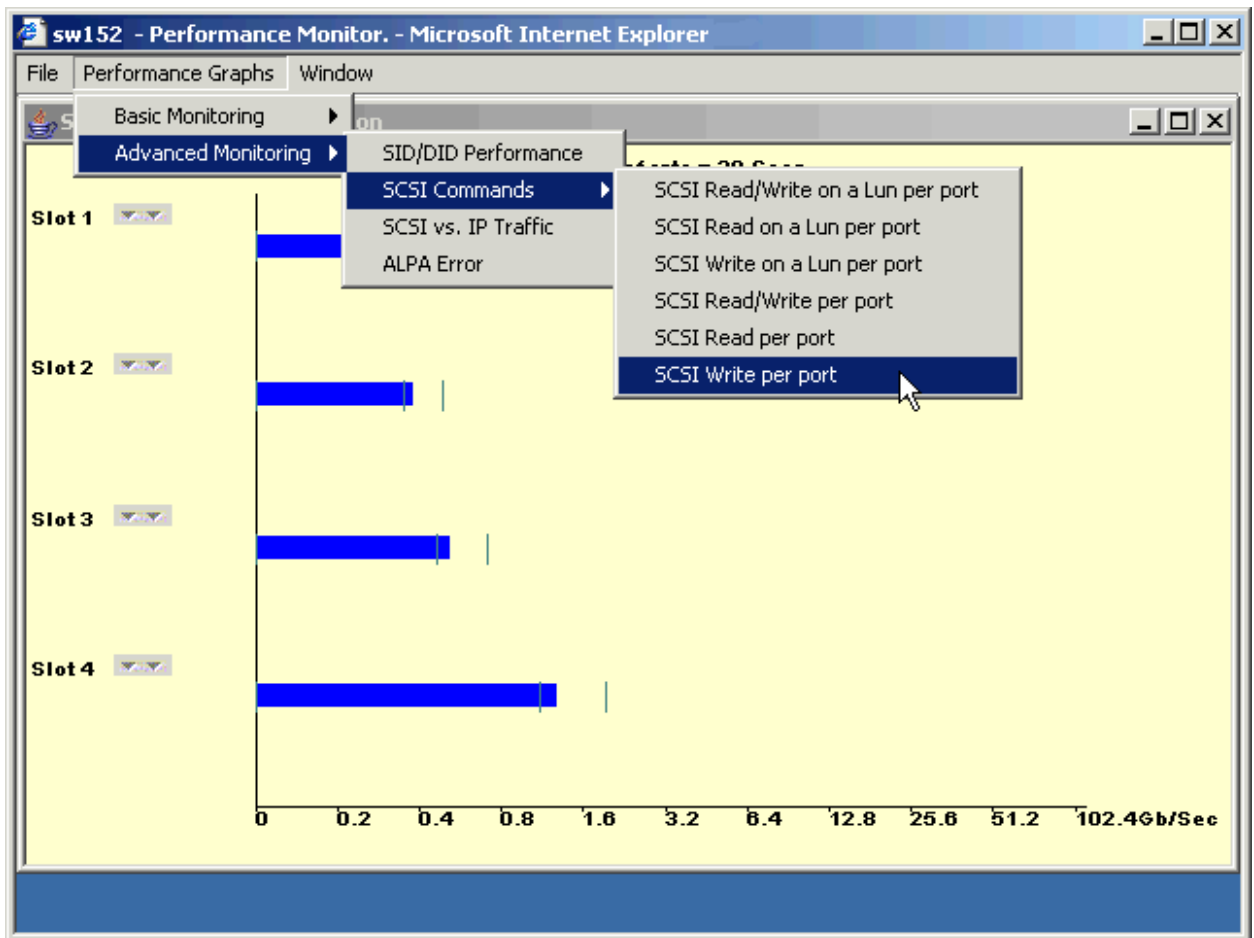
**Figure 14-1** Accessing Performance Graphs

Port throughput utilization is represented by a horizontal bar for each selected port, which gets longer or shorter depending on the percent utilization for that port at the last poll time. Thin short vertical intersecting bars give a historical perspective by representing the highest and lowest values reached for each selected port since the graph was opened. A third bar between them represents the average of all values polled. (See Figure 14-1.)

On page 14-3, replace Figure 14-1 with this one:
