# Brocade Fabric OS v6.3.0b

## Release Notes v1.0

October 30, 2009

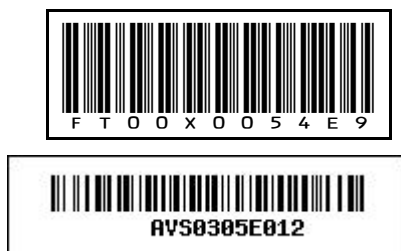
The switch serial number is provided on the serial number label, examples of which are shown here:

The serial number label is located as follows:

- Brocade 4100, 4900, and 7500/7500E — On the switch ID pull-out tab located inside the chassis on the port side on the left
- Brocade Encryption Switch, 300, 5000, 5100, and 5300 — On the switch ID pull-out tab located on the bottom of the port side of the switch
