# Brocade Fabric OS v6.3.0b

## Release Notes v2.0

December 7, 2009

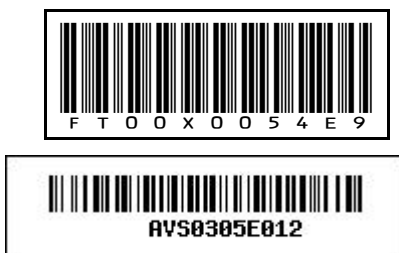
The switch serial number is provided on the serial number label, examples of which are shown here:

The serial number label is located as follows:

- Brocade 4100, 4900, and 7500/7500E — On the switch ID pull-out tab located inside the chassis on the port side on the left
- Brocade Encryption Switch, 300, 5000, 5100, and 5300 — On the switch ID pull-out tab located on the bottom of the port side of the switch
