# Brocade Fabric OS v6.3.1a

## Release Notes v3.0

April 23, 2010

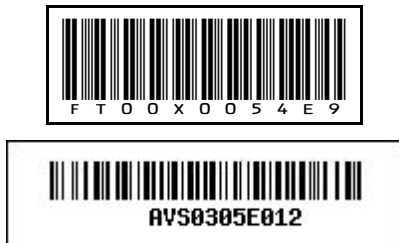
The switch serial number is provided on the serial number label, examples of which are shown here:

The serial number label is located as follows:

- Brocade 4100, 4900, and 7500/7500E — On the switch ID pull-out tab located inside the chassis on the port side on the left
- Brocade Encryption Switch, VA-40FC, 300, 5000, 5100, and 5300 — On the switch ID pull-out tab located on the bottom of the port side of the switch
- Brocade 7600 — On the bottom of the chassis
- Brocade 7800 — On the pull-out tab on the front left side of the chassis underneath the serial console and Ethernet connection and on the bottom of the switch in a well on the left side underneath (looking from front)
- Brocade 8000 — On the switch ID pullout tab located inside the chassis on the port side on the left and also on the bottom of the chassis.
- Brocade 48000 — Inside the chassis next to the power supply bays
- Brocade DCX — Bottom right of the port side
- Brocade DCX-4S — Back, upper left under the power supply
