# Brocade Fabric OS v6.3.1c

## Release Notes v1.0

May 19, 2010

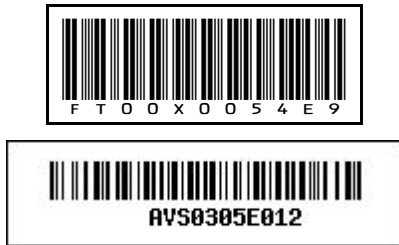
The switch serial number is provided on the serial number label, examples of which are shown here:

The serial number label is located as follows:

- Brocade 4100, 4900, and 7500/7500E — On the switch ID pull-out tab located inside the chassis on the port side on the left
- Brocade Encryption Switch, VA-40FC, 300, 5000, 5100, and 5300 — On the switch ID pull-out tab located on the bottom of the port side of the switch
- Brocade 7600 — On the bottom of the chassis
- Brocade 7800 — On the pull-out tab on the front left side of the chassis underneath the serial console and Ethernet connection and on the bottom of the switch in a well on the left side underneath (looking from front)
- Brocade 8000 — On the switch ID pullout tab located inside the chassis on the port side on the left and also on the bottom of the chassis.
- Brocade 48000 — Inside the chassis next to the power supply bays
- Brocade DCX — Bottom right of the port side
- Brocade DCX-4S — Back, upper left under the power supply
